## MIFACE Investigation: #01MI006

SUBJECT: Pastor struck by falling roof ice dam, subsequently died from complications

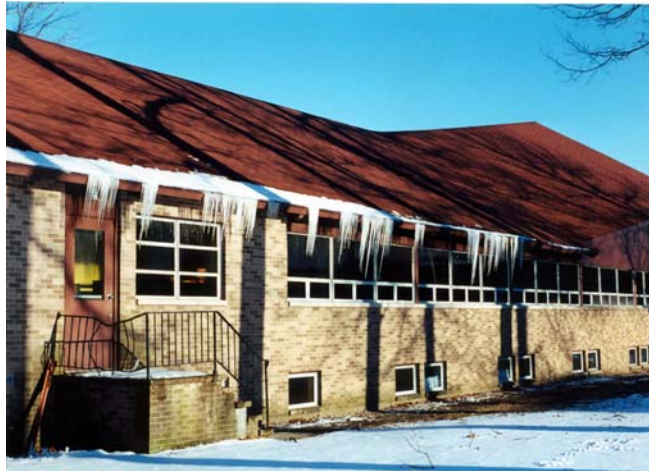
On January 28, 2001, a 48-year old male died of injuries he sustained approximately two weeks earlier when he was clearing icicles from the church roof at the church where he was pastor. The victim stood facing the church building and used a snow shovel to knock off icicles from the west side of the building roof. He began the roof clearing operation by clearing the small icicles from the roof first. After clearing the smaller icicles, he began work on the bigger icicles. Starting from the tip of the

icicle, he used the snow shovel to break the icicle into smaller portions. The victim apparently loosened an ice dam at the roof edge during the icicle clearing operations, and the icicle and the associated rooftop ice dam, estimated weight of one-half ton, fell on him. The icicle crushed his foot, and the ice dam hit his shoulder. He was rushed to the hospital, and due to the extent of the injury, his leg was amputated below his knee. The victim was treated and eventually released from the hospital to continue recuperating from the injury at home. Several weeks later, he began to feel ill, and had difficulty breathing. He was rushed to the hospital, where he died a short time later from a blood clot in his lung.

- Increase truss space ventilation to alleviate accumulation of warm air at the peak of the truss space, subsequent melting of snow that refreezes at the eave edge resulting in an ice dam.
- Increase truss space insulation to minimize heat loss from the building below.
- Identify and seal ceiling openings that allow heat to escape from the heated area of the building to the truss space.
- Use proper tools and removal techniques to remove accumulations of snow on the roof or other methods to minimize ice dam formation.

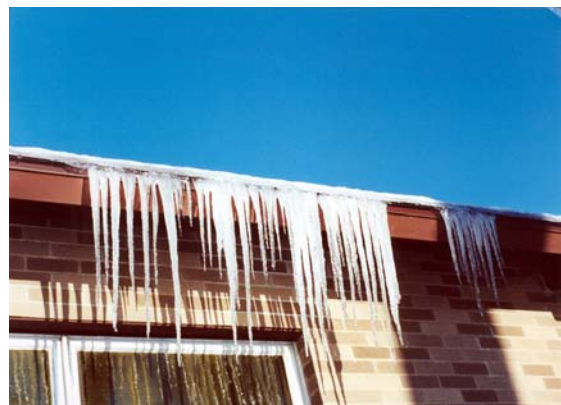
An ice dam is a barrier formed at the roof edge that prevents melt water from running off a roof. Ice dams can form when as little as 1 or 2 inches of snow accumulates on a roof - if the snowfall is followed by several days of sub-freezing temperatures. An ice dam develops when there is a temperature difference between different areas of a roof. In the winter, heated air enters the truss space, accumulating at the truss space's peak unless it is vented outside. Because warm air rises, the upper portion of the truss space is always the warmest. Lower areas of the roof, especially the area just above the eave, remain cold. The area near the eave may have a roof temperature that is not

much higher than the ambient outdoor temperature. Especially in an unvented truss space, heat high in the truss space raises the roof sheathing temperature and causes snow to melt near the roof peak. The water from the melting snow flows toward the eave area, where colder roof temperatures allow it to freeze. If conditions persist over several days, this refreezing of snowmelt can form an ice dam. Deeper snow and colder temperatures increase the likelihood and size of ice dams. Every inch of snow that accumulates on the roof's surface insulates the roof deck a little more, trapping more indoor heat beneath the roof deck. Frigid outdoor temperatures assure a fast and deep freeze at the eaves. So the worst ice dams usually occur when a deep snow is followed by very cold weather.

Upgrades in both ventilation AND insulation must be made for maximal effectiveness to reduce the potential for ice dam formation.

The church does not have any truss space ventilation. Truss space ventilation can help to diminish the temperature differential between the roof peak and the eaves by allowing the heated air to escape from the truss space. The most effective way to eliminate heated air from a truss space area is to combine a ridge vent with soffit vents. A ridge vent is a continuous opening along the entire ridgeline of the roof. The soffit vents must be installed on opposite sides of a building to allow for effective truss space ventilation. With appropriate truss space ventilation, the heat is vented out of the truss space creating a colder roof surface and diminishes snowmelt from the roof surface to refreeze on the eave area, diminishing ice dam and icicle formation.

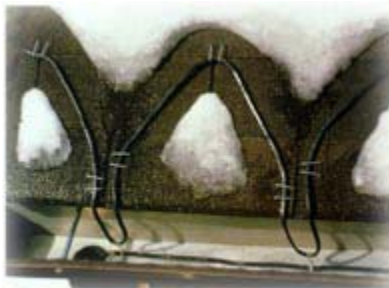
#### *Heat Tapes*

Heat tapes or roof de-icing cables can be used to help prevent ice dam formation on the eaves. Disadvantages to heat tapes or de-icing cables are that they are heated by electric power, are expensive to install and use, and can leak water through loose fasteners. At times, the electric cable creates an ice dam just above it. A qualified contractor is recommended for installation of heat tapes and/or roof de-icing cables.
