MIFACE INVESTIGATION: #02MI029

SUBJECT: Farmer Died After Being Struck While Seated On The Tractor By an Unrestrained Rectangular Haylage Bale That Fell Out of An Elevated Front-End Loader Bucket That Independently Elevated

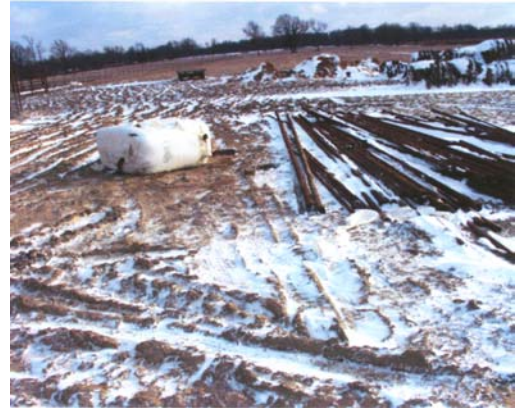
Figure 1. Overview of incident layout and terrain

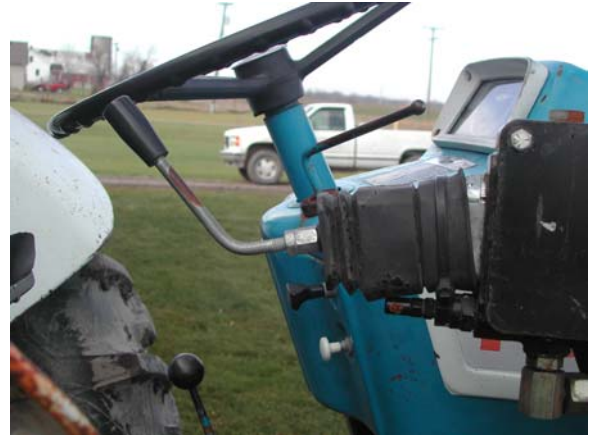
The victim controlled the loader's arm and bucket movement by the use of a joystick. See Figure 2. Moving the joystick up and down raised and lowered the loader arms. Moving the joystick side to side tilted the bucket.

Figure 2. Joystick control operating front-end loader

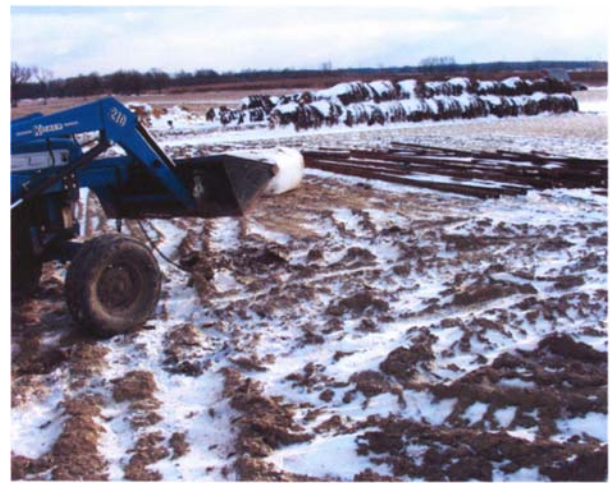
The ground surface conditions on the day of the incident contributed to the fatality. According to the Record of Climatological Observations at the Lapeer WWTP station from the National Weather Service, several days of above freezing temperatures occurred prior to March 11 that caused freeze/thaw conditions at the ground surface. March 7 and 8 high temperatures were 37 degrees and 35 degrees respectively. On March 9, two days before the incident, the temperature reached nearly 60 degrees. It was raining, and the snow that had fallen two days before melted. During the early morning on March 10, the two inches of snow fell. As temperatures increased, the snow changed to rain. The high temperature on March 10 was again nearly 60 degrees, causing muddy conditions. The temperature fell on the night of March 10; one inch of snow fell and a maximum temperature of 22 degrees was reached on March 11. Operating the loader repeatedly over these days in this area contributed to the rutted conditions seen in Figure 3. The police report stated that the winds were strong from the west, and there was less than one inch of snow on the ground. The Record of Climatological Observations did not have any wind speeds recorded for this weather station.

Figure 3. Ground conditions and moved tractor after the incident

The victim kept his plastic-covered haylage bales in rows near the barn and the buffalo pen. The buffalo pen was located behind the barn. To the west of the buffalo were the bales and metal pipes running in a north and south direction. Tracks in the snow indicate the victim was driving the tractor facing west to southwest. See Figure 3.

The operator was operating a two-wheel drive tractor loader over frozen, rutted, snow-covered ground, thereby decreasing the vehicle's control and maneuverability. An inspection of the area and consequent identification and control of the hazards, such as selection of an alternate path or building an improved road-bed pathway to the feeding area may have prevented the tractor's rear wheels from becoming lodged in a rut and causing the victim to rock the tractor to free it.

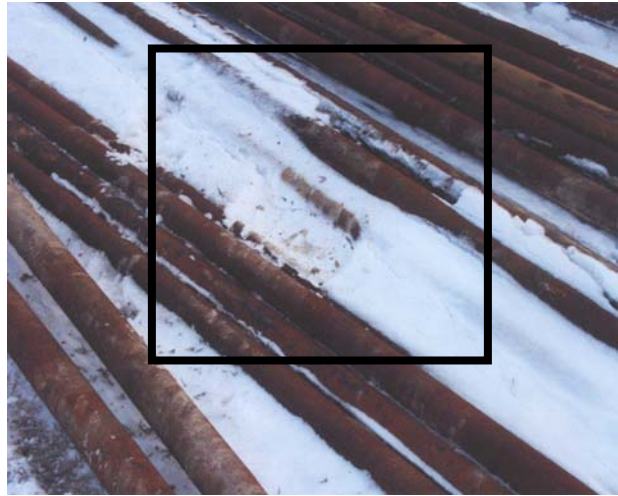
The victim's wife stated that the victim had twisted to look toward the rear of the tractor in her direction while backing up with the hay bale in the bucket in a low position, approximately three to four feet off of the ground. The rear wheels rolled into a depression and became stuck. The police report states that the left front tractor tire was directly on the ground and the right front tractor tire was on the metal pipes. See Figure 4 for the right front tire mark on the metal pipes.

Figure 4. Mark of right front tractor wheel on metal pipes

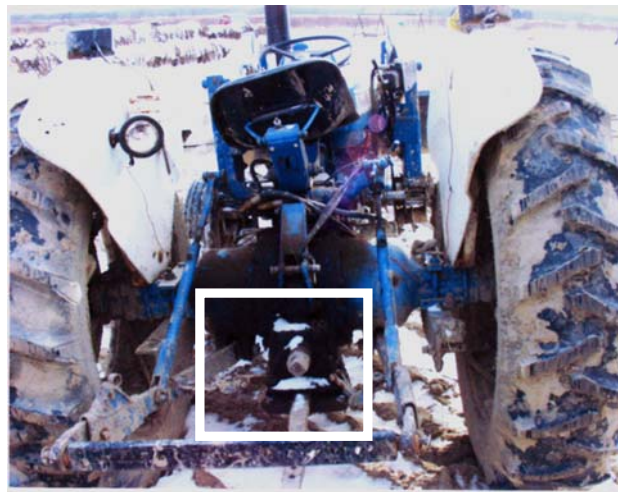
Figure 5. Bent steering wheel and tractor seat. Note unguarded tractor PTO stub

When the bale struck the victim, the weight and force of the bale caused the tractor seat to twist down from right to left. The steering wheel was also bent downward right to left as a result of being struck by either the victim or the bale. See Figure 5.

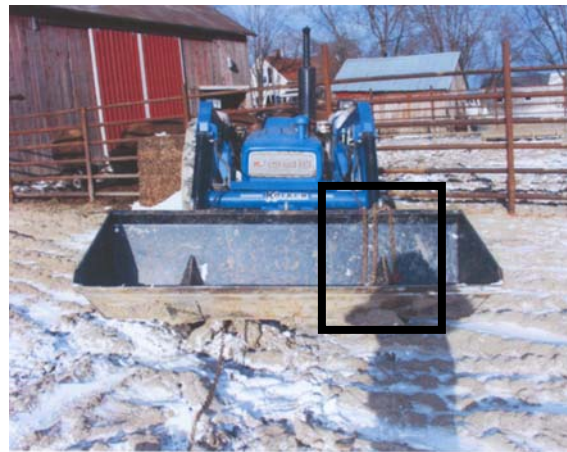
The police found the tractor with the loader's arms elevated and moved the tractor to another location. They set the bucket a few feet off of the ground, turned the tractor off and took the keys. See Figure 6.

Figure 6. Moved tractor with bucket in semi-raised position and loose chain

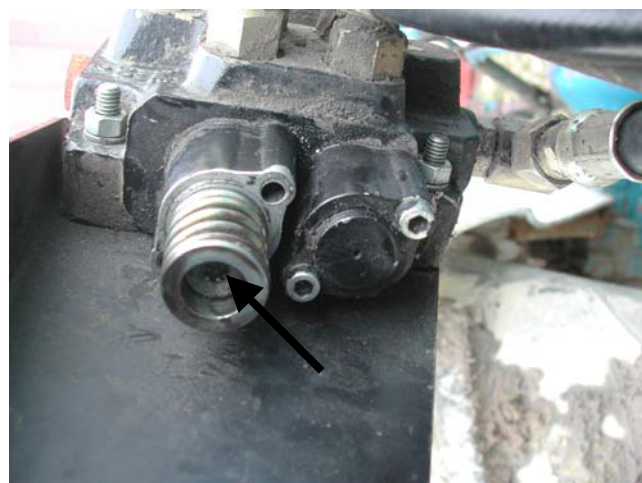
The next day, she spoke with the tractor dealership about the problem. The dealership representative told her to tighten the setscrew that controlled the loader's hydraulics. She found that after removing the protective cover that the setscrew had loosened over time. The loosening of the setscrew permitted the loader's arms to rise independently without touching or operating the control valve. She stated that prior to the day of the incident, the loader arms had not elevated independently.

She tightened the setscrew and that resolved the independent loader arm movement for a few months. After a few more months use, the setscrew loosened again and the loader arms raised independently. The setscrew, according to victim's wife has loosened an additional two times. Each time she tightened the setscrew resolving the problem and continued to use the tractor.

Figure 7. Setscrew controlling hydraulic valve

On the day of the MFACE visit, the setscrew again needed adjustment and the victim's wife demonstrated how the bucket independently elevated when she started the tractor. The MIFACE investigators and the representative of the company selected to replace the joystick observed the loader arms raise without the victim's wife touching the loader's joystick when she turned on the tractor. The victim's wife removed the cover and demonstrated how the dealership recommended she fix the

- The joystick manufacturer should consider reevaluating the design or assembly methods of the joystick control valve to ensure that it cannot loosen once adjusted.

If approved by the manufacturer, a threadlocker compound (an adhesive that cures in the absence of air) could be used on the setscrew to limit its movement without constant tool adjustment.

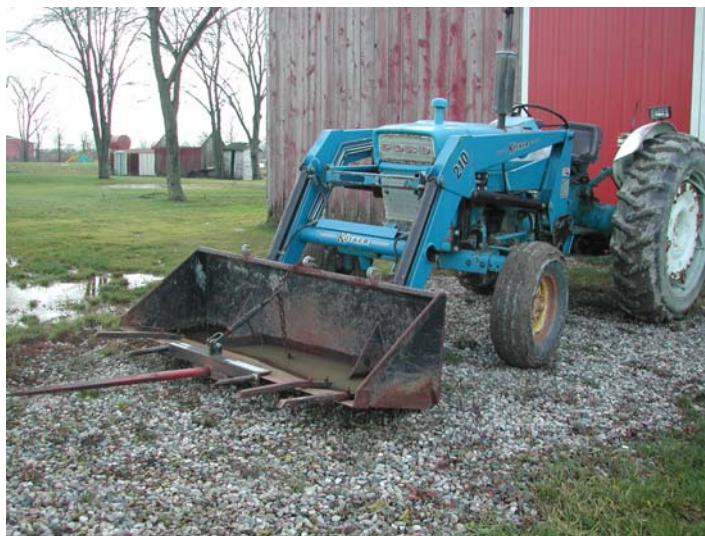
Moving the bale with a tractor equipped with a front-end loader that did not have a grapple to secure the bale was a contributing cause of the fatal incident. The use of the front-end loader without a grapple as a means for handling the large square hay bale presented a hazard, particularly when the loader arms raised independently above the front end of the tractor. A front-end loader equipped with a grapple, designed for the task being performed by the operator would have provided a safe means for handling the hay with less risk to the operator. After the incident, the loader bucket was equipped with a bale spear. See Figure 8. The spear attachment is not normally designed nor intended for use

Figure 8. Bale spear attachment to loader bucket

- When using a tractor loader to move a bale, properly secure the bale with a manufacturer's approved device such as a bale spear, clamp or grapple.

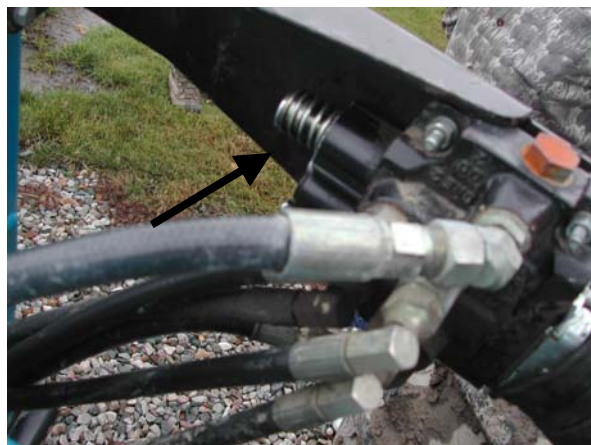
The joystick control valve has a setscrew that regulates the hydraulic component of the front-end loader. The setscrew tightens the spring centering mechanism that keeps the loader in a neutral position. The setscrew does not have a lock washer or other mechanism to keep it in place. During use, this setscrew loosens. The spring centering mechanism allows the hydraulic fluid to be pumped to the loader’s arms resulting in the loader’s arms elevating.

Figure 10. Hydraulic control setscrew location

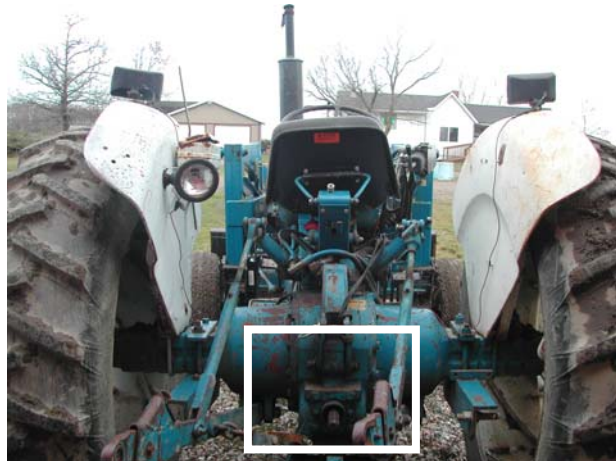
Exposed rotating shafts are hazardous situations that can cause serious injury. A PTO operating at 540 rpm rotates around 9 times/second. It takes only about one second to completely strip off an article of clothing or if the cloth does not tear away, and to wrap a body or body part around a shaft. Clothing is pulled around the shaft much quicker than a person can pull back or take evasive action. Even a quick reaction time, one-half of a second, would permit a piece of clothing to wrap around a shaft rotating at 540 rpm at least two times.

A total shielding system for a PTO driveline includes a tractor stub master shield, the PTO driveline shield and an implement shield. The master shield prevents the operator from accidentally coming into contact with the tractor stub shaft. Figure 5 and Figure 9 show the unguarded PTO shaft.

Figure 9. Exposed PTO shaft

- Although not a factor in this incident, MIFACE recommends that the tractor PTO stub shaft be guarded at all times to prevent entanglement.

Most newer tractor manuals recommend that a PTO stub shaft guard be used to completely enclose the tractor stub shaft when the PTO is not being used. The stub shaft guard will not only protect the operator but also keep the PTO stub shaft clean and in good condition.

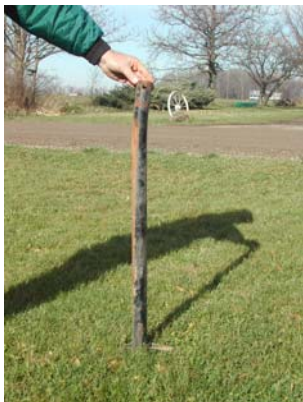
The loader was equipped with one self-storing stand (see Figures 11-13) that was designed to support the bucket during bucket quick disconnect. The support stand bent when the victim used it to support the loader crossbar while he was disconnecting the bucket. The MIFACE researchers do not know under what conditions (type of terrain, level/sloping, wet/dry, stand incline angle, etc) the support stand was used. The farm homestead land was fairly flat. Other Koyker front-end loader models have dual stands to support the loader crossbar during bucket disconnect. The manufacturer does not recommend the installation of the dual-support stand loader models on the victim's tractor model. MIFACE suggests that the equipment manufacturer reevaluate the design of the model of loader recommended for the victim's tractor to insure that the loader can be adequately supported by one support stand and if the current support stand material is strong enough to support the loader under all conditions of use.

Figure 11. Loader's bent support stand

- The front-end loader manufacturer should consider reevaluating the loader model support system design.

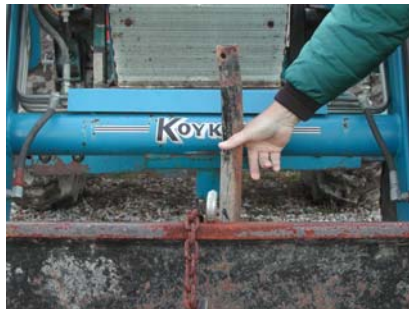
Figure 12. Single central support location

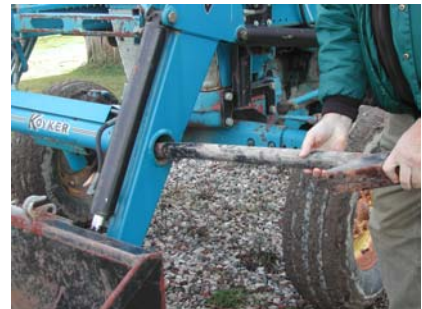
Figure 13. Location of support storage
