## **MIFACE INVESTIGATION: #02MI121**

### **SUBJECT: Electrocution of Family Member When Welding on Rotary Disc Mower on Farm**

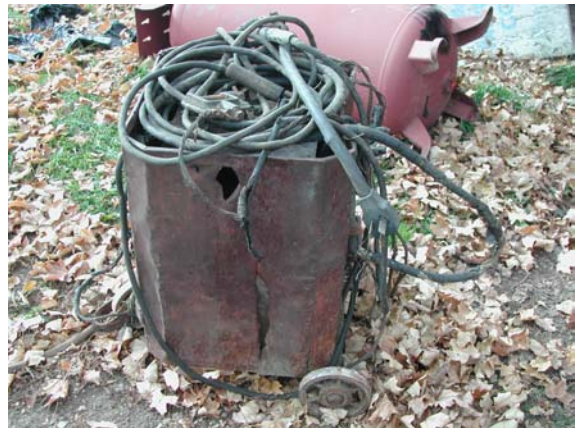
Figure 1- Overall Poor Welder Condition

- Equipment should be maintained in good operating condition

The brother of the victim indicated that they both knew about the condition of the “ground” cable insulation and the overall condition of the welder. They talked about repairing the welder, but never got around to it. Maintaining equipment is integral to safe operation of the equipment so that it can provide the protection it was designed to do.

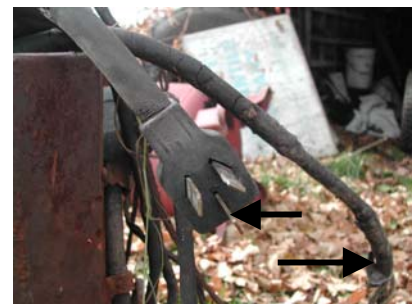
The welder was a portable, plug-in-cord Miller Electric 240V arc welder. The family bought the welder used in the 1960's. The welder was kept inside the farm shop, plugged in at an outlet. The welder's ground wire inside the plug was broken off; the ground tong could be easily moved by hand. The insulation was in poor condition on both the welding lead and the ground cable. (See Figure 2).

Figure 2-Ground prong loose and damaged insulation

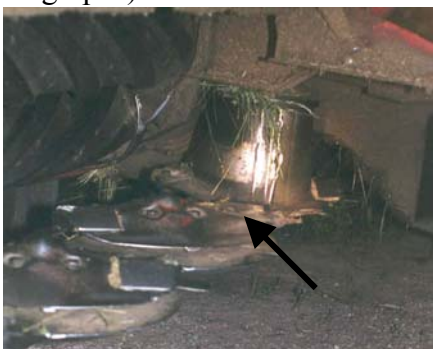
The rotary mower was a New Holland Discbine, Model 441. With use that year, part of the disc had broken and the stone guard also had to be fixed (See Figures 3 and 4 – state police photographs).

Figure 3 – Damaged Mower Disc

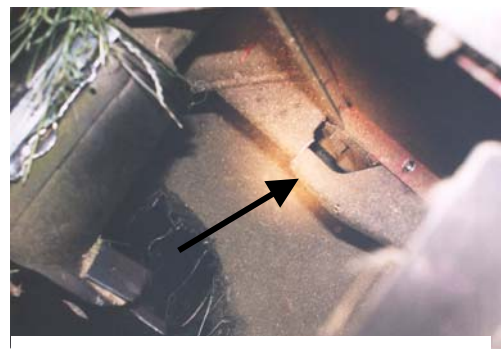
Figure 4 – Damaged Stone Guard

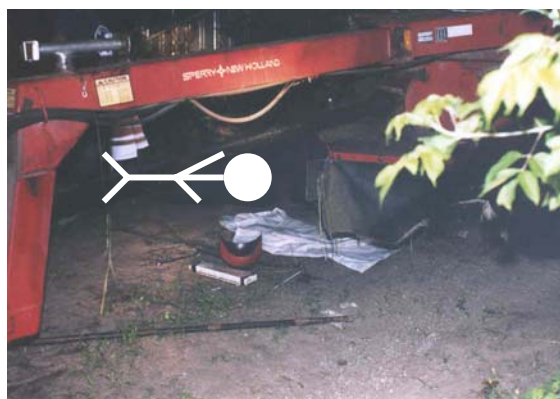
His brother came by to check on him after completing his chores. He saw him laying on the ground and thought he may have fallen asleep after a long day (See Figure 6). The brother went to the house and spoke with his mother about the victim. She said to go back and check on him. He went back to the machine shed and rolled the victim over. He was going to give CPR but the obvious condition of his brother made it unnecessary. The mother, upon arriving at the incident site, touched the mower and received a shock. The dog also touched the mower and yelped. While the victim's brother turned off the circuit breaker, the mother called for emergency response. When the state police arrived, the welding mask and welding rod apparatus were on the ground several feet from where the victim was laying. The victim was declared dead at the scene.

Figure 6 – Position of Victim

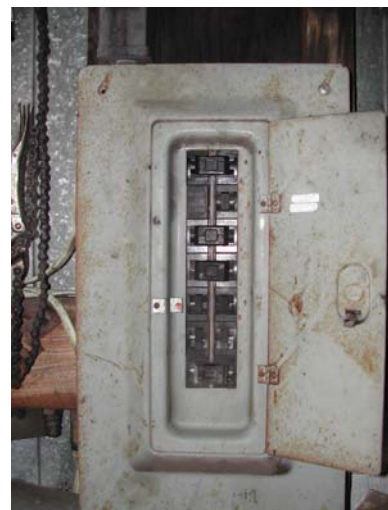
The circuit breaker in the machine shed did not have labels on the box (See Figure 7). It is recommended that labeling of all breakers be done to, not only identify the breaker and the system it is responsible for, but also to aid in an emergency situation so that individuals trying to turn off power to a system can quickly identify it.

Figure 7. Unlabeled circuit breaker box in shed

- All circuit breaker circuits should be labeled as to the outlets covered by each breaker.
