MIFACE INVESTIGATION: #02MI157

SUBJECT: Hispanic Laborer Dies When Dump Mechanism of Lift Truck Activates and Crushes Him Between the Truck Bed Bulkhead and Bridge Beam

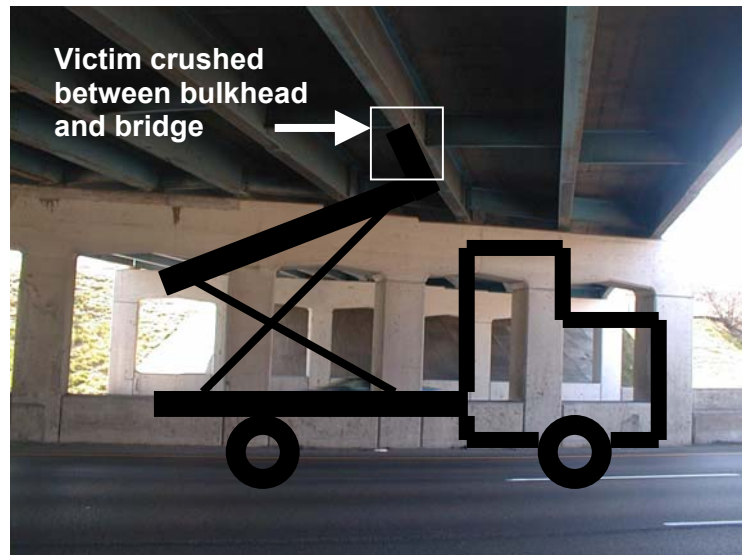
Figure 1. Position of Truck Bed Under Bridge

On November 21, 2002, a 20-year old Hispanic laborer and coworker were removing bridge formwork while working from an elevated truck bed. They had previously been patching a road when the foreman instructed them to begin the removal of bridge formwork. The truck used was designed so the truck bed may act as an aerial lift or as a dump truck. The victim and coworker were in a raised position, approximately 10 feet off the ground in the truck bed and had been working for approximately one hour. The control to raise and lower the truck bed was located near the bulkhead of the truck bed. They attempted to lower the raised truck bed, but it wouldn't move. They called down to another coworker, who told them to try to raise the bed a little, and then try to lower the truck bed. The victim and coworker were standing near the bed's bulkhead when one of them tried to raise the truck bed. When they attempted to raise the bed, the truck bed bulkhead was thrust upward and the rear of the truck bed dropped quickly toward the ground (See Figure 1). The victim and coworker were crushed between the bulkhead and a bridge beam, and then slid off the angled truck bed to the ground. 911 was called and emergency responders arrived. Both individuals were taken to a local hospital, where the victim died of the injuries sustained in the incident. The coworker survived.

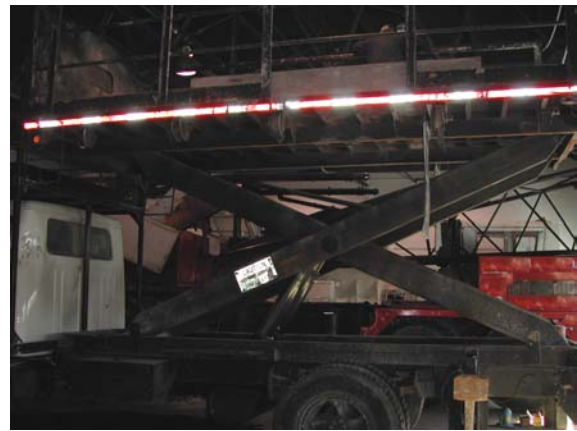
Figure 2. Truck bed in raised position

The truck, built in 1985 was purchased used in 1996 in another state and driven back to Michigan. It did not come equipped with an operator's and/or maintenance manual. The truck was stationary when the incident occurred; its outriggers were deployed. The truck bed is usually raised and lowered when employees are in the truck bed, although it can be raised and lowered by controls from within the cab. The truck bed is 16 feet long and 8 feet wide. The truck bed has a 4-foot safety rail installed on the 2 sides; it did not have a safety gate on the back of the truck.

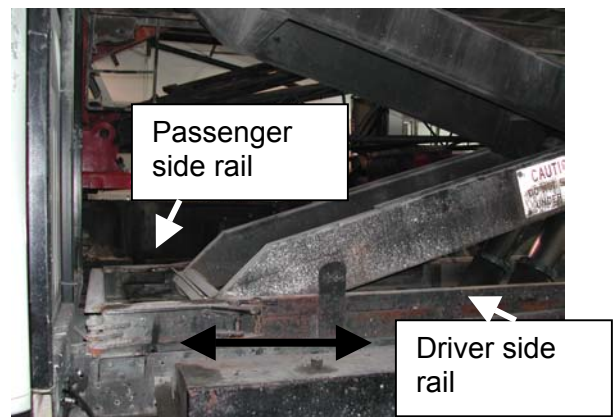
Figure 3. Truck frame/scissor arm configuration

The truck is designed so the truck bed may act as an aerial lift and as a dump truck. At the base of the truck bed are scissor arms. One scissor arm has rollers on each side of the arm that moves horizontally along a rail mounted on the truck frame. The rail on the truck frame that is on the driver's side of the truck is identified as the "driver's side rail" and the rail on the passenger side of the truck is identified as the "passenger side rail" in this report. The other scissor arm is permanently attached to the truck frame. The scissor arm with the roller provides the mechanism that raises and lowers the truck bed, and permits dumping of a load. The double-sided arrow indicates roller movement along the rail.

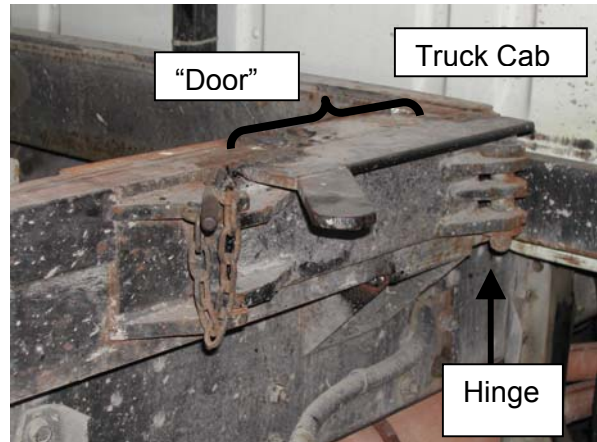
Figure 4. Rail “door” in closed, pinned position

On each side of the truck frame near the cab is a hinge that allows the “doors” on the rail to be in an open or closed position. (See Figure 4). When the rail “doors” are closed and pinned, the rollers move horizontally along the rail on the truck frame and the truck bed will only raise and lower. As the rollers move toward the rear of the truck, the truck bed raises; when the rollers return toward the truck cab, the truck bed lowers. There is an audible alarm as the truck bed lowers to truck frame level.

After the incident, company personnel discovered that the driver's side rail "door" was closed and pinned and the passenger side rail "door" was open. The following sequence of events is proposed: When the truck bed was raised, the driver's side roller continued toward the rear of the truck on the inside of the rail as designed to raise the truck bed. But, when passenger side roller reached the open rail "door" position, it entered the open "door" as it was designed to do to dump. This exerted pressure on the passenger side roller causing it to leave the rail and "ride" on top of the rail. When the employees were trying to lower the truck bed after completing their task, the passenger side roller was on top of the rail and the driver side roller was within the rail. The action of trying to lower the truck bed exerted additional pressure on the roller within the rail. When the employees tried to raise the truck bed, further pressure was exerted on the driver's side roller causing it to jump out of the rail. With both rollers outside of the rail, the truck bed dumped. The sudden action caused the truck bulkhead to slam the workers against the bridge beam and they subsequently slid down the truck bed to the ground.

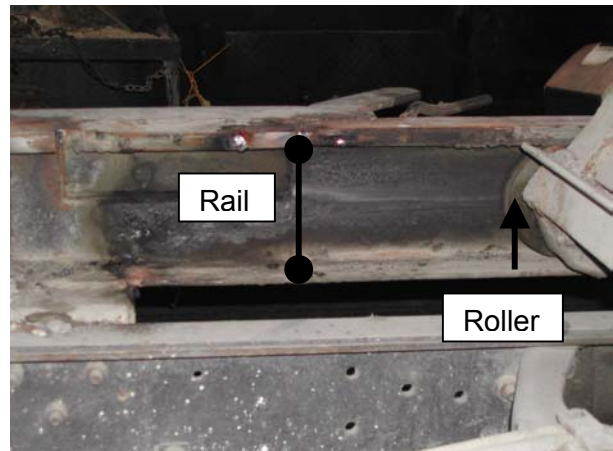
Figure 5. Close-up of roller, rail

The rail "doors" must be in the open position to allow the dump mechanism to operate. To open the rail "doors," a locking pin is removed and the "door" handle is moved toward the truck cab. A toggle switch initiates the dump sequence. The rollers at the base of the scissors move along the rail until they reach the open "door" position and leave the rail track. With the rollers stopped outside the rail, instead of lifting the whole truck bed levelly, the truck bed bulkhead starts to rise while the rear of the truck bed remains stationary. This causes the truck bed to incline and dump. See Figure 5.
