## MIFACE INVESTIGATION: #03MI025

SUBJECT: DPW Worker Run Over by Pickup Truck Exiting the Vehicle to Open an Overhead Garage Door

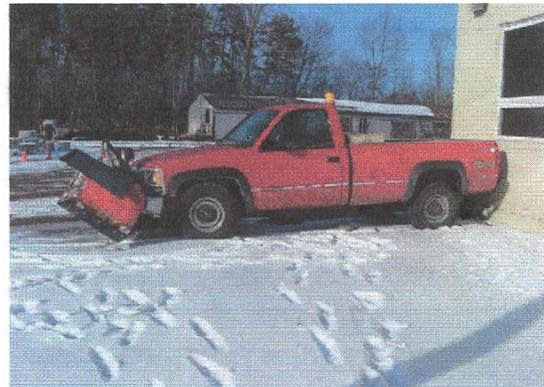
Figure 1. Final resting place of truck

snow are thought to be efforts he made to climb back into the truck, presumably to stop the truck. The imprints are repeated three times. He placed the front half of the right foot on the ground. The impression in the snow indicated his foot slid to the right and back. It appears that he lost his footing, fell, and was run over by the driver's side front truck tire, rolled by the truck undercarriage, and then struck by the plow. The truck continued in reverse in a smooth, symmetrical, circular arc (approximately a 270-degree arc) from the point where the victim may have driven the truck onto the apron to the resting point at the northwest corner of the garage wall. Figure 5 shows the area behind the garage where the footprints were visible. The orange cones mark the path of the truck as it traveled in reverse before coming to rest against the west wall of the garage. The truck finally came to rest against the west wall, the truck cab facing to the west with its wheels spinning. (See Figure 1 on Page 1 of this report)

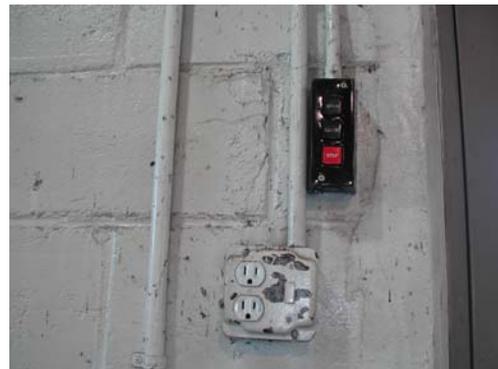
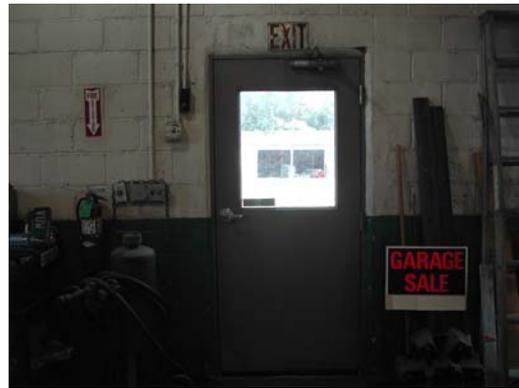
Figure 2. Remote garage door opener by pedestrian door

by a garage door opener mounted on the wall approximately 6-inches from the frame of the pedestrian door located adjacent to the overhead door. On the day of the incident, the pedestrian door was left unlocked; the victim did not need to remove his keys from the ignition to unlock the door. See Figures 2 and 3.

Figure 3. Remote control garage door opener by pedestrian door

- The DPW should explore assigning each operator or equip each vehicle with a remote garage door opener for the overhead door.

The DPW had installed a remote control overhead door operating system near the pedestrian door to assist operators in opening and closing the overhead door. MIFACE recommends that the DPW explore the possibility of having a remote control garage door opener assigned to each

operator or equip each vehicle that is driven and stored in the garage with a garage door opener. This would allow an operator to stay in the vehicle to open as well as close the overhead door when coming out of the garage if he/she is the only individual present. This would eliminate the need for the operator to exit the vehicle and provide for operator safety, not only in inclement weather but also at night.

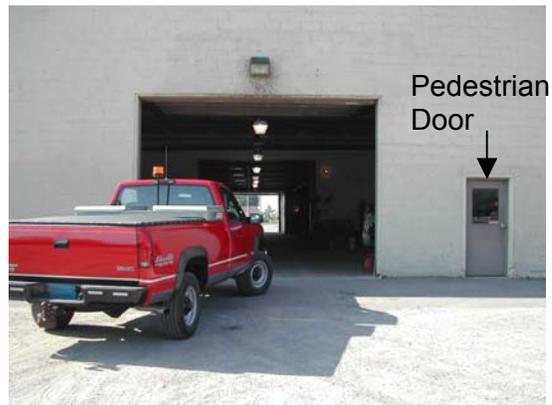
During the MIFACE visit, a DPW worker positioned the truck to the location where the victim might have driven the truck to prior to exiting. (See Figure 4) The plow was raised approximately 10-inches from the ground. There is a slight incline at the entrance to the overhead door. The truck's front wheels would have probably been turned at an angle as a result of making a circle to enter the overhead door and to position the truck so it could be parked. Vehicles were parked in the DPW garage at an angle. Figure 4 shows the truck orientation at the garage and location of the pedestrian door. Note that the front wheels are turned as a result of driving to this location through the back lot and positioning the truck to drive at an angle into the garage.

Figure 4. Possible location of truck when pulled onto asphalt apron

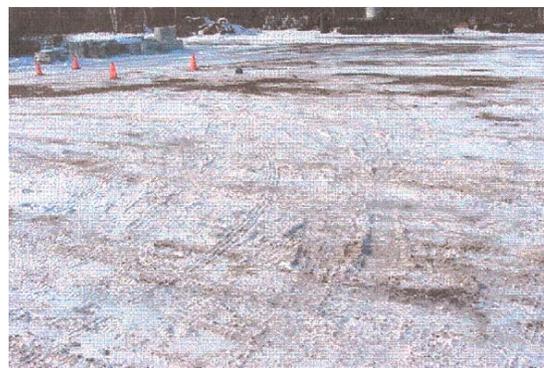
Figure 5. Area behind truck where victim tried to reenter truck

- Employees should be instructed never to try to stop a moving vehicle.

Operators should be instructed that they are not to attempt to remount a moving vehicle. Although the truck was moving at idle speed, his best safety action would have been to let the truck come to rest naturally instead of trying to get back into the cab to stop its movement. It should have been let go and retrieved once it came to rest.
