MIFACE INVESTIGATION: #04MI108

SUBJECT: Farmer Died When Run Over by Rear Wheel When He Started the Tractor While Standing On the Ground

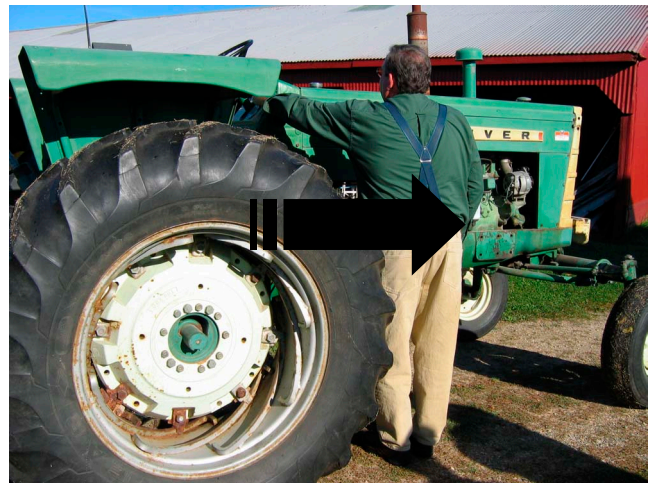
Figure 1. MIFACE researcher standing in victim's probable location while starting tractor and tractor movement

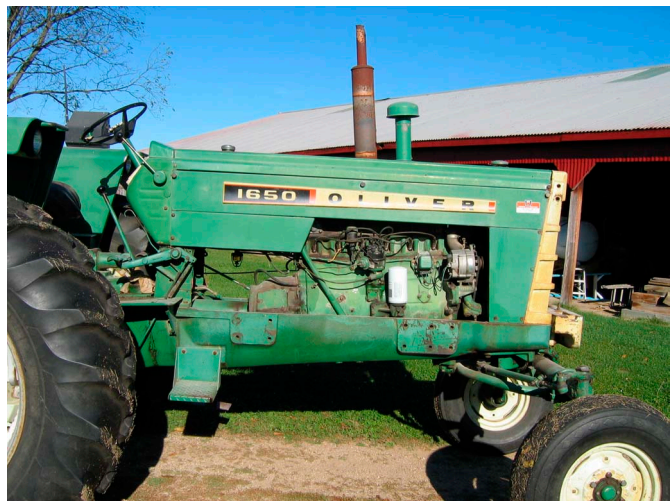
The deceased had purchased the wide-front, gasoline-powered 1650 Oliver tractor new in the 1960s. It is unknown if the victim had the operator's manual available. The clutch and brake pedals on the tractor were smooth on the pedal surface. The six-ply, chloride-filled rear tires added weight for traction. The tractor had a neutral gear, but did not have a neutral-start safety feature. Figure 2 shows an overview of the tractor. The gearshift was 23 inches long. It was located on the floor between the tractor seat and the dash under the steering wheel, approximately six inches from the dash at its base on the floor. The edge of the seat to the dash was approximately 13 inches. The tractor key was approximately 67 inches off of the ground on the operator's right when seated on the tractor. The distance from the key to the center of the rear tire was 36 inches. The victim attached a homemade step to each side of the tractor as an assist in mounting and dismounting the tractor.

Figure 2. Tractor involved in incident from the operator's right side

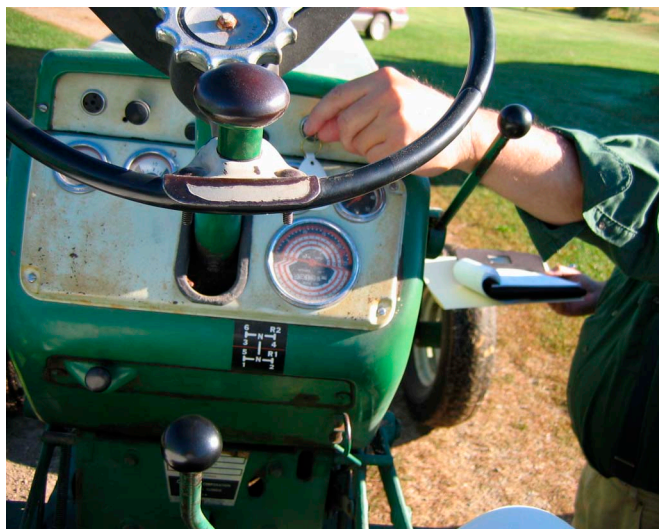
His son stated that his father, prior to dismounting the tractor, would place the gearshift in neutral and turn the tractor key to the "off" position. He would not normally depress and lock the tractor brakes. The victim usually dismounted the tractor from the operator's left side because of his knee replacement. It is hypothesized that while attempting to dismount from the tractor, one of the victim's legs struck the gearshift and placed it into first gear.

Figure 3. Location of tractor starter key, gearshift and steering wheel

Unbeknownst to him the tractor was in gear. Standing on the ground in front of the operator's side right rear tire, he reached up to turn the key to start the tractor's engine. Because the tractor was in gear, it began to move forward. He was unable to get out of the way of the rear tire. (See Figure 3). The tractor ran over him, continued on into a lean-to type barn, entered the second bay in the barn and was stopped by the side of the barn where the engine eventually stalled out.

- Tractors should only be started when the operator is on the tractor platform sitting in the operator's seat.

The operator's seat of farm tractors and other machines provides a workstation from which the operator can maintain proper control of the machine. When a tractor engine is started in gear, it may move suddenly and run over anything in its path. Starting the tractor while it is in gear is an unsafe practice. Proper control is necessary not only during operation of a tractor or machine, but also whenever an engine is started. While seated in the operator's seat, an operator should check the engine throttle position, disengage the clutch and shift the transmission into neutral or park before the engine is started. Setting the brakes will prevent the tractor from rolling before the operator engages the transmission. Before starting a tractor engine, the operator should also ensure the power take off is disengaged. Performing these steps will reduce the likelihood of a tractor or machine accidentally moving forward or backward after the engine starts. In addition, if a tractor or machine does unexpectedly begin to move after starting, an operator seated in the seat will not be in danger of being run over and will be in position to maintain safe operating control.

Many modern tractor systems are equipped with additional safety interlock systems. Tractors equipped with neutral-start safety switches prevent the starter from cranking the engine if the transmission or clutch is engaged. When using an older model tractor without these safety interlock systems, one must be particularly careful to follow safe tractor starting procedures.
