## MIFACE INVESTIGATION: #05MI046

### SUBJECT: Lawn Technician Dies When Pinned Between Motorized Spreader Handles and Roof of Work Van

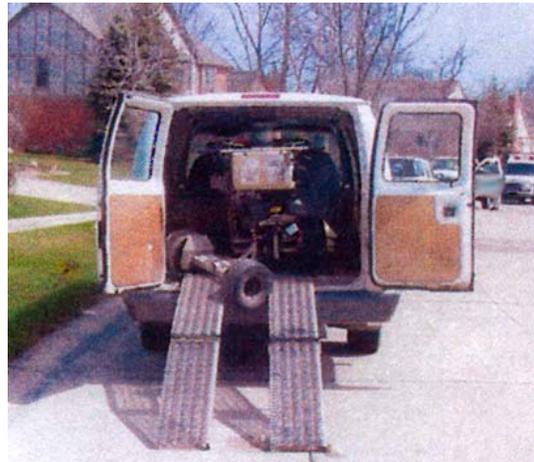
Figure 1. Van with sprayer and ramps leading to ground

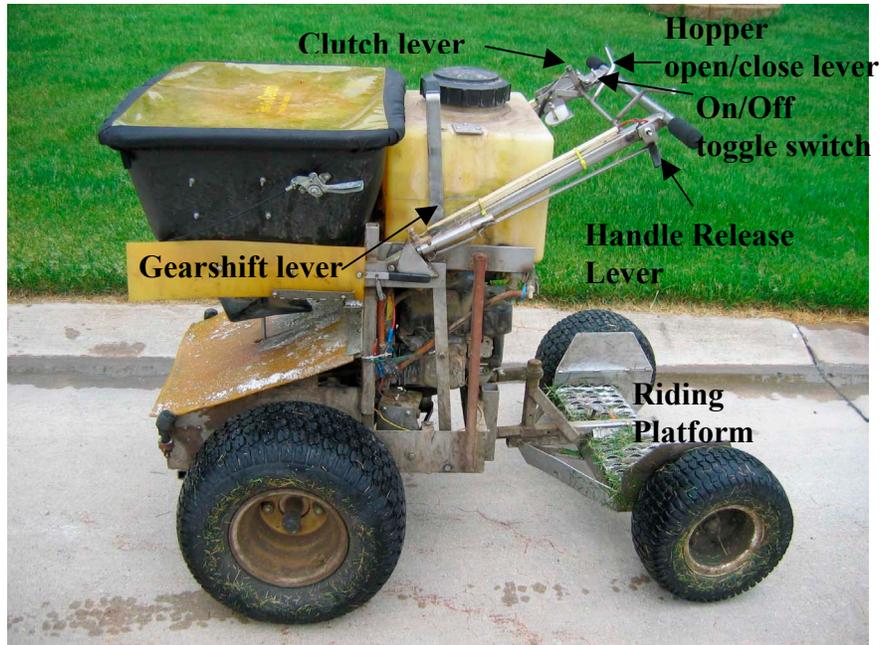
The victim was using a Perma-Green Supreme Robin 6.0 model, gas powered, clutch driven, ride-on sprayer-spreader. (The sprayer/spreader will be referred to as spreader for this report). The company bought this machine new in 2002. The spreader had a handle release, a clutch, gearshift, throttle, and brake. The machine was equipped with an attached riding platform for the operator. (See Figure 2) The machine could be operated as a walk-behind as well as a riding machine. To convert it to a walk-behind, the operator pulled the handle release lever and stepped backwards off the riding platform while pulling the handle down.

Figure 2. Ride-on spreader/sprayer

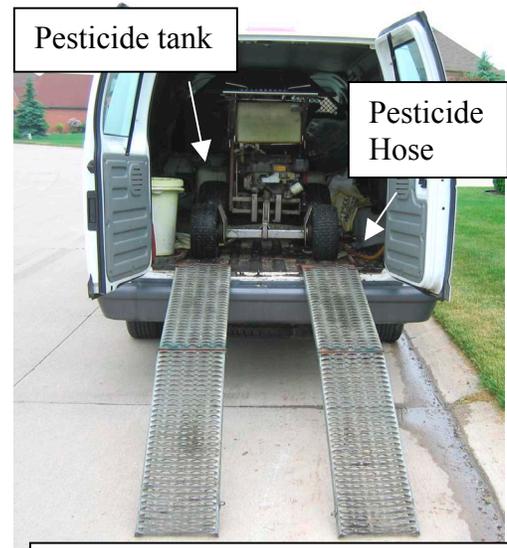
Figure 3. Position of spreader in standard size van prior to unloading

into and removed from the transport van. The unwritten procedure to unload the machine from a standard size van was as follows: To remove the spreader, the operator opened the back doors and pulled down the ramps. The operator shifted the spreader transmission into neutral, pulled the machine back about three to four inches to the back of the van, turned the machine on by activating a toggle switch, placed the machine in reverse, and started the spreader with the pull cord. The operator would then exit the van, move the handles down, and pull and hold the clutch lever. The machine could then be backed down the two unloading ramps. Reverse gear was the farthest forward position followed by neutral. To load the spreader, the machine was maneuvered up the ramps and placed against the pesticide storage tank anchored on the van floor (See Figure 3).

The MIFACE researcher observed the victim's trainer fill the machine with pesticide while the spreader was in the van. To do this operation, the employee was required to lean over the handles to maneuver the pesticide hose to the spreader's reservoir (See Figure 3). It is unknown whether the spreader's pesticide tank the victim was using had been filled. Another possible scenario is that while the victim was filling the spreader's pesticide tank, he may have unknowingly caught his glove or he bumped his arm against the gearshift and inadvertently moved the gearshift to the reverse position. When he started the machine while inside of the van, the machine moved and he was pinned.

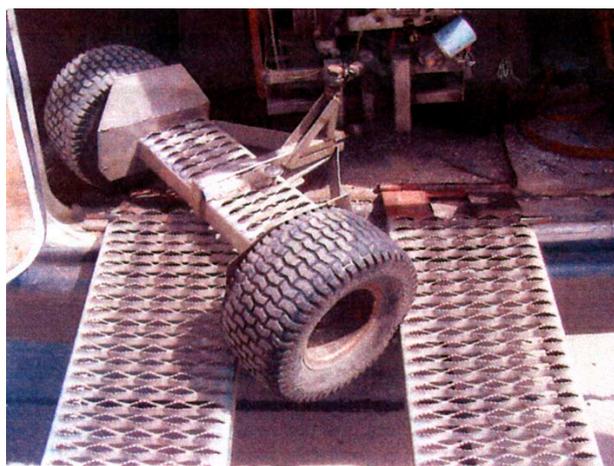
The hopper had not yet been filled with granular fertilizer. It appeared that he was in the process of unloading the spreader from the back of the extended van when he became pinned between the handles of the spreader and the roof of the van. When the responding police arrived they noted that the spreader engine switch was in the "on" position, and the engine was not running although there was still gas in the tank. The gear selector was in the reverse position. They also noted that there were scrape marks on the tires and the van floor, which indicated that the machine had been running but eventually stalled out. Fresh rubber powder was observed in line with the tire and metal ramp tie down bar. The spreader's rear right wheel was hanging between the two ramps. Its left rear wheel was still inside the van. (See Figure 4) A torn work glove was hanging from the handle of the machine. The van was still running, idle speed.

Figure 4. Position of rider platform tires outside of van

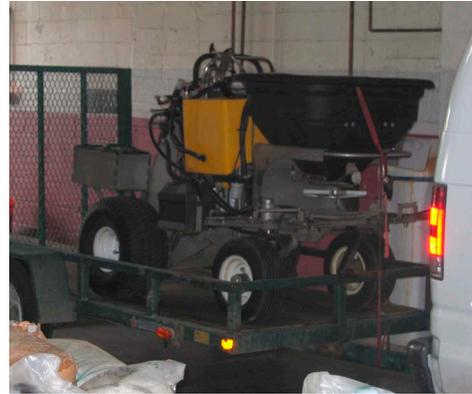
Figure 5. Trailer on back of work van

The trailer in Figure 5 and the basket in Figure 6 must be equipped with at least one rear lamp mounted on the rear, which, when lighted, shall emit a red light plainly visible from a distance of 500 feet to the rear (MVC Sec. 686(1)). When the spreader is placed on the trailer or basket platforms, the spreader may obscure the rear registration plate. According to Section 686(2), the registration plate must be clearly legible from a distance of 50 feet to the rear.

The company has reviewed the use of a van to transport the spreader/sprayers and is currently retrofitting their work vans and pickup trucks (as shown in Figures 5 and 6) to minimize the hazard of placing the employee in a confined space with the equipment. Figure 5 shows the retrofit installation of a hitch/trailer combination on the back of a company van. This combination has a full ramp to load and unload the spreader on the trailer. Figure 6 shows the retrofit installation of a “basket system” for the equipment at the rear of a company pickup truck. Depending upon the configuration of the trailer, it may be possible to anchor the pesticide tank or other type of tank to the trailer and thus keep the tank on the outside of the vehicle.

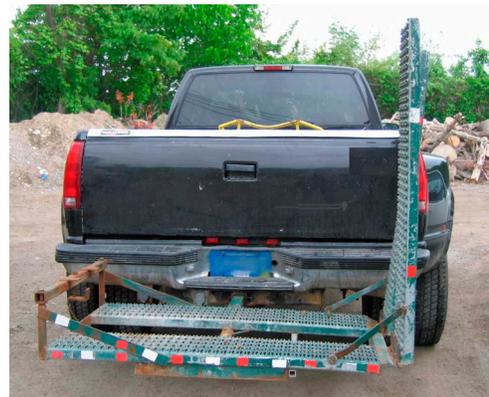
Figure 6. Basket mounted on pickup truck

Michigan MVC Sec. 686 states that "motor vehicles, trailers . . . shall be equipped with at least one rear lamp mounted on the rear, which, when lighted as required by this act, shall emit a red light plainly visible from a distance of 500 feet to the rear". Figure 6 shows the basket added to the rear of one of the company's pickup truck. The configuration of the basket's vertical ramp obscures the pickup's right rear taillight. If the equipment loaded obscures the other pickup taillight, the company would be in violation of the Code and a possible violation could be issued
