MIFACE Investigation #06MI117

Subject: Male Siding Installer Dies After Falling From a Roof While Installing a J Channel on a Dormer

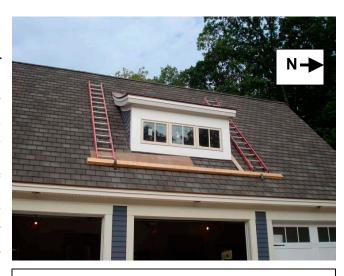
Figure 1. Re-enactment of incident scene showing placement of the roof brackets, planks and ladders.

After arriving on the worksite, the decedent, who was working by himself, installed the metal roof brackets for the roof bracket scaffold platform. The brackets were designed for a 2x4-inch wood plank (Figure 2). He positioned the brackets 11 feet apart (Figures 1 and 2). The employer stated that the decedent had not screwed the bracket in the way the had been trained nor in the way the company normally installed the roof brackets.

• Employers should ensure employees use the correct roof brackets and are trained and follow the "best safe work practice" when installing a roof bracket scaffold platform – using the correct roof bracket for the roof pitch and securing the bracket by 16d nails anchored into a roof rafter.
