MIFACE INVESTIGATION REPORT: #07MI044

SUBJECT: Farmer Dies When His Tractor was Rear-ended by a Semi

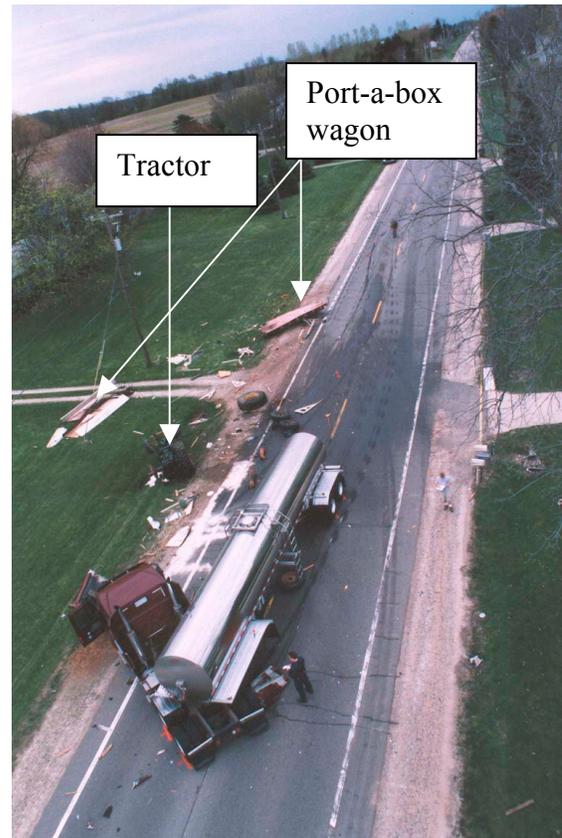
Figure 1. Overview of incident scene

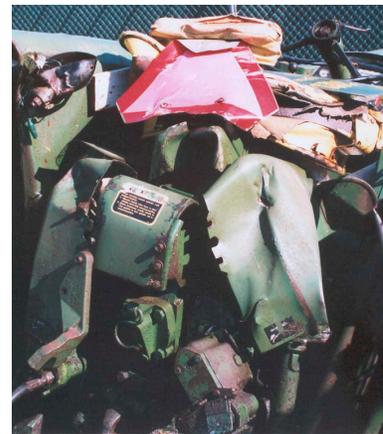
Figure 2. Police photo after the incident showing SMV emblem affixed to the tractor

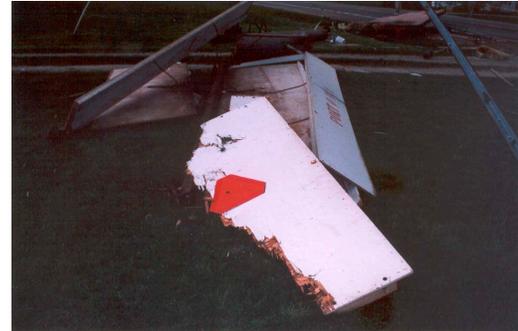
He attached the port-a-box wagon, which had a retro-reflective SMV emblem attached to the rear (Figure 3), and proceeded home via the direct route at approximately 2:00 p.m. The road upon which he was traveling when he was struck had a dry, blacktop surface with paved shoulders that transitioned to gravel, and then grass ditches. The roadway was straight at the crash location; there were no hills, curves or dips in the road. The posted speed limit was 55 mph. There were no traffic control devices, fixed objects, or vision obstructions in the area or near the roadway.

Figure 3. SMV emblem on wagon

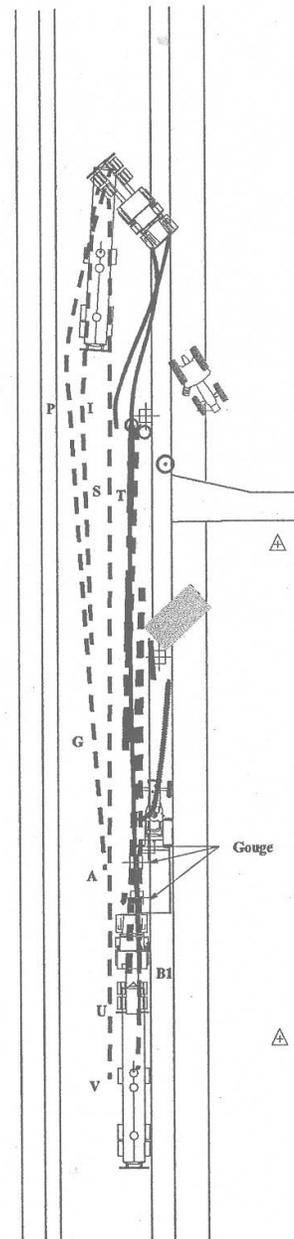
Both the decedent and a semi truck hauling an empty milk tanker were traveling northbound (Drawing 1). A tractor driver, also traveling northbound was approximately one-half mile behind the decedent. This tractor driver stated in the police report that the semi approached his tractor, so he moved to the right hand far shoulder of the roadway. The semi driver slowed down and passed him in the southbound lane, waved as he passed, and then moved back into the northbound lane.

The semi driver stated he swerved but indicated he didn't have time and was too close to be able to avoid a collision. The right front of the semi cab struck the left rear corner of the wagon and then struck the tractor, causing the wagon and tractor to become separated

Drawing 1. Police drawing of incident scene

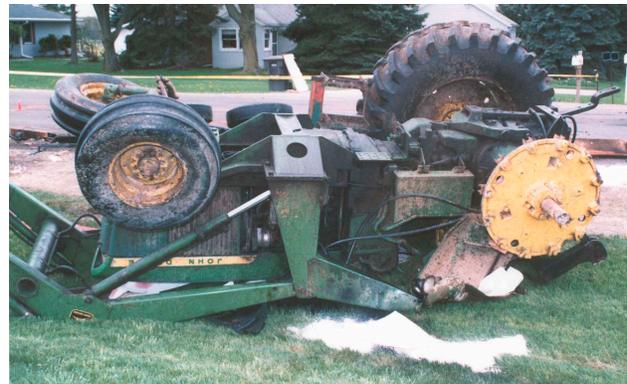
Most of the damage was on the right rear end of the tractor, which was contact damage. The 3-point hitch was broken off from the tractor and the right rear tire was broken off from the rim and axle. The left rear tire had fresh rubbings where it had rubbed on the semi milk tanker.

The decedent's tractor flipped and landed in the ditch upside down on the east side of the road with the front end facing southeast (Figure 4). Part of the wagon was on the east side of the road with the front facing in a southwest direction; the rest of the wagon was northeast of the wagon bed in a yard. The decedent was ejected from the tractor and was lying on the ground between the semi milk tank and the tractor. There were skid marks from the tires of the tractor and wagon also on the road veering off to the right. Post impact tire marks for the tractor were also observed. There was a large tractor tire mark that began directly on the fog line for northbound traffic, and then proceeded between the fog line and the gravel on the east side of the roadway. This tire mark led directly to the area of the first portion of the wagon.

Figure 4. Tractor upside down after being struck by semi

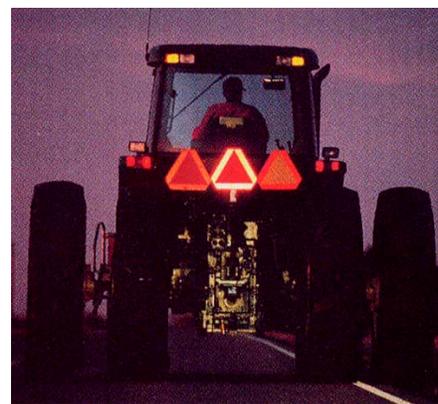
Figure 5. Comparison of SMV emblems

The new SMV emblems have fluorescent material aiding daytime visibility and reflective material aiding nighttime visibility (Figure 5). Replacing worn SMV emblems is important because the orange fluorescent center portion of the SMV emblem fades and turns color over time, changing from orange to yellow, pink or white. This portion is the most vulnerable to light and moisture degradation because fluorescent dyes decompose.

Retro-reflective material as found in the outer border of the SMV emblem reflects the headlights of vehicles approaching from the rear at night. Retro-reflective material holds up longer than fluorescent material. The retro-reflective readings on SMV emblems meeting the new ASAE standard are over ten times greater than most of the readings on SMV emblems currently in use. Figure shows a comparison of older and newer SMV emblems. The SMV on the left is a new sign under the old standard, the SMV in the middle is a new sign under the new standard, and the SMV on the right is an old sign under the old standard.

- Upgrade old slow moving vehicle (SMV) emblems to the new retro-reflective SMV emblems.

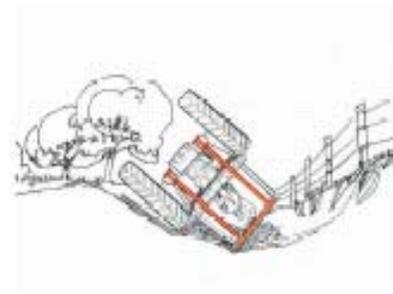
ROPS are designed to help limit a tractor overturn to 90 degrees and to provide the operator a “zone of protection” (Figure 6). The operator must stay within this zone. *The operator will not be protected by the ROPS during an overturn if the operator is not wearing a seatbelt.* Without a seatbelt, the operator may be totally or partially thrown off the tractor. The seatbelt keeps the operator within the "zone of protection" provided by the ROPS. Even inside a cab, seat belts are important to keep the operator from being thrown against the frame, through a window, or out a door. Therefore, when an older tractor is retrofitted with a ROPS, approved seatbelts must also be installed. Seat belts may or may not be included with an available ROPS package.

Figure 6. Operator Zone of Protection when wearing seat belt

- Retrofit older tractors with properly designed, manufactured and installed ROPS and seat belt when available.

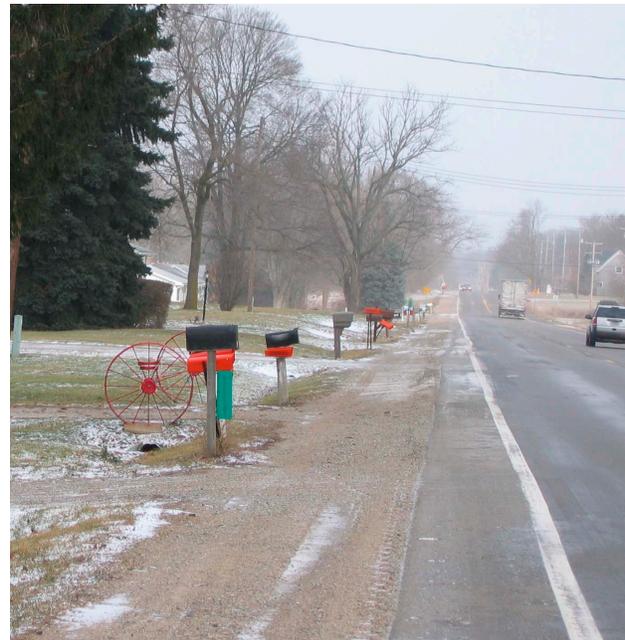
The MIFACE researchers recreated the travel route of the decedent. Although the photograph does not do it justice, it was very apparent that the orange paper boxes affixed to either mailboxes or free standing used to store delivered papers could provide visual confusion to any vehicle operator who was driving on the road (Figure 7). Although the paper boxes were located primarily on the southbound side of the road, as the researcher was looking on the northbound lane in the distance, the orange color blended into the roadway.

Figure 7. Orange mailboxes on southbound side of roadway

MIFACE encourages communities to assess potential visual cue confusion issues, such as orange paper delivery boxes and illegally mounted SMV emblems. MIFACE encourages communities to mandate that objects on the side of the road be of a color that cannot be confused with the colors of warning symbols, such as slow moving vehicle emblems. These objects should be

removed and replaced. Communities should also direct their enforcement agencies to inform the public about the misuse of SMV emblems as markers and ensure the SMV removal.
