MIFACE Investigation Report #10MI069

SUBJECT: Hispanic Farm Laborer Electrocuted in Potato Field

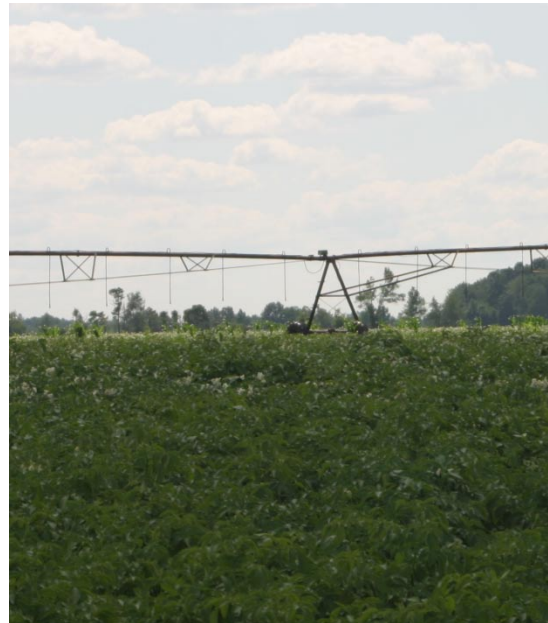
Figure 1. Irrigation unit involved in incident.
