MIFACE Investigation Report #12MI008

Subject: Farm Laborer Died When Struck By Front End Loader Bucket

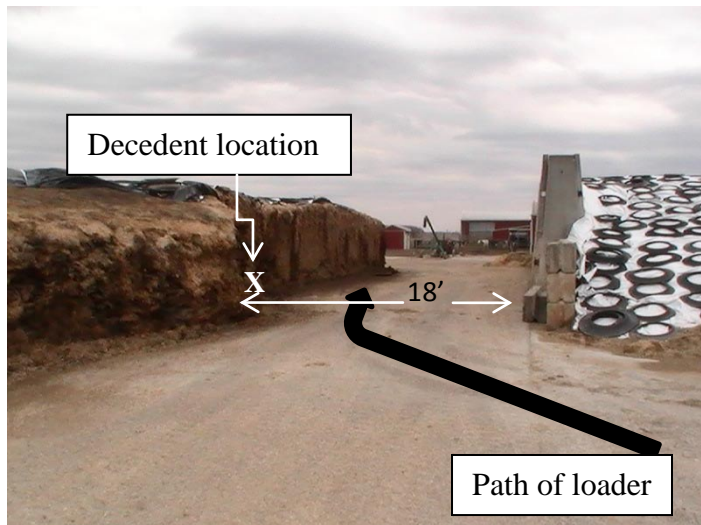
Figure 1. Incident area showing decedent's location and travel path of loader

working, the silage protruded approximately seven feet, which placed the decedent in the shadows. The front end loader operator was rounding the corner of the bunker silo on his way to obtain additional feed. It is hypothesized that the corner of the front end loader bucket struck the decedent. The impact knocked the decedent to the ground and he was run over by the front left loader tire (Figure 1). The decedent was alert and breathing when transported by helicopter to a nearby hospital. He died the following day from complications of the injuries sustained at the time of the incident.

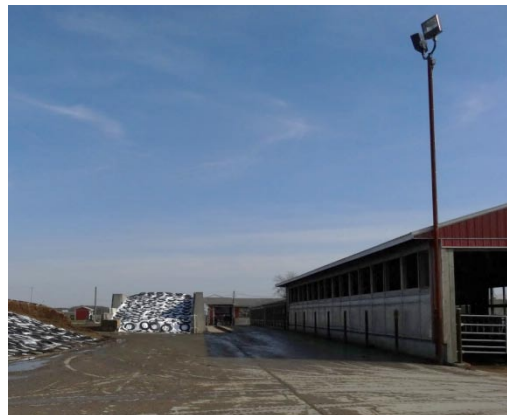
Figure 2. Location of high lumen sodium light.

- Reflective work vests are required for work during dark hours (before dawn and after dusk)
- Placed high lumen sodium yard lights to illuminate work area (Figure 2).
- Cut back silage pile to make a wider transport aisle for loader (Figure 3).
- Changed bunker wall configuration to minimize equipment turn radius (Figure 3).
- Moved feed mixing area nearer to the dairy operation.
- Change in feed work practice: One individual uses the loader to load feed and stays in the loader – another individual works by feed mixer to cut hay bale strings.
- Heightened safety awareness with added zero tolerance for risky work practices.
- Established the incident area as a restricted work area until daylight hours.

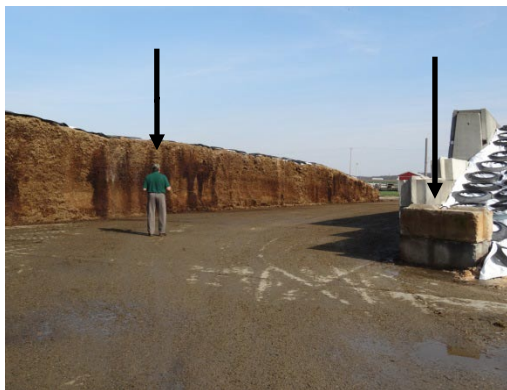
Figure 3. Bunker configuration change – note angle of cement compared to Figure 1 and approximate location of decedent.

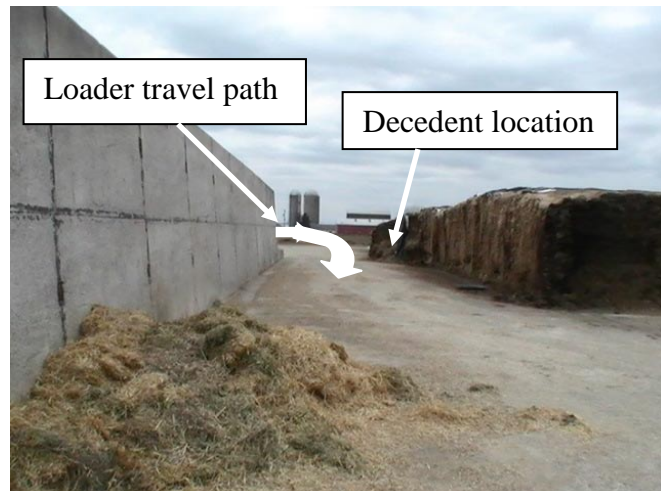
Figure 4. Incident area, standing on east end of bunker silo looking west.

With the front end loader facing south, the operator unloaded the contents of the bucket of the loader. The operator then backed up while turning the rear of the loader to the west so that the loader faced east. He then drove forward and began to round the corner of the bunker silo (Figure 4). He did not know that the decedent was working in the area

The front end loader operator did not see the decedent because of the dark and dusty conditions and because decedent was on the ground on foot in dark clothing. Both the police and the farm owner hypothesized that the decedent was struck by the loader bucket and then run over by the left front wheel of the loader while the operator was driving forward.

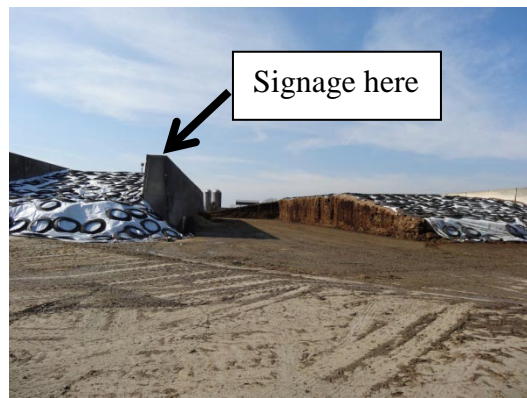
Figure 5. Possible signage location.

- Post a pictogram or a KEEP OUT/RESTRICTED WORK AREA sign in both Spanish and English sign on the bunker near the driveway entrance to alert workers.

The farm has established the area where the incident occurred as a restricted work area - restricting personnel access when it is dark. Although training had been performed, a sign/pictogram could be placed on the bunker walls (Figure 5) warning workers of the danger in the area and of the restricted nature of the area to serve as a visual reminder. Because the farm had workers who spoke Spanish, MIFACE recommends posting this area with a pictogram or sign in both English and Spanish as a reminder to workers.

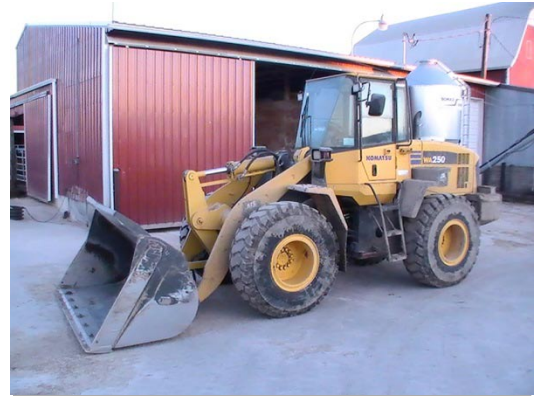
Figure 6. Front end loader involved in incident.

- Consider mounting auxiliary lighting (such as a light bar) on the front end loader and skid steer loaders for use during non-daylight hours.

A significant amount of work on a dairy farm is performed during non-daylight hours. Additional lighting on the loader (Figure 6) and the skid steer would increase the visibility of workers on foot as well as providing the machine operators better visibility for equipment operation.

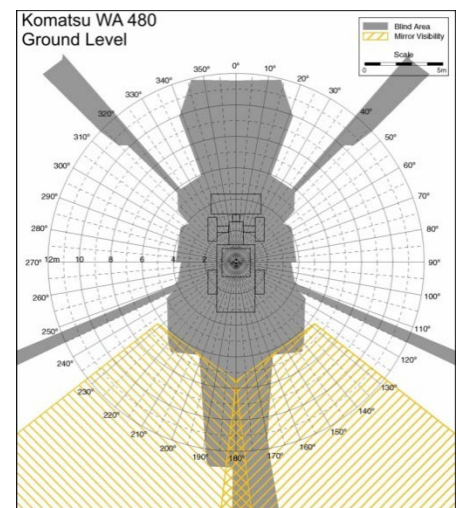
Although not the same model number, the NIOSH Workplace Safety and Health Topic, Highway Work Zone Safety, Construction Equipment Visibility provided a ground level blind area diagram for the Komatsu WA 480. Illustration 1 shows the ground level diagram identifying the machine operator blind spots for objects at a 3-foot height (approximately the height of a construction barrel). The areas in grey show the areas that the machine operator cannot see. With the decedent bending over, he would have been less than three feet high and it would have been extremely difficult for the operator to see him.

Illustration 1. NIOSH Construction Equipment Visibility Chart, Komatsu WA 480, ground level

- Train machine operators and workers on foot regarding the machine operator blind spots.

Employers should use the blind spot diagrams provided by NIOSH to train both the work on foot and the machine

operator to develop awareness about hazardous areas around construction vehicles and equipment due to limited visibility.
