MIFACE INVESTIGATION REPORT #13MI043

SUBJECT: Truck Driver Crushed By Roll Off Scrap Metal Box During Unloading From Truck

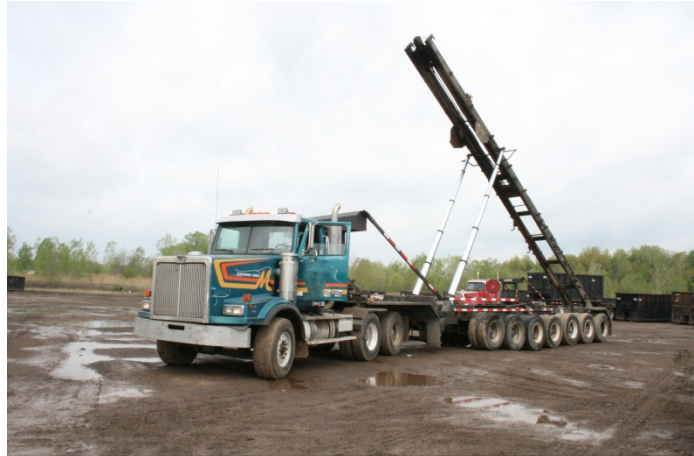
Figure 1. Overview of incident scene in company yard.

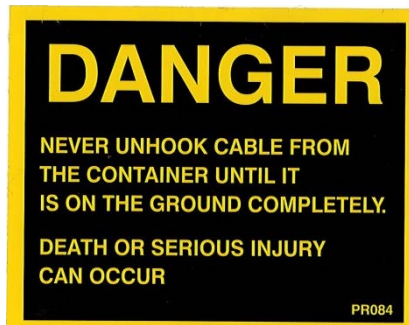
- The firm now holds safety meetings every two weeks at the end of the workday.
- The firm developed a written safety program.
- The firm developed a safety label to apply near the operator controls to remind workers to not unhook the cable from the container until it was completely on the ground. See Figure 2.

Figure 2. Company-developed safety label.

In addition to the existing safety reminders, MIFACE recommends that manufacturers develop and apply a safety notice/label near the operator's controls that reminds employees that the cable should not be unhooked until the container is completely on the ground.

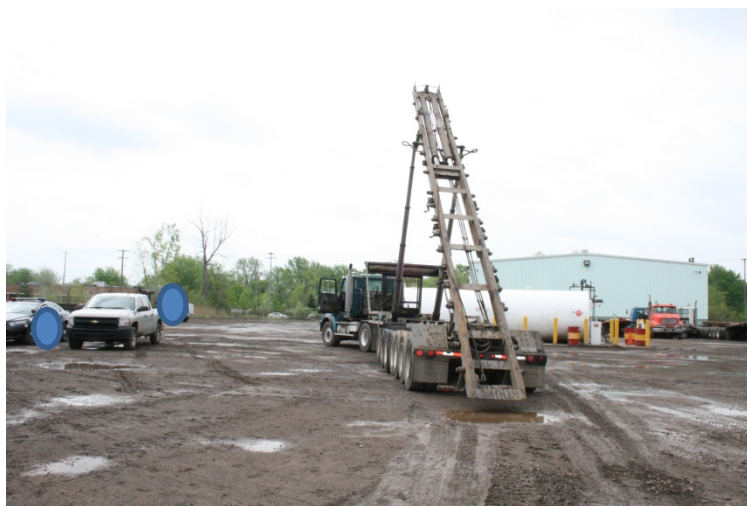
Figure 3. View of truck/trailer from near container and decedent’s location. Note that stinger is not fully on the ground.

question. When his coworker arrived at the location, he observed the tilt frame fully extended, the stinger almost touching the ground (but not under the container), the container off the trailer and fully resting on the ground, and the decedent under the box See Figure 3 for the location of the stinger in relation to the ground. The front end loader driver ran back to the shop to get help and have someone call 911.

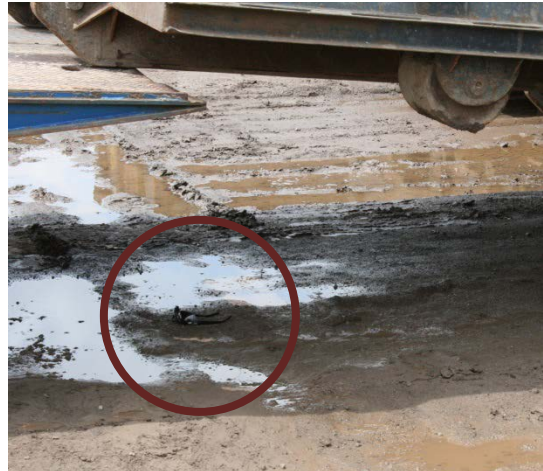
When the container was raised, the decedent's unfolded sunglasses were found under the box (See Figure 4). A fresh gouge mark was noted on the driver's side trailer bed rail (See Figure 5). Presumed scenario: Contrary to company procedure, the decedent did not fully deploy the container to the ground prior to releasing the wire rope. While the container was still on the stinger/trailer tilt frame, his sunglasses fell out of his pocket. He may have been reaching under the container to retrieve his sunglasses when the container fell from the trailer tilt frame, pinning him against the ground.

Figure 4. Sunglasses location found under container.

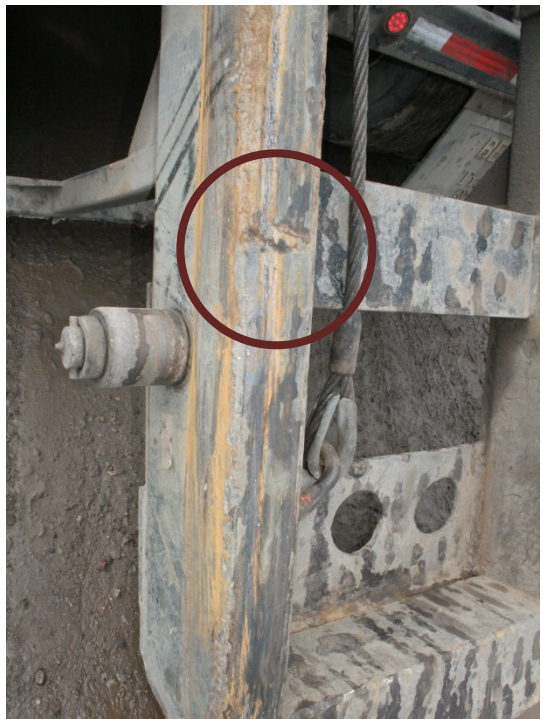
Figure 5. Fresh gouge mark on the driver's side trailer bed rail.
