MIFACE Investigation Report #13MI136

SUBJECT: Dump Truck Driver Entangled in Dump Box Power Take Off Driveline

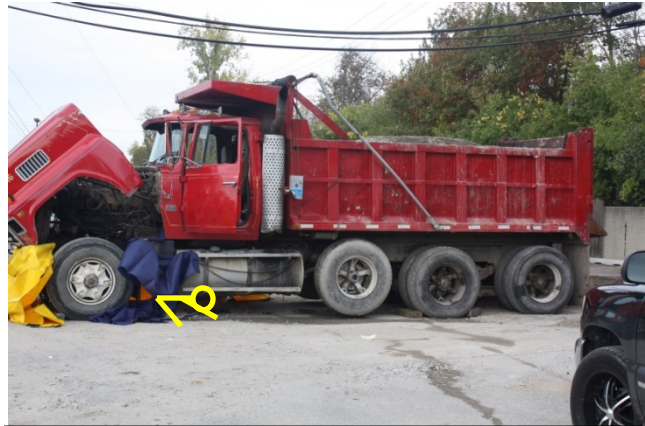
Figure 1. Decedent’s dump truck and position of decedent at incident location

- Truck not turned off and PTO rotating when he went underneath the truck
- PTO driveline not shielded

- Truck drivers should be aware of the potential dangers associated with PTOs and prior to engaging in any work process that exposes them to a PTO, should ensure that the PTO is disengaged and the truck engine is shut off.

- Dump truck drivers should perform a daily pre-trip inspection that includes raising and lowering the dump box, to ensure the truck is working correctly prior to driving and/or loading.
- When working around rotating shafts, do not wear loose clothing.
- Engineering changes should be developed to include a PTO driveline guard for existing machinery – including dump trucks - to shield any open, unguarded power take-off drivelines and locate the gearbox in a more accessible location.

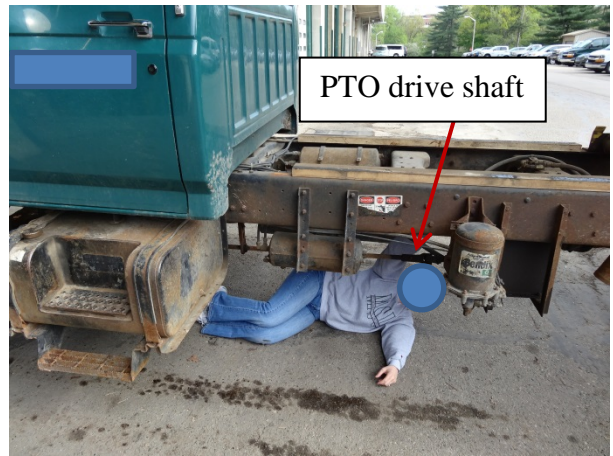
With the truck running and PTO activated, the decedent went under the truck to try to ascertain the problem. A possible scenario was that he was attempting to determine if there were loose cable connections (used to raise and lower the dump box) at the “gear box” controlling the hydraulic valves (See Figures 2 and 3 re-enactment).

Figure 2. Re-enactment of position of decedent as shown in the police pictures

As he was reaching up, his clothing contacted the spinning drive shaft and wrapped around it, pulling his neck against the driveline, and choking him. At some point, the truck stalled. At approximately 9:35 a.m., the individual who had subcontracted his services arrived at the incident site. He walked over to the truck, noting it was stalled, and called the decedent’s name while tapping on the truck. When the decedent did not answer him, he looked under the truck and saw the decedent. He immediately called 911.

- Truck drivers should be aware of the potential dangers associated with PTOs and prior to engaging in any work process that exposes them to a PTO, should ensure that the PTO is disengaged and the truck engine is shut off.

The decedent may not have understood the dangers posed by the operational PTO shaft. Truck drivers should be aware of the potential dangers of an operational PTO and ensure they recognize the hazards and the proper safe operating procedures when working around a PTO shaft. Anytime a driver must conduct work that exposes them to a PTO, the PTO should be disengaged and the truck engine turned off, even if it requires getting out from under a truck and re-entering the cab to start the engine, build up the air pressure and engage the PTO to determine if the problem was fixed.

- Engineering changes should be developed to include a PTO driveline guard for existing machinery – including dump trucks - to shield any open, unguarded power take-off drivelines and locate the gearbox in a more accessible location.

The Ford LTL 9000 dump truck was manufactured in the 1980s and did not have a shielded PTO driveline. Manufacturers should develop a guard that can be retrofitted to these older trucks that would prevent inadvertent contact with moving parts of these PTOs. Although the primary prevention strategy for this fatality should be separating drivers from the hazard by eliminating

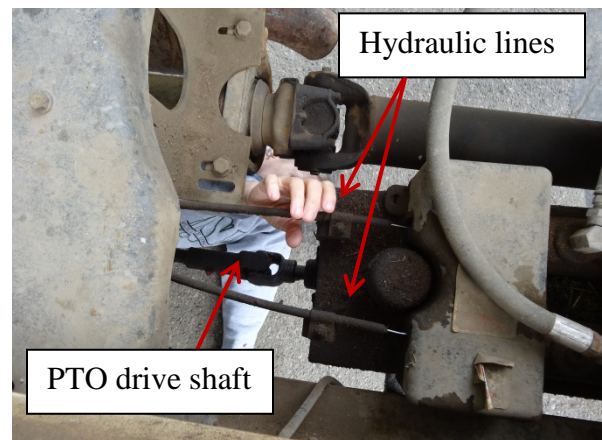
Figure 3. Re-enactment scenario of decedent’s activity

- When working around rotating shafts, do not wear loose clothing.

The risk of entanglement in rotating shafts and machine components can be reduced if operators do not wear loose fitting clothing. Work clothing should be well-fitting and zippered or buttoned, not open. Clothing should be free of flaps and other potential grab points for a rotating PTO shaft. Frayed or loose fitting clothes, jackets and sweatshirts with drawstrings, and boots or shoes with long shoelaces should be avoided. Long hair should be tied back or under a cap.

The gear box is located under the truck and near the PTO line. A more accessible gear box would allow drivers to check connections in a safer manner.
