# MIFACE INVESTIGATION REPORT #13MI149

## SUBJECT: Truck Mechanic Pinned By Truck's Sway Bar and Link

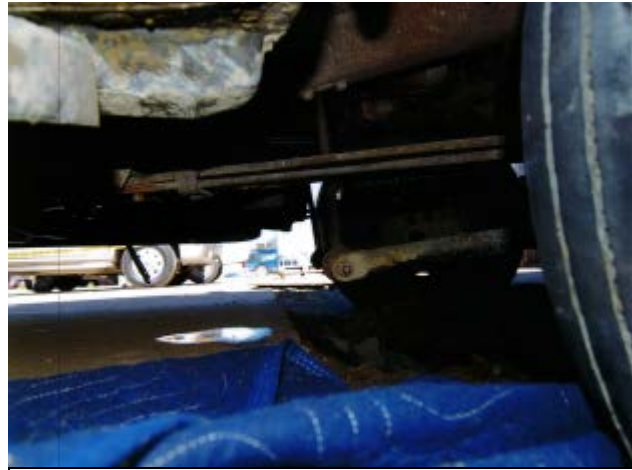
Figure 1. Picture of sway bar/linkage, passenger side, decedent's work area

brake. No wheel chocks were used to prevent truck movement. At some point while lying on his back working under the truck, the truck moved backward, with the front wheels entering a 5-inch deep dirt trench. The truck's sway bar and link to the rear of the front axle fell on the decedent's chest, pinning him against the cement (Figure 1). A building employee had left approximately one hour earlier and had noted the truck running. When he returned, the truck was still running, so he looked under the truck. Seeing the decedent, he screamed for help. Emergency response was summoned. A jack was used to raise the truck. The decedent was transported to a local hospital and declared dead.

- Persons performing vehicle maintenance should ensure that vehicles are adequately supported while maintenance is performed underneath and that vehicles are protected against inadvertent movement.

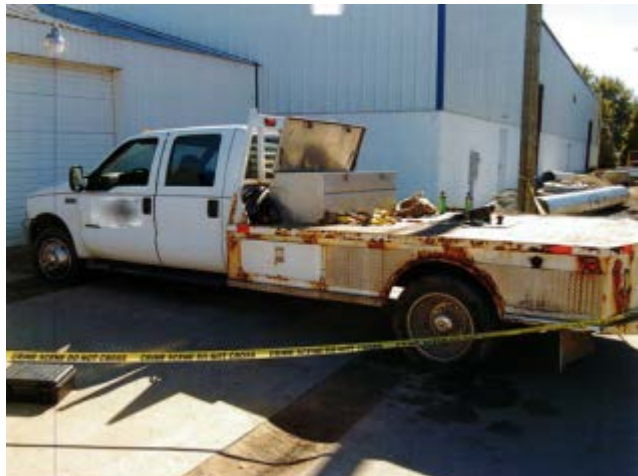
Figure 2. Truck involved in incident. Truck facing east, front wheels in trench

At approximately 9:30am, the friend drove the truck to the back of the auto parts store, parking the truck facing east (Figure 2). There had been two newly created trenches near the building due to the removal of concrete. The trench located a few feet from the building was approximately three feet wide and approximately five inches deep. The second trench was approximately 19 ½ inches wide, was concave in nature, and was located approximately 14 feet away from the building. There was a slight pavement decline from the building toward the center of the property to allow for water drainage. The decedent's friend parked the truck with the truck's front wheels over and several inches past the easternmost trench, in front of an overhead door to allow for more space under the truck for the decedent to work. The friend placed the manual transmission in park and turned the ignition key to off. The work plan did not include jacking the truck up from the ground.

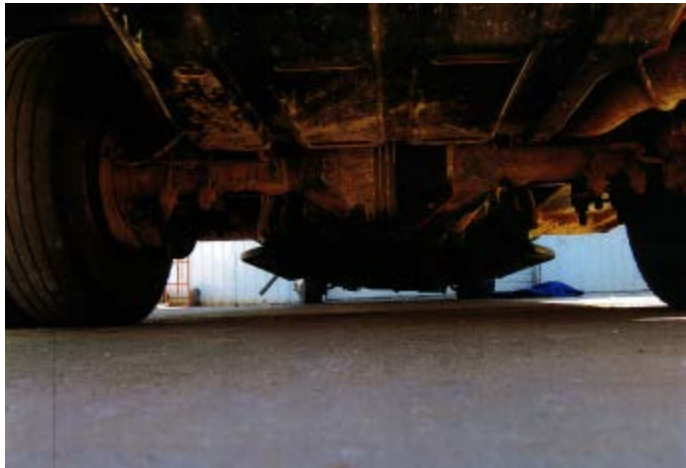
Figure 3. View of undercarriage and distance between sway bar and linkage and cement

For reasons unknown, while he was under the truck, the truck rolled backward four to five inches and fell down hard as the tires entered the five inch deep dirt trench. The ground clearance on the driver's side of the vehicle near the front bumper (minus the plastic air dam) and lower fender area measured approximately 12 inches. Police personnel measured 5¼ inches from the compacted earth near the west edge of the trench to the bottom of the sway bar where it connected to the passenger side sway bar link. A second measurement from the concrete west edge to the lower passenger side leaf spring was measured at approximately 9 inches.

A safer way of performing this task would have been to set the parking brake, use a rated jack to lift the vehicle, a jack stand rated for the weight of the truck on each side of the front of the vehicle for support and to prevent the vehicle from falling, and appropriate wheel chocks on both rear tires.

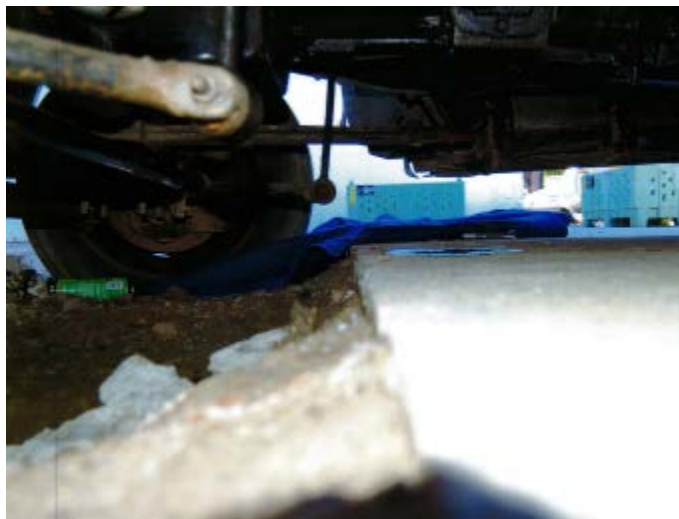
Figure 4. View of incident area looking from driver's side.
