REPORT#: 18MI213

REPORT DATE: 6/24/20

Farmer Pinned by Tree Limb When Tree Shifted While Limbing/Bucking Tree

State **FACE** Program

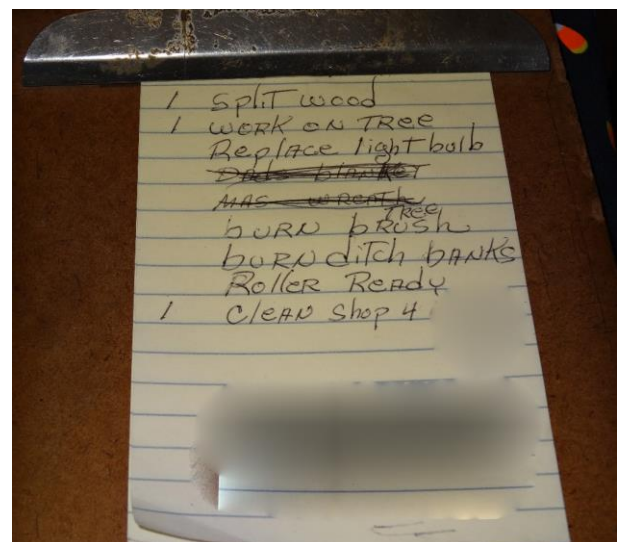
Photo 1. Decedent's chore list

his organization, he had written a list of “things to do” and had identified chores to be completed prior to a major holiday with a “1” in front of the chore (Photo 1). As can be seen from the chore list, “work on tree” was to be completed.

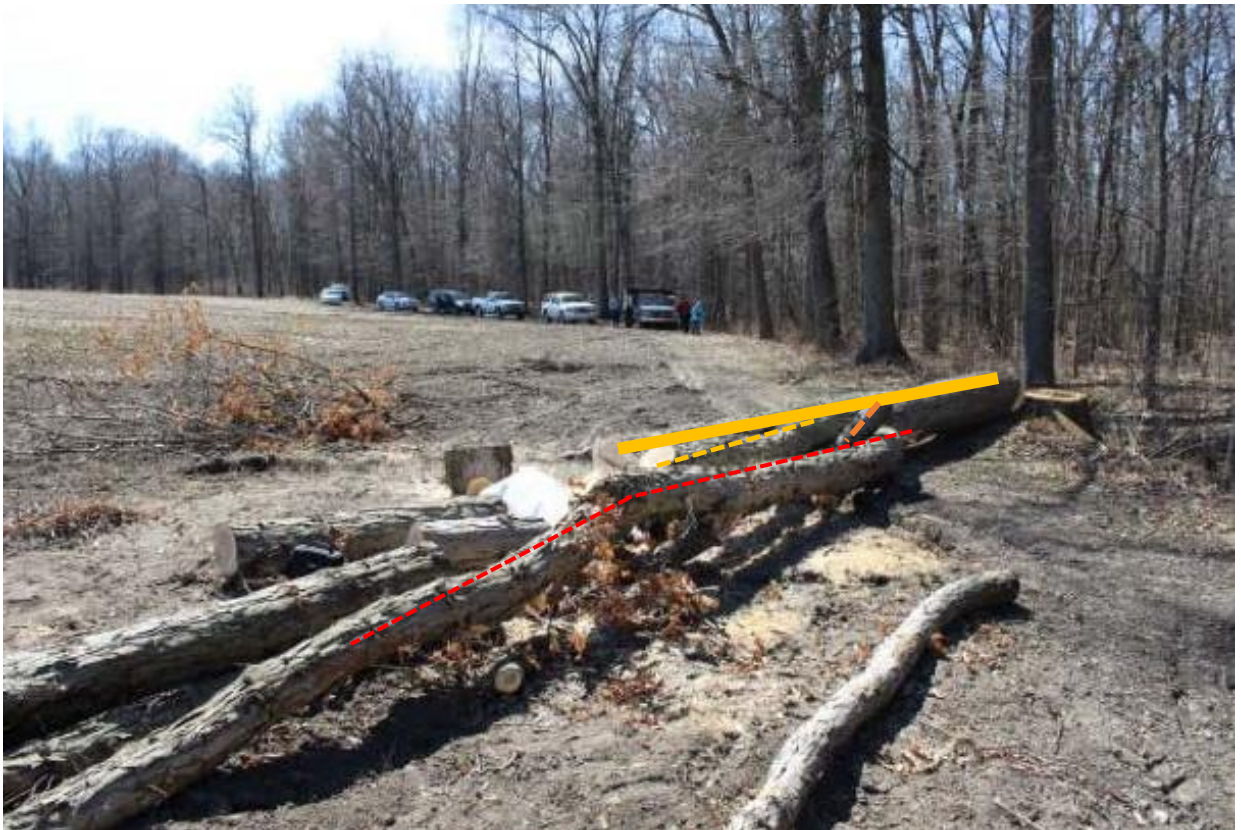
Photo 2. Incident scene, looking south. Solid yellow line is primary trunk of tree. Dotted yellow line is limb striking decedent. Red dotted line is limb that was laying on the ground. Orange dotted line is supporting limb. Trunk and other limb were oriented above the limb laying on the ground.

The species of tree was unknown. The tree branches were striking the combine as it harvested the corn during the harvest the previous year. His son wanted to just cut down the branches striking the combine, but the decedent wanted to cut down the entire tree (Photos 2 and 3).

- Limb diameter where he was struck: 23-24”
- Limb area cut from him: ranged from 20 inches down to 11 inches diameter
- Stump diameter: 33 inches
- Stump Notch: 10 inches

Recommendation #1: When felling and limbing trees, recognize differences in soil characteristics between “forest” trees and “fence line” trees.

Discussion: Ground impaled limbs have caused many of the issues regarding “fence line” cleaning. The impaled limbs tend to react differently on “ag soil” verses “forest soil” possibly due to hardpack soil horizons. When performing fence line cleaning, MIFACE encourages individuals to “backstop” trunk sections where there are impaled limbs to minimize tree movement. This could be done by appropriately chaining the tree to a tractor or supported by a loader, blocking, or perhaps backing the tractor up to the trunk from the cutting side.

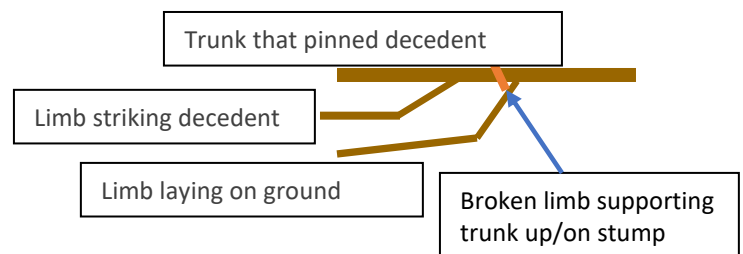
Drawing 1. Looking south, diagram representation of tree

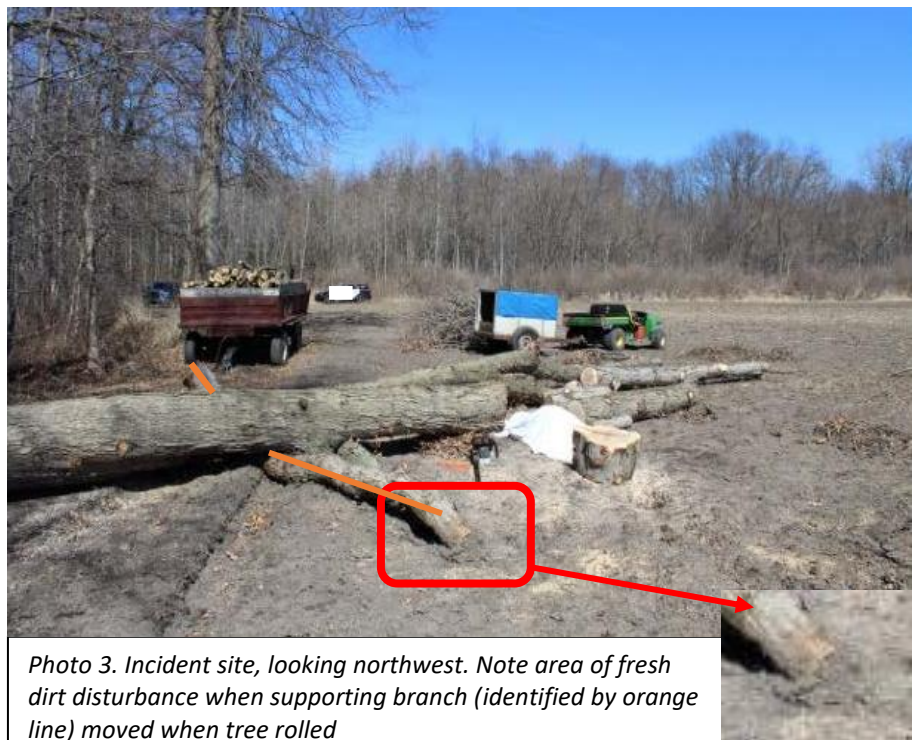
Photo 3. Incident site, looking northwest. Note area of fresh dirt disturbance when supporting branch (identified by orange line) moved when tree rolled

allow the tree to roll to the north; rather, the a supporting tree branch on one of the raised limbs broke away from the large limb and the tree to rolled south. The moving tree caused pressure on “wedged” branch, which made the fresh dirt marks ward causing the fresh dig marks on the ground. (Photos 3, 4 and 5).

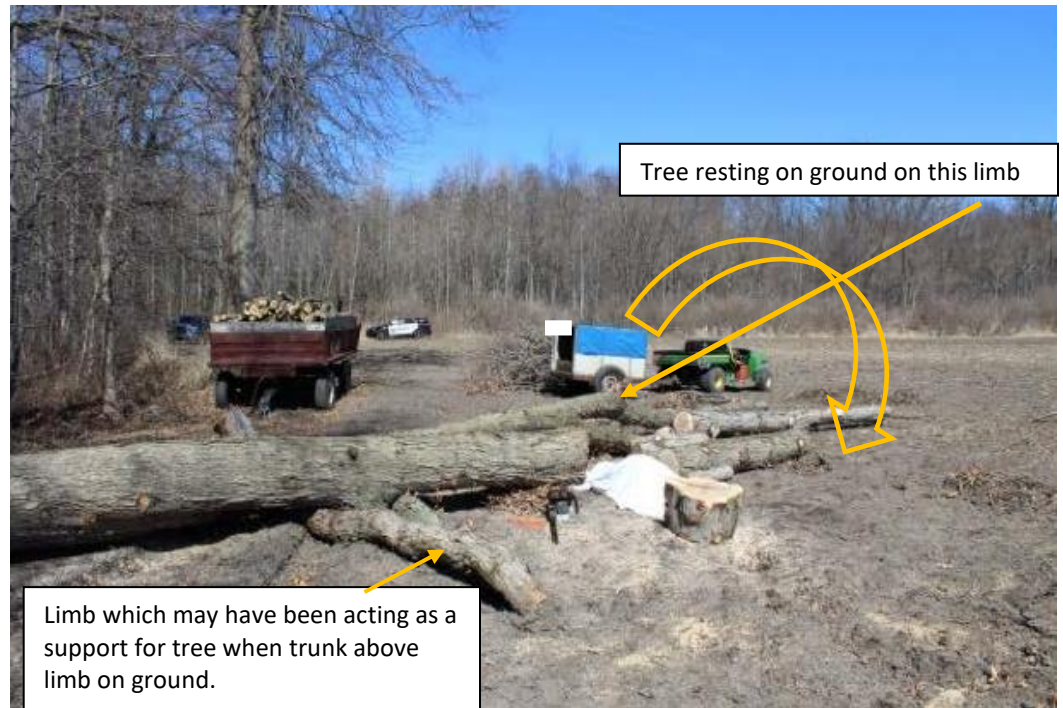
Photo 4. Incident scene looking north. Curved arrow shows direction of tree rotation, limb upon which tree was balanced.

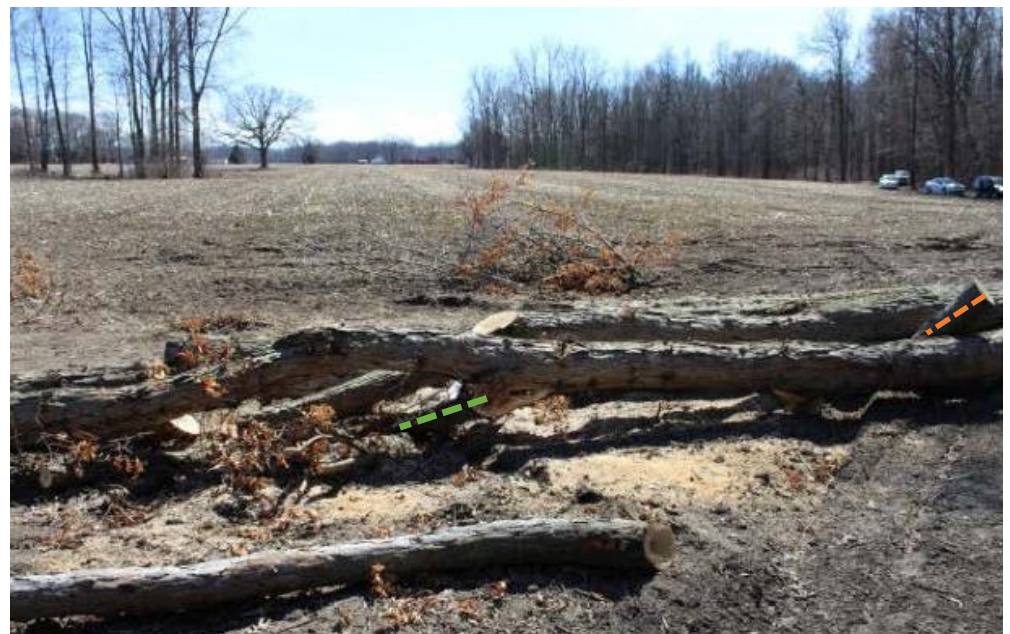
Photo 5. Looking south. Orange dotted line shows limb supporting tree. Green dotted line shows another supporting branch which broke away from the tree when it rolled to the south.

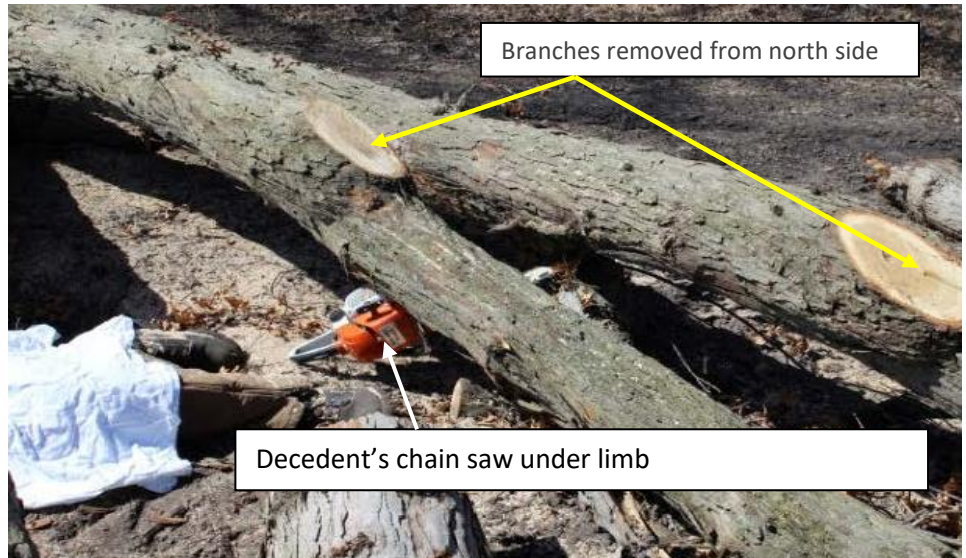
The incident was unwitnessed. Based on police photographs taken during their investigation, it is apparent, due to the fresh sawdust accumulation, that the decedent first started to remove branches from the north side (Photo 6).

Photo 6. Close view of chainsaw location under limbs and branches removed when working from north side

The decedent was unable to get out of the way of the tree movement and was pinned by the tree trunk. His chain saw was found by responding police under another large tree limb (Photos 6 and 7).

Recommendation #2: Use safe work practices when performing limbing or bucking activities with a chainsaw including performing a hazard assessment, standing uphill when possible, not working alone and wearing appropriate personal protective equipment.

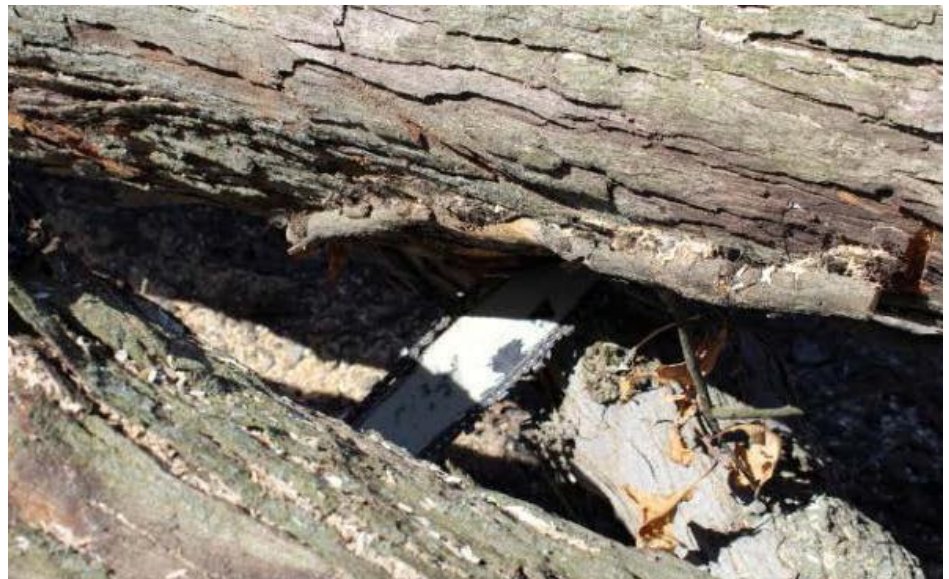
Photo 7. Chainsaw blade near freshly cut limb
