REPORT#: 15MI110

REPORT DATE: 1/16/19

Construction Laborer Working in Highway Work Zone Struck by Van

Michigan Fatality Assessment and Control Evaluation (FACE) Program

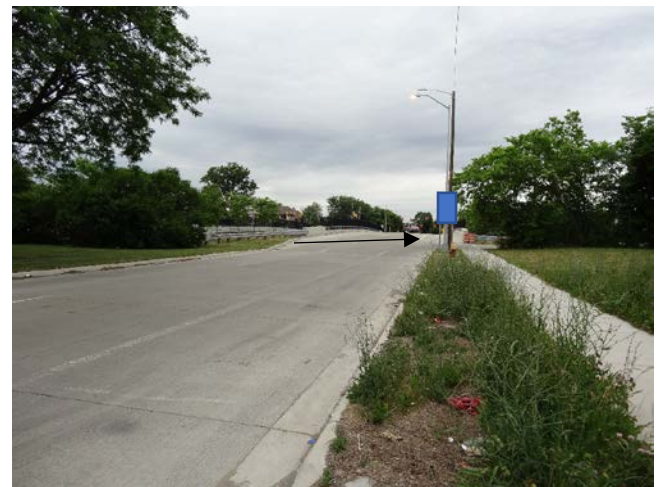
In the direction in which the work crew was working, there were four expressway entrance ramps within the 2-mile long work zone (See Figure 1). The responding police accident investigator stated to the MIOSHA compliance officer that both ramps #1 and #2 had barricades erected; the accident investigator had to drive around the barricades at ramp #2. Sight lines to the entrance ramp #2 were unobstructed (Photo 1). After entering the expressway, the roadway curved (Photo 2).

Photo 1. Visual sight lines to entrance ramp #2. Arrow shows ramp #2 entrance

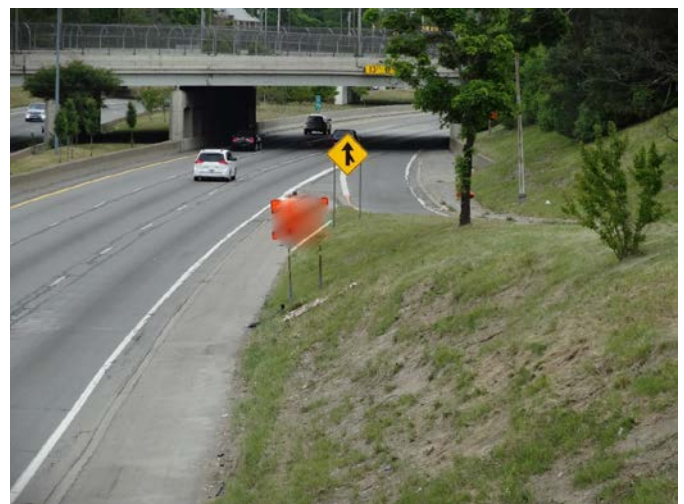
Photo 2. View of entrance ramp #2 from overpass. Note roadway curvature.

The driver of the conversion van striking the decedents/kettle truck lived near entrance ramp #2. It is hypothesized that entrance ramp #2 is the ramp the driver of the conversion van used to enter the freeway. After the incident, a family member of the conversion van driver ran down entrance ramp #2 in an attempt to investigate the crash.

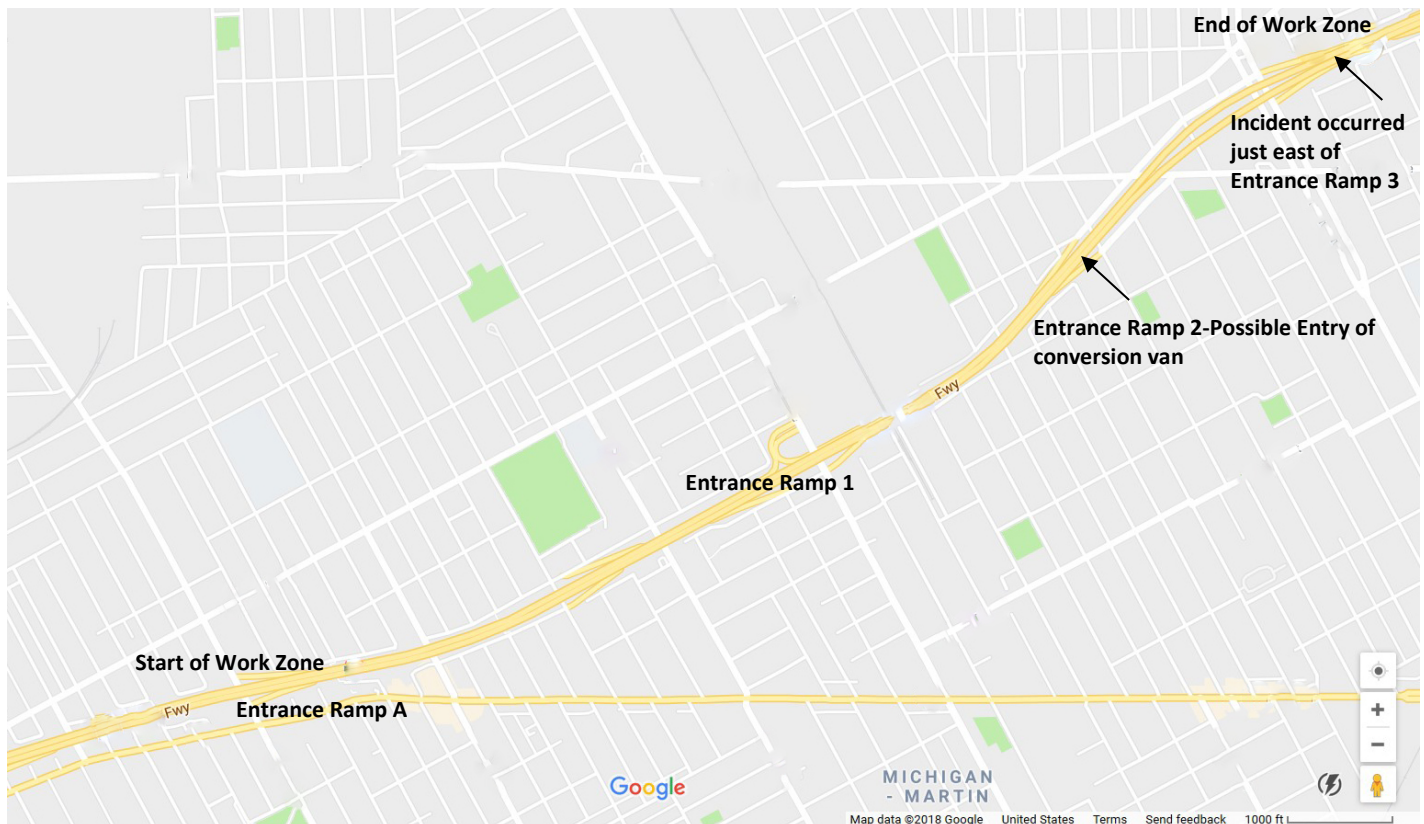
The crew consisted of lead truck (“over truck”) with 4 workers. The “over truck” was located approximately 65 feet east of the second crew (decedent and his coworker) with a kettle truck. The “over truck” workers used high pressure air to clean out roadway cracks and seams to prepare the cracks/seams for sealing. The decedent and his coworker followed with the kettle truck and used a pressurized wand to inject a molten asphalt based material into the now open and clean seams/cracks. At the time of the incident, the over truck was working just east of the foot of the entrance ramp #3e (See Figure 1)

Figure 1. Google Map view, with identifying street names removed, of the incident site

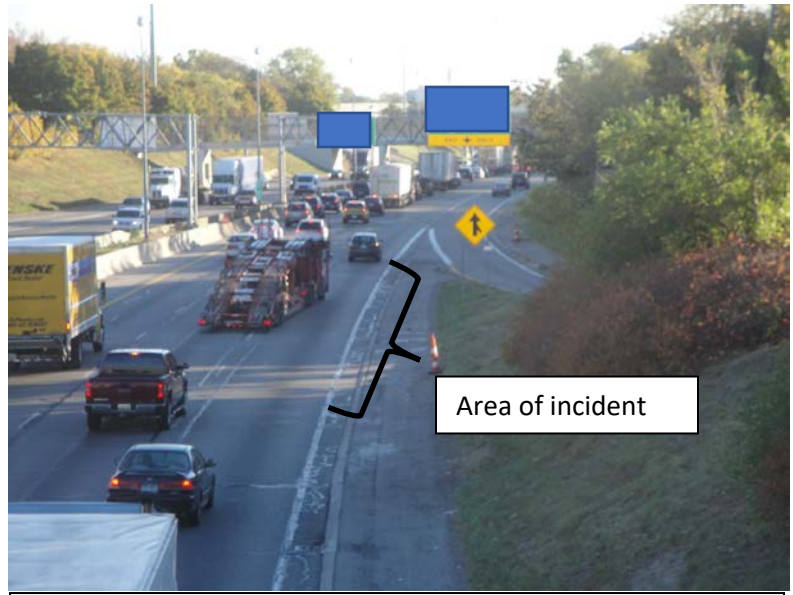
The decedent and his coworker were wearing Class 3 high visibility vests; scene pictures show the vests had substantial amounts of sealing material on them. The workers were on break and waiting for the “over truck” crew to move ahead. The decedent’s coworker was positioned at the rear of the truck on the driver’s side checking the temperature of the crack sealing material. He saw the decedent walking toward him from the right shoulder of the roadway (Photo 3).

Photo 3. Overview of Incident site. View of expressway just east of entrance ramp #3.

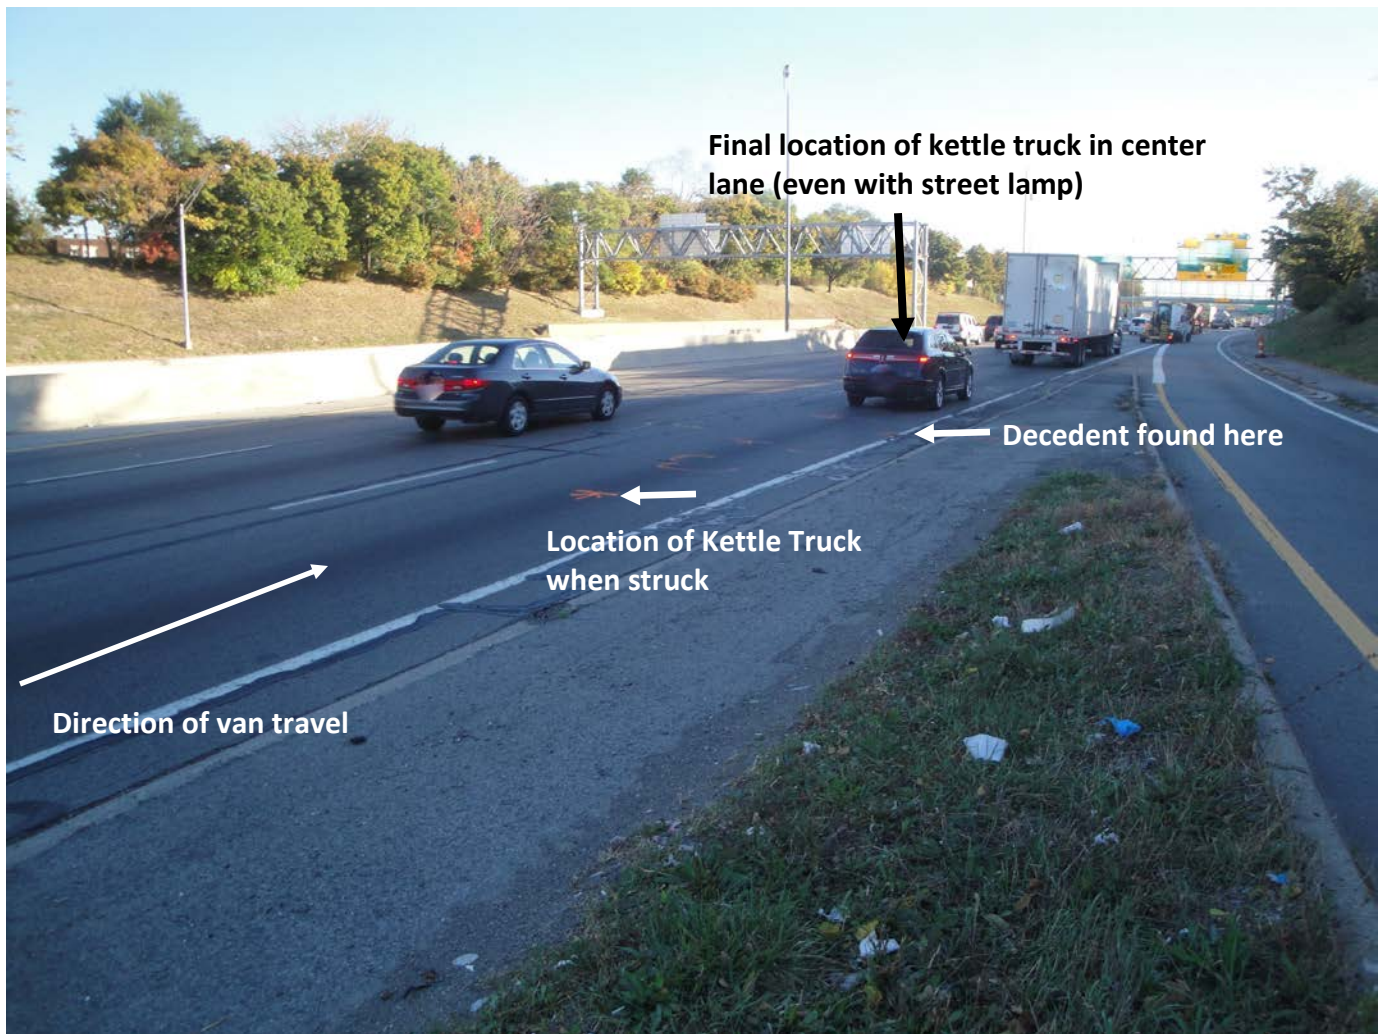
Photo 4. Close up of gore area of entrance ramp #3 where incident took place

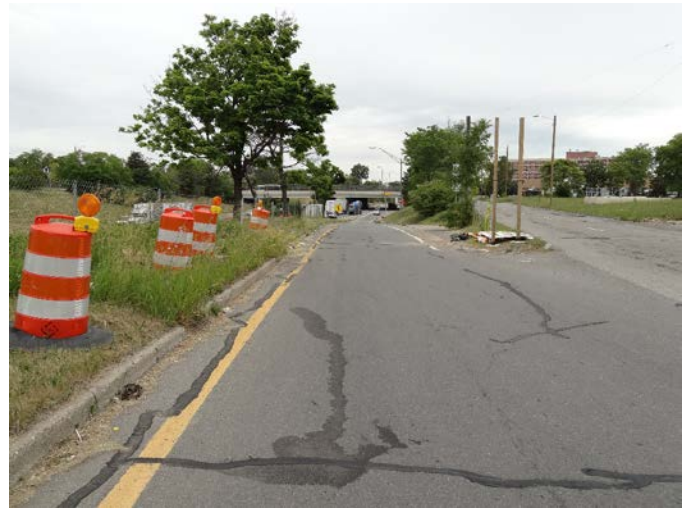
Additionally, MIFACE recommends that the employer include on the checklist the date in which they remove the construction signage, barricades, cones, etc. MIFACE personnel visited the incident site approximately 5 months after the incident and the barricade and several construction barrels were present at entrance ramp #2, and no construction was being performed on the expressway in the area (Photo 5). In MIOSHA compliance officer pictures taken the day after the incident, the construction barrels were not present, but the downed signage was present.

Photo 5. Construction materials at entrance ramp #2
