**REPORT#: 15MI117**

## Construction Laborer Died in a Trench Wall Collapse

## Michigan Fatality Assessment and Control Evaluation (FACE) Program

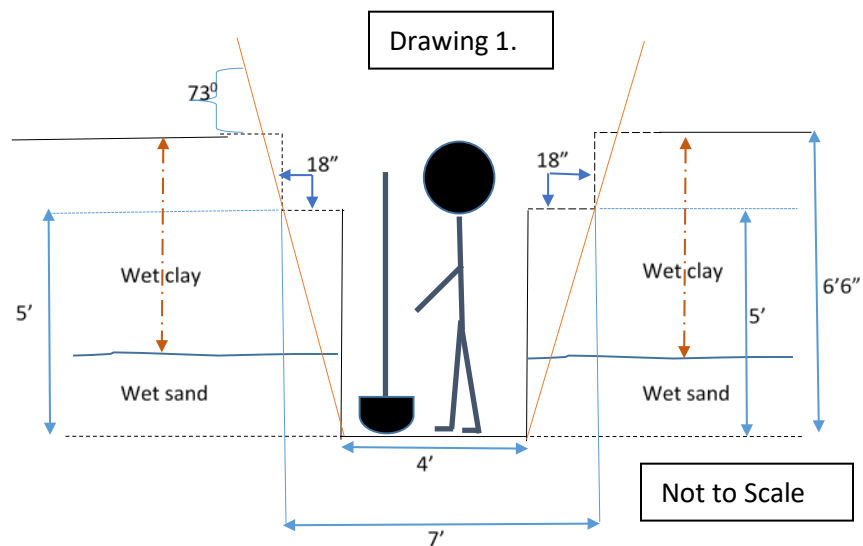
The trench in the incident area was approximately 7 feet wide at its top, 6½ feet deep, and 4 feet wide at its base. An 18-inch bench was cut approximately 18 inches below the top of the trench and 5 feet from the base. The trench had a 1½-foot seam of wet sand at its base, and then another 5 feet of wet clay. (See Drawing 1).

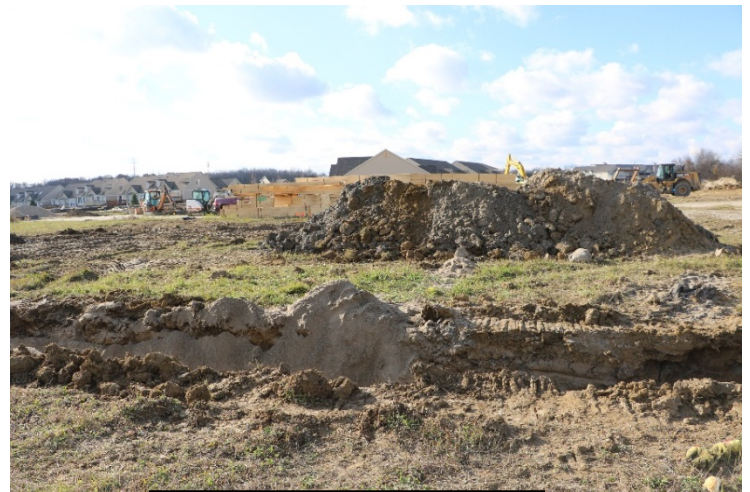
Figure 1. Placement of spoils

Coworker 2 was using a Kawasaki excavator with a 3-foot wide bucket. He placed the spoils on the side of the trench that collapsed. The spoils were placed more than 2 feet away from the trench wall as required by MIOSHA standard Part 9. (See Figure 1).

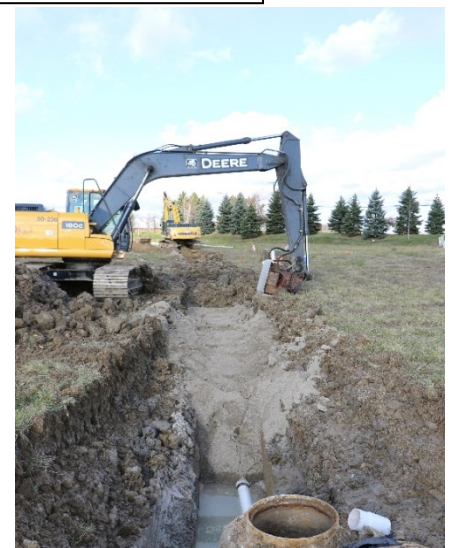
Figure 2. Water location in trench

Earlier that morning the excavator operator noticed more water at the west end of the trench and asked the decedent if he wanted the trench box that was onsite. The decedent stated no. (See Figure 2).

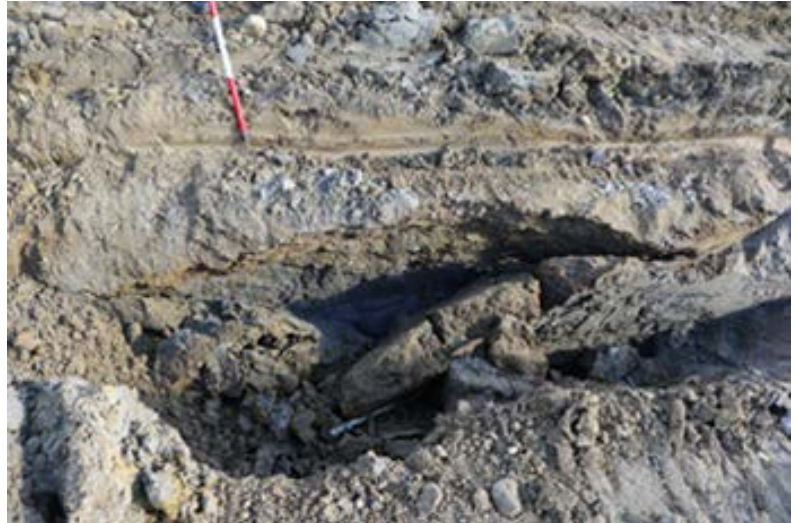
Figure 3. Trench wall collapse

When the foreman finished the placement of the survey stakes, he walked the site to check out progress. He came to the incident trench area where the decedent and Coworker 1 were working. The foreman looked over and noticed the south wall starting to give way and yelled for the decedent and Coworker 1 to get out of the trench. Both workers began to run east toward the ramp. Coworker 1 was able to safely exit the trench. The south clay/dirt wall collapsed, striking the decedent on his right side, burying him from the waist down side and pinning him against the north trench wall (See Figure 3). The decedent's shovel was pushed into the decedent's right side but never penetrated. The force of the south wall collapse caused the decedent to strike the north wall also causing part of the north wall to also collapse, although the bench was still intact.

The MIOSHA compliance officer investigating the fatality utilized a penetrometer to determine the consistency/hardness of the soil from the spoils pile. Readings found predominately sand and read 0.0 T.S.P. and clay clumps at 3.0 T.S.P. Based on trench measurements provided by one of the top management employees, the MIOSHA compliance officer calculated angle of repose of the trench walls at 73 degrees. Based on the soil characteristics, the trench walls should have been 34 degrees.

Employees engaged in pipe installation activities in an excavation that had been benched on each side where the step back of the benches did not extend to the angle of repose as required by table 1, exposing the employees to a cave-in of the excavation, resulting in a fatality. The excavation, as observed by employees and others on site, was 6'-4" deep, 7' wide at the top, 4' wide at the bottom, and 25' long. The north and south sides of the excavation each had a 5' high bench that stepped back 18", achieving an angle of repose of 73 degrees. The soil was a wet sand at the bottom 18" of the excavation, with the remainder being a wet clay.

Employees engaged in pipe installation activities in a benched excavation where the height of the lower bench on each side was greater than the width of the trench measured at the bottom, exposing employees to a cave-in that resulted in a fatality.

***Recommendation #1: Employers should ensure that employees working in excavations are protected from cave-in by an appropriate protective system, such as trench boxes, shields, benching and/or appropriate sloping of trench sides designed in accordance with MIOSHA Construction Safety Standard, Part 9, Excavation, Trenching, and Shoring. To ensure this is done correctly, a qualified person must inspect and approve the excavation, adjacent areas, and supporting systems on an ongoing basis.***
