REPORT#: 16MI090

Ironworker Fell 25 Feet While Working From/Relocating a Ladder in a Shaft way

Michigan Fatality Assessment and Control Evaluation (FACE) Program

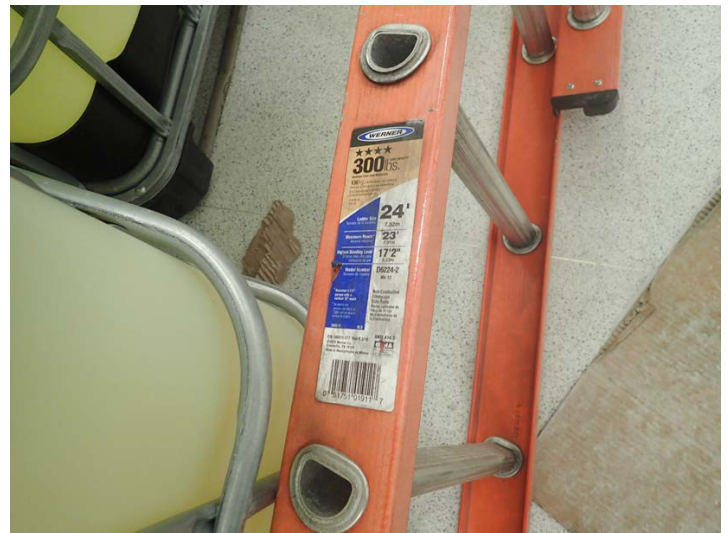
Photo 1. Ladder used by decedent

The 24-foot fiberglass extension ladder involved in the incident was missing the manufacturer-supplied rope or equivalent to raise or lower top section of ladder from the base section.

The fiberglass two-section extension ladder was not properly maintained; It was missing the manufacturer supplied rope or equivalent to raise or lower top section of ladder from the base section.

Recommendation #2: Ensure ladders are inspected, set up and used correctly. Remove ladders from service if found defective.

ladder and should not be removed, or if removed when the ladder is disassembled, it should be re-installed when the ladder is reassembled.

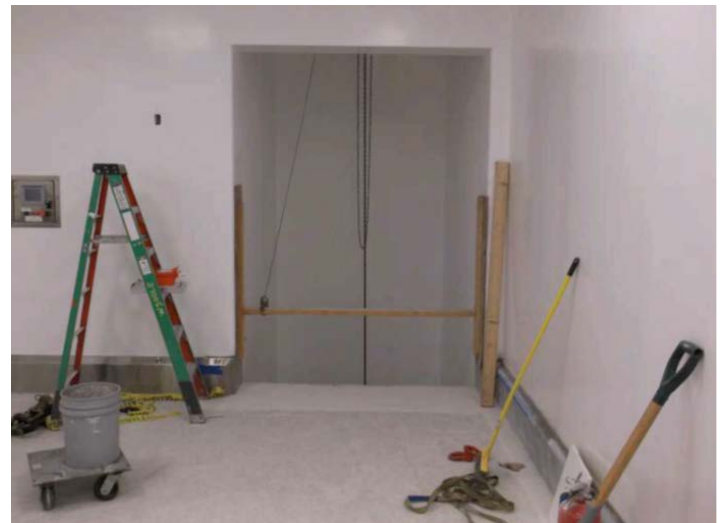
At some point during the construction process, a make-shift wood barrier system using two pieces of wood was installed at the opening on the north side of the shaft way on the second floor. The two wood guardrail pieces were wedge-fit into the opening with cardboard protecting the wall areas; the guardrails did not overlap beyond the opening nor mechanically fastened to the wall. It is unknown when the top section of the wood barrier was removed leaving only the mid-rail, located approximately 21 inches above the floor (See Photo 2). A coworker indicated the top rail was removed for easier positioning of the ladder.

Photo 2. Lifeline attached to midrail at time of incident

After moving the chain fall, the ladder was to be removed so a scissor lift could be used within the shaft way. The decedent came down from the ladder and stopped on the bottom rung. The apprentice indicated the decedent removed the retractable lifeline from his harness and secured it to the mid-rail. The decedent, still wearing his harness, then attempted to retract the fly section of the ladder. It appeared that the decedent positioned himself on the 2nd and/or 3rd rung of the ladder base. The decedent was lifting/bumping the fly section to unlock the rung hooks and allow the ladder to compress in order to get it out of the opening. In the process of doing this, the ladder base slipped inward, into the opening and fell feet first, striking the lift equipment and rotating approximately 180° before landing on the first floor. The decedent fell 25 feet to the concrete first floor, landing in the northeast corner of the shaft way. The decedent's foreman was in the area prior to the incident and was just walking away when the incident occurred. He was with a factory rep for the company that supplied the equipment. The foreman had to leave the building to call 911 because of poor reception inside the building.

Recommendation #1: Workers should always use fall protection when working above a height per the appropriate regulatory requirement. In this incident, the decedent was performing a steel erection activity, and fall protection was required when working at a height above 15 feet.

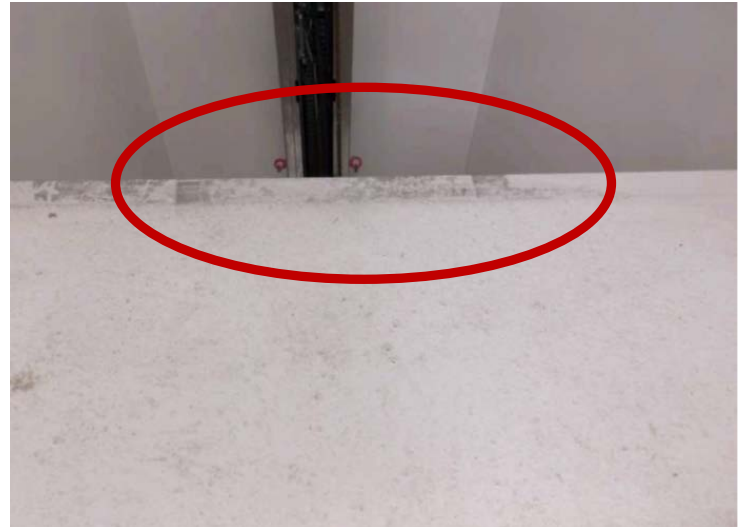
Photo 3. Ladder marks on edge of second floor

The ladder was not tied, blocked, or otherwise secured to prevent displacement at either the top or at the base when it was positioned across the shaft way. The bouncing motion of the ladder as the decedent attempted to unlock the rung locks contributed to the ladder feet sliding from their position at the edge of the shaft way into the open shaft way. If the ladder feet had been appropriately secured, the ladder base would not have moved.

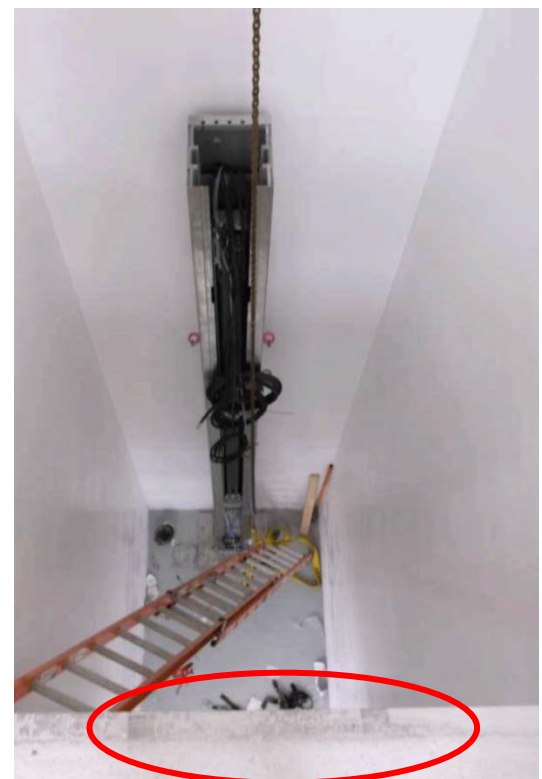
Photo 4. View of shaft way from second floor. Red circle locates the ladder feet marks on the edge of the shaft way

A fiberglass extension ladder set across the elevator shaft opening with a horizontal projected distance of approximately 8 feet and a vertical distance approximately 16 feet. The pitch exceeded the allowable 1:4 ratio. Employees using the ladder were exposed to a 22-foot fall to interior of the elevator shaft.

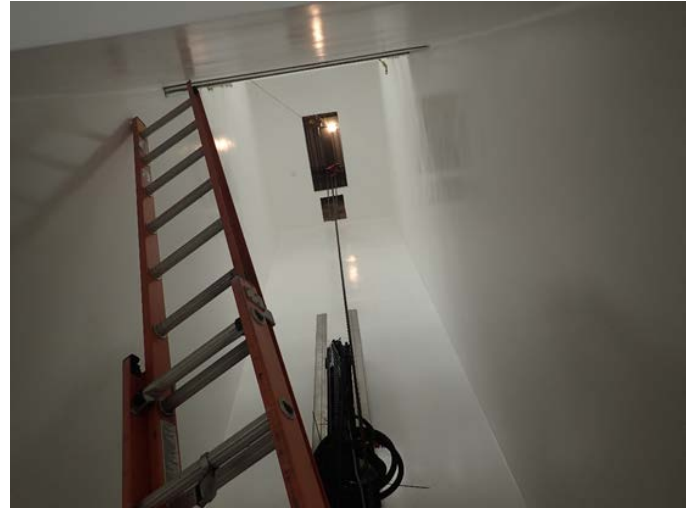
The top guardrail was re-installed after the incident and was wedge-fit into shaft way opening with cardboard, protecting the wall areas from scratching. The ladder also appeared damaged from possibly striking the top of the installed lift equipment.

Photo 5. View of shaft way looking up from the ground floor.
