INCIDENT FACTS

22MI005

Head Milker Struck by Wheel Loader at Night

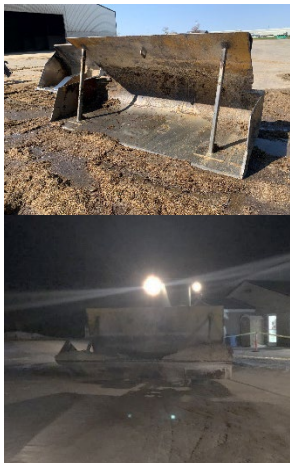
Front view of loader with
bucket elevated.

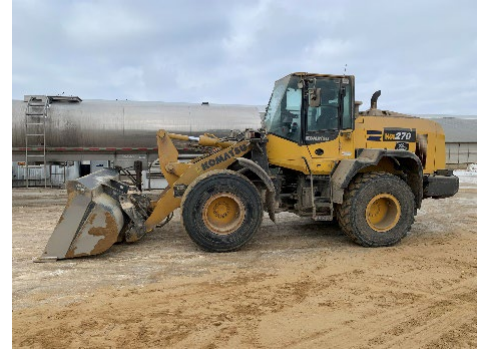
Komatsu Wheel Loader involved in the
incident.

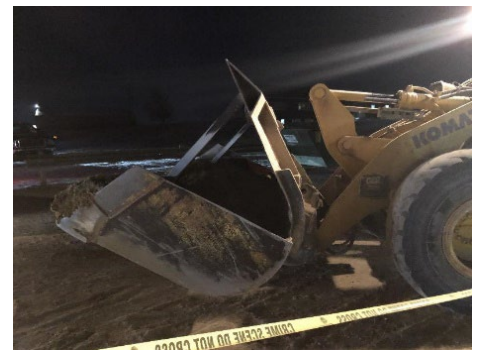
Side view of loader with bucket elevated
showing lights obscured.

- Develop and implement a formal training program for loader operators.
- Ensure operators and pedestrians required to work in areas of machine/pedestrian traffic are aware of machine blind spots.
- Consider mounting additional lighting on loaders for use during non-daylight hours if lighting is obscured by attachments.
- Ensure all areas where equipment traffic and pedestrian travel occur are well-lit and pedestrian pathways are well defined.
- Provide appropriate high visibility garments to workers and require their use when working non-daylight hours.
 - Considered battery powered lighted options such as vests, hats, and/or head lamps if there are areas of shared machine/pedestrian traffic during non-daylight hours.
- Restrict the use of devices that limit the ability of workers to be fully aware of their surroundings.

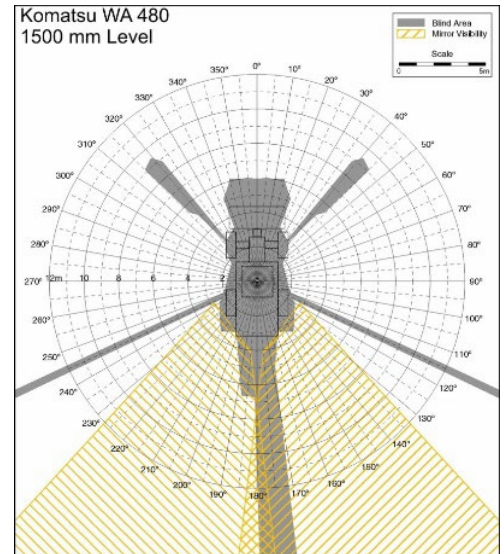
NIOSH Construction Equipment Visibility Chart, Komatsu WA 480, 1500 mm level
