**REPORT #:**  
22MI107

**SCENE:**  
Residential Home Under Construction

## CONSTRUCTION FATALITY NARRATIVE

### Framer Dies in 40-foot Fall from Roof

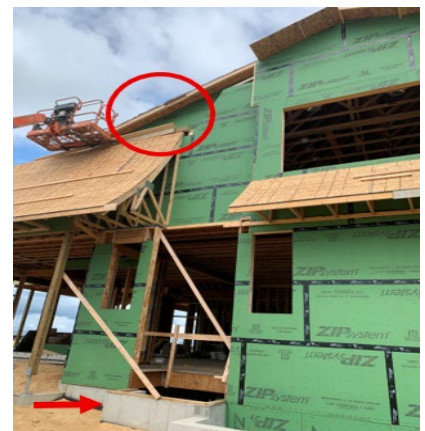
At approximately 11:30 am, a framer died after falling 40 feet from the front sloped porch roof of a single-family home under construction to the concrete basement floor below, striking his head on the top of the exposed basement wall during the fall. The multi-employer worksite consisted of a general contractor (GC), a primary builder (PB) who worked under the GC, and the decedent's carpentry company, which was subcontracted to the PB. MIOSHA indicated two workers, the decedent and a PB employee, utilized a Sky Power 600SC telescopic boom lift to access the roof to install fascia boards. Both workers left the boom lift platform without wearing fall protection. His coworker stated to police that they were working approximately 3 feet away from the lift platform edge. The decedent was utilizing a nail gun. The coworker indicated that he and the decedent were standing on an approximate 2-foot-long, 2"x4" slide guard nailed to the steep slope roof. It is unclear if a 2"x6" side guard support was present. The slide guard came loose/broke away from the roof, causing both to fall from the roof. The coworker stated he attempted to catch the decedent but was unsuccessful. The coworker fell to sand, suffering a non-fatal hip injury. The decedent struck his head on a vertical foundation wall and then fell an additional 10 feet to the concrete basement floor. His nail gun was located on the basement floor near him. On the ground were an approximate 2-foot-long wood 2"x4" (possibly the slide guard) and a wood 2"x6" (possibly the trim being installed - see open space in red circle in the picture above), both with multiple nails in them. Police noted the 2"x4" had 3 nails that were bent over and sticking out approximately a half inch out of the side which would have been against the plywood on the roof. At the time of the fatality investigation, MIOSHA opened an inspection with each company, citing the GC, the PB, and the decedent's company (subcontractor) for lack of fall protection. The decedent's company (subcontractor) and the PB, who both had employees exposed to the fall were also cited for lack of an accident prevention program and medical/first aid. Another fall protection citation was issued at a later date because MIOSHA determined during the interview process that prior to the fatality, there were other times the company was not using fall protection on this job.

Red circle: area where the decedent and his coworker were working. Arrow: points to opening (hole) where the decedent struck his head. Source: MIOSHA

- Provide and enforce the proper use of fall protection equipment when employees are exposed to a fall of six feet or more above a lower level. Consider performing unannounced “spot checks” to ensure compliance.

- **Do not use slide guards as a primary means of fall protection!** Slide guards, constructed with 2”x4” and 2”x6” boards (2”x4” is placed against the roof, and the 2”x6” 90 degrees to the roof on top of the 2”x4” and nailed to the 2”x4” top) may be used as a secondary means of protection if appropriately anchored to the roof truss using 16 penny framing nails (3 to 3.5 inches long). Do not use shorter nails (for example, trim nails) as anchors.

- Cover all holes (a gap or void 2 inches (5.1 cm) or more in its least dimension, in a floor, roof, or other walking/working surface) and ensure covers are secured and able to withstand twice the anticipated load. Label cover as “hole” or “cover.”

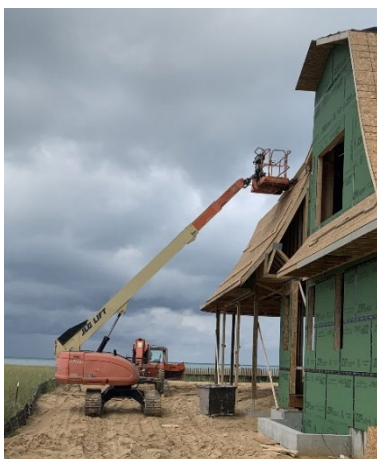
View of the construction project and the boom lift utilized to elevate the workers. Source: MIOSHA

- Ensure aerial platform operators are appropriately trained and have an operator’s permit. If employer permission is granted to exit the platform to an unguarded work area, ensure the provision and use of fall protection as required in CS Part 45, Fall Protection.
