22MI010

September 8, 2023.

## Sawmill Loader Operator Crushed Performing Maintenance on Front-End Loader

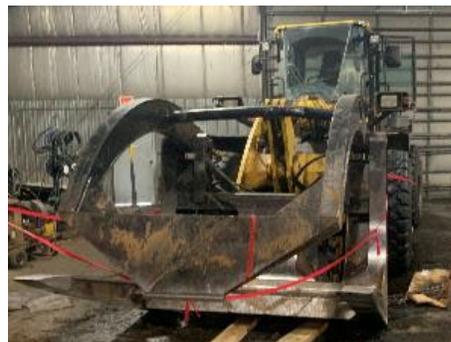
The assisting loader operator had to step away and radioed a maintenance worker to take over assisting with the repair. When the maintenance worker arrived at the scene, he found the victim crushed between the boom and the frame. Police, fire, and EMS arrived on scene to free the loader operator. The loader operator was declared dead on scene. While attempting the repair, it was concluded that the loader operator loosened the wrong hydraulic line causing the boom to lower under load.

Front-end loader with log clam equipped.

- Develop, implement, and enforce lockout/tagout procedures for maintenance tasks, including the use of cylinder locks or adequate blocking when the boom is required to be in the raised position during servicing and/or maintenance.
  - When developing lockout/tagout procedures, pay special attention to all sources of potential energy and ensure all tasks involving the potential release of hazardous energy area covered.
- Conduct periodic inspections of authorized employees and review energy control procedures.
