INCIDENT FACTS

REPORT #:
22MI067

Worker Struck by Vehicle While Clearing Fallen Tree from Road

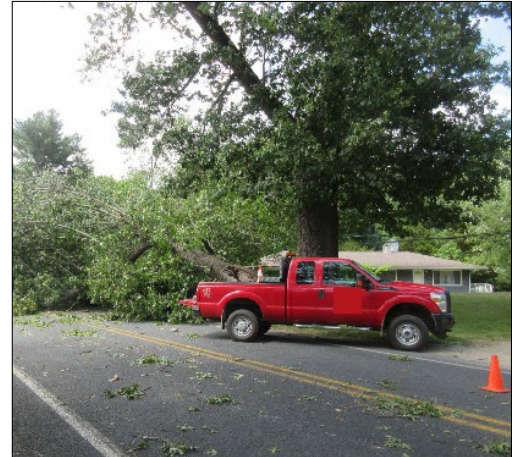
Arrangement of truck and tree branch blocking the road on the north side of the downed tree.

- Enhanced Traffic Control Measures
 - Employers should ensure that during roadway incidents involving fallen trees or other hazards, a minimum of two vehicles are deployed to provide a barrier for both directions of traffic. This measure is crucial for the safety of workers from errant vehicles approaching from either direction.

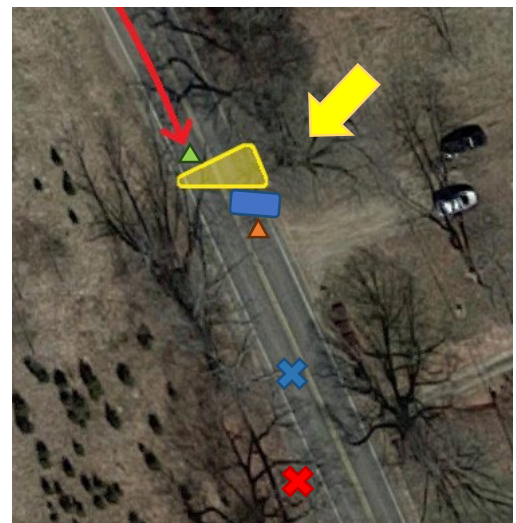
A satellite view of the area where this incident took place. A yellow arrow points to the tree from which the branch fell. The shaded yellow area shows the approximate area of the road blocked by the branch. A red arrow shows the direction in which the vehicle involved in this incident was traveling. A red X represents the approximate location of the driver's car after the incident. A blue rectangle shows the approximate location of the decedent's work truck. A blue X shows the decedent's location following the collision. The triangles show where the green and orange traffic cones were placed by the decedent.
