## MIFACE INVESTIGATION: #01MI003

### SUBJECT: Operator Crushed Between a Rotating Barrel and Its Hoist Support Bar

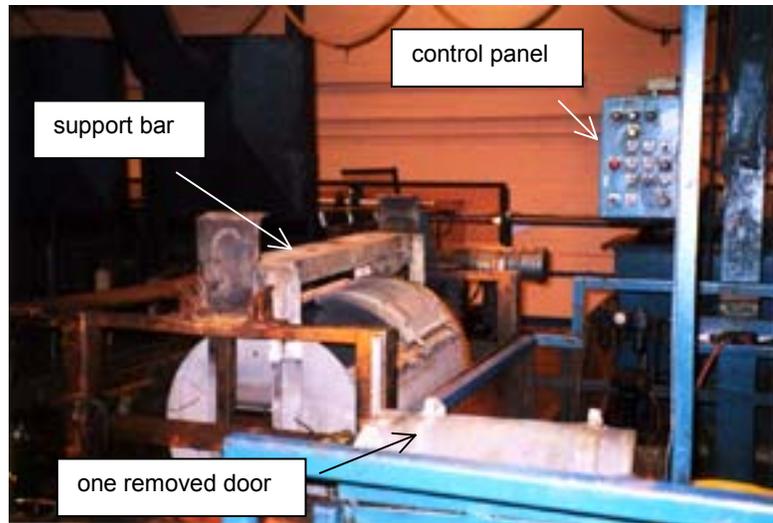
Figure 1  
Operator's Workstation

The barrel approached the operator's station from the right. The operator's workstation measures approximately 6 feet by 6 feet and was located 5 feet above the plant floor level. The barrel was approximately the size of a 55-gallon drum, 4 feet in length and 2 feet in diameter. Just before the barrel reached the operator's station, the hoist placed the barrel on a track that allowed a cart to move the barrel to the station. A ring gear on one end of the barrel engaged a drive motor that rotated it in a clockwise motion. The barrel approached the operator's station and rotated relatively slowly. Speed of operation was not an issue.

As the barrel reached the operator's station, a tab located on the barrel opposite the ring gear contacted a wire attached to a limit switch. The limit switch stopped the barrel's rotation so that two doors on the barrel faced the operator. Each of the two doors was approximately 18 inches square. The operator removed the doors by loosening four 5/8-inch nuts with an impact wrench and removing the nuts. He then lifted the doors off the barrel and set them onto a 28 inch square table to the left of the workstation. He pressed two palm buttons on a 12-inch square control panel located to the right of the workstation to activate the barrel to continue to a dump station eight feet further down the track to the left. The emergency stop for the equipment was located on this control panel.

Although no one saw the incident take place, it is presumed that the operator reached into the barrel to remove some parts that had not fallen out at the dump station as the barrel was returning to the operator's station. The barrel would have been rotating to find its position for the replacement of the doors. It is believed that his sweater became entangled on something inside the barrel, and he was not able to extricate himself. His sweater was torn on the left arm. Apparently the limit switch did not function to stop the barrel from rotating at the unload station. The left side of the victim's head was pulled into the hoist support bar and crushed between the bar and the rotating barrel. When the equipment was tested after the event, the limit switch did not stop the barrel rotation.

- A light curtain was installed, so that the equipment will shut down if anyone reaches through it into the path of the returning barrel.
- The rail guarding was extended so that an operator cannot reach into a barrel before it reaches the unload station.
- The position of the limit switch was moved further to the left of the unload station, so that the barrel stops rotating well before it reaches the unload station.
- An emergency stop was installed on the left side of the unload station within the reach of the operator standing at the unload station.
