MIFACE INVESTIGATION: #01MI008

SUBJECT: Welder Struck By Falling Steel Frame

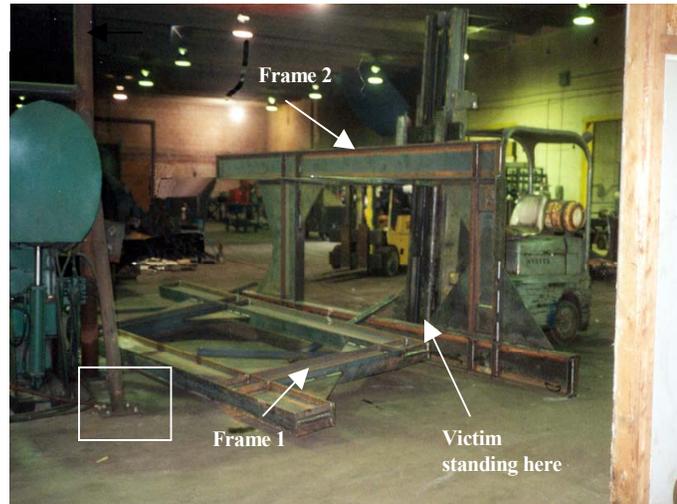
Figure 1

Frame 1 was moved to an upright, vertical position next to a hoist's vertical support pole, and left in an unrestrained, freestanding position. Two three-inch steel channel bars were tack-welded to the base of Frame 1. The channel bars were thought to provide upright support as well as a positioning aid for Frame 2. Frame 2 was moved into position by the forklift, and the channel bars from the base of Frame 1 were positioned on the top of the I-beam base of Frame 2. The forklift was supporting the top I-beam of Frame 2, and the victim was facing the forklift and standing between the unsecured Frame 1 and the forklift supported Frame 2. The victim was directing the forklift driver to properly position Frame 2. He was also helping with minor position adjustments of Frame 1. When Frame 2 was in the proper position, the victim was going to tack-weld the channel bars from Frame 1 to Frame 2's base I-beam. During the positioning of Frame 2, the forklift driver observed Frame 1 begin to fall. The driver yelled to the victim to get out of the way. The victim could not react quickly enough, and the top I-beam of Frame 1 struck the victim, and he fell against Frame 2. Fellow workers called 911 and lifted Frame 1 from the victim. Paramedics arrived and took the victim to the hospital where he died a short time later.

Frame 1 was the first section to be moved into position. A forklift moved frame 1 to an upright, vertical position next to a hoist’s vertical support pole, in an unrestrained, freestanding position, standing approximately 6 feet in height. Two three-inch steel channel bars were tack- welded to the base of Frame 1 to provide both upright support and to act as a positioning aid for Frame 2. Frame 2 was moved into position by the forklift, and the channel bars from Frame 1 were positioned on the base of the I-beam of Frame 2. The forklift was supporting the top I-beam of Frame 2, and the victim was facing the forklift and standing between Frame 1 and Frame 2. He was directing the forklift driver to properly position side 2. He was also assisting in minor position adjustments of Frame 2. When Frame 2 was in the proper position, the victim was to tack-weld the channel bars from Frame 1 to the Frame 2’s base I-beam. During the positioning of Frame 2, the forklift driver observed Frame 1 begin to fall. The driver yelled to the victim to get out of the way. The victim could not react quickly enough, and the top I-beam of Frame 1 struck the victim and he fell against Frame 2. Fellow workers called 911 and lifted Frame 1 from the victim. Paramedics arrived and took the victim to the hospital where he died a short time later.

- ◆ **TIE OFF:** Tie off any unsupported I-beams using a chain or "C" clamp to a secure mounting area. The secure mounting area should be properly secured at both top and bottom. Although not used, the hoist vertical support was properly secured and supported at ground level via a plate with bolts. (See Figure 1, white box). The type of support at the top of the hoist pole is unknown. Before using this method of securing a freestanding piece, ensure that the structure used for support is capable of supporting the additional weight of the structure being tied off.
