MIFACE INVESTIGATION: #01MI011

SUBJECT: Machinist Struck and Killed by Fragments from Ruptured Steam Turbine Housing

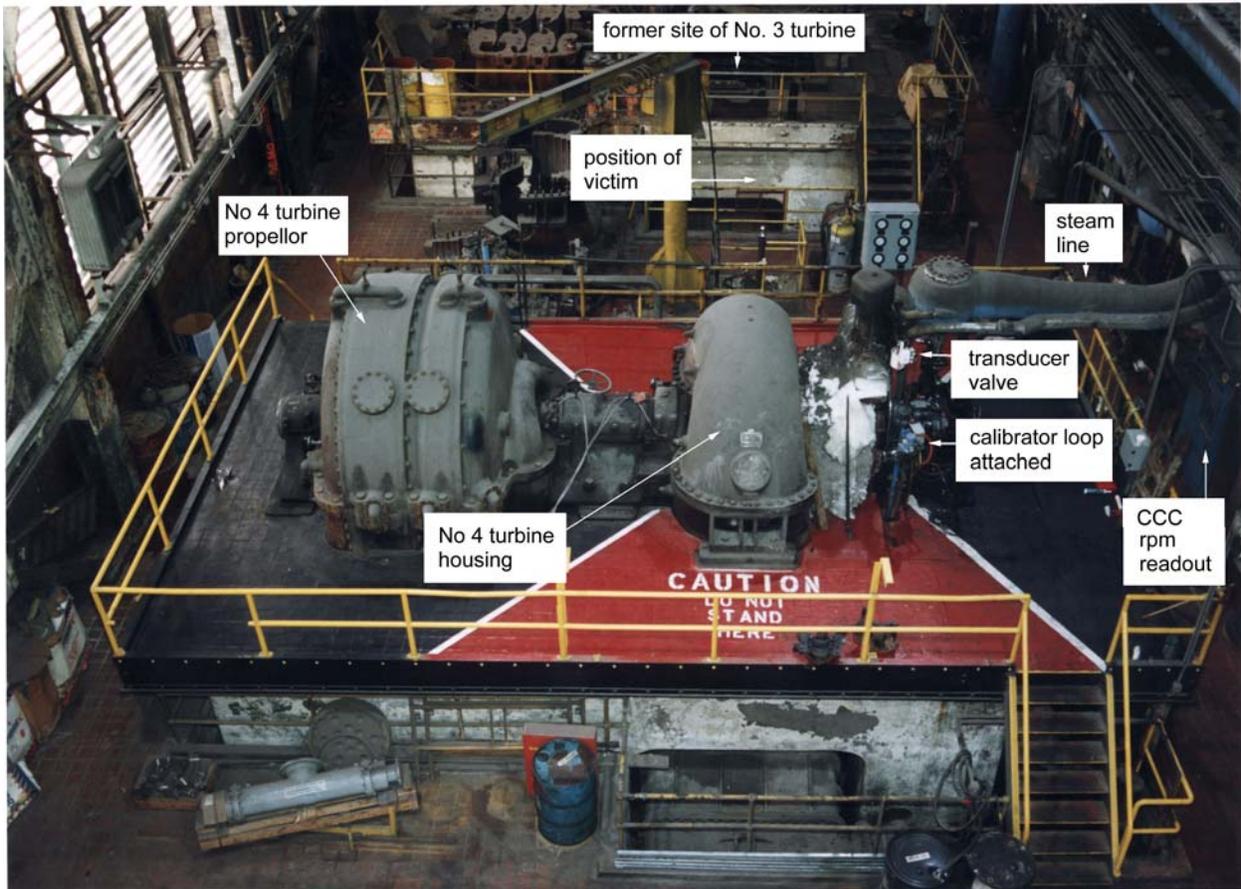
Figure 1
Plant Area Showing Former Site of Turbine No 3 and Site of Turbine No 4

Although guardrails, barriers and signs cannot be the primary means to protect workers, they provide a useful visual reminder of existing hazards to supervisors and workers. The area identified as restricted surrounding No 4 turbine (Figure 1) would have encompassed the position where the victim was standing. A visual reminder should be sufficient in itself to warn a worker of a hazard. They also serve to underline the authority of a verbal reminder.

- No one is allowed near the equipment during the test.
- Barricades, warning signs, and markings identify the restricted area. These warnings can be seen in Figure 1 as they were implemented for the No 4 steam turbine.

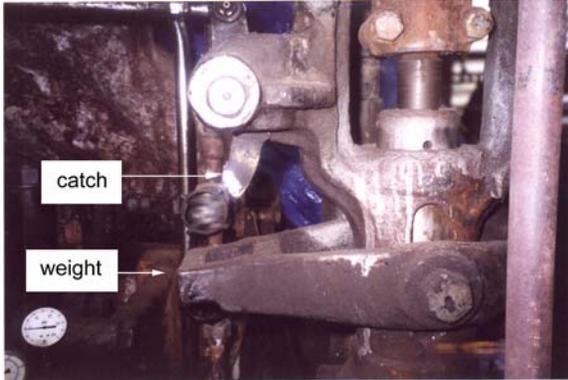
Figure 2
Mechanical Trip Device

situation and signaled for the milliamp current that was controlling the transducer to be reduced, it was too late to stop the turbine from overspeeding. The mechanical shutoff device did not trip (Figure 2). The turbine buckets overran their safe speed causing a catastrophic failure of the turbine rotor. There were 12 rings on the turbine shaft (Figure 3). One hundred buckets broke away from one of the twelve rings on the shaft and pierced the two-inch thick turbine housing. The other eleven rings remained intact. The fragments resulting from the broken housing and turbine buckets struck the victim causing severe injuries and death.

The rpm gauge on the turbine was located at a critical position next to the mechanical trip device. Someone positioned at that location would have been able to immediately identify the overspeed condition and physically trip the device. The gauge was placed there for just that reason. Because it was unusable, the designed safety control of the proximate position of the two parts was overlooked. The safety redundancy was subsequently eliminated.

- Redundant safety controls were established for conducting the overspeed trip test: the manual shutoff valve is the primary control, the person in the control booth conducting the test is located next to an emergency stop; the computer controlling the test is programmed to electronically shut down at a particular ceiling speed.
