MIFACE INVESTIGATION: #01MI022

SUBJECT: Truck Driver Dies in Excavation Cave-In During Diesel Tank Removal

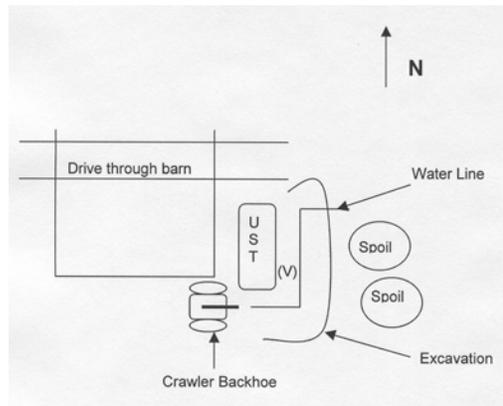
The crawler backhoe was repositioned to begin work on the tank's south side. As excavation of the south side continued, the backhoe neared the water line around the tank. At this point, the excavation was approximately 5' wide, 7' deep at the north end tapering to approximately 5' at the south end. As the backhoe extracted a bucket of dirt and was spinning to unload the dirt from the bucket into the spoil area, the victim entered the excavation. The victim appeared to be trying to help expose the waterline as it went around the south end of the tank to where it connects to the main line near the front south-west corner of the barn. He began to remove shovel loads of dirt from around the water line. One witness observed the east wall of the excavation "begin to move" and yelled to the victim "to get out of there". The wall collapsed, striking the victim from the backside, and pinning the victim, who was facing west, against the south-east corner of the tank. The soil was waist-high on the victim. The collapsed portion of the excavation wall measured approximately 1 cubic yard.

He began to remove shovel loads of dirt from around the water line. One witness observed the east wall of the excavation "begin to move" and yelled to the victim "to get out of there". The wall collapsed, striking the victim from the backside, and pinning the victim, who was facing west, against the south-east corner of the tank. The soil was waist-high on the victim. The collapsed portion of the excavation wall measured approximately 1 cubic yard.

The MIOSHA Construction Safety Standard Part 9, Excavation, Trenching and Shoring R408.40925 defines an excavation as any man-made cavity or depression in the earth's surface, including its sides, walls or faces, formed by earth removal. When earth is removed from the ground, the walls are left unsupported and pressures are generated at the face of the excavation. Where the soil can no longer withstand the pressure, the wall will shear and break away. Usually, soil at the base of the excavation falls into the hole first, then, as support is lost from below, higher wall failure may occur. One cubic foot of soil can weigh 100 pounds or more, depending on the soil's composition. Each cubic yard of soil may weigh more than one ton (2,500 pounds), producing a crushing injury to anyone caught in the wall collapse. A cubic yard of soil weighs nearly the same amount as a mid-size automobile. In this incident, MIOSHA estimated at least 1 cubic yard of soil collapsed from the excavation wall face onto the victim.

- Employers should ensure that employees working in excavations are protected from cave-in by an adequate protection system such as shoring, sloping or excavation box designed in accordance with MIOSHA Construction Safety Standard, Part 9, Excavation, Trenching, and Shoring, R408.40941.

To protect workers from the danger of wall collapse, the Excavation, Trenching and Shoring Standard requires that the excavation, 5 feet or more in depth (unless soil conditions mandate protection in excavations less than 5 feet) be protected from cave in. Rule 942 of the Excavation standard explains what must be evaluated during an excavation to protect workers inside the excavation. The selection of preventative measures are based on this evaluation. Methods such as sloping (angle of repose), sloping and benching, tight sheeting, or trench boxes and shields may be used to protect personnel in the excavation.
