## MIFACE INVESTIGATION: #01MI029

**SUBJECT:** Farmer Crushed between lift arms and frame of skid-steer loader

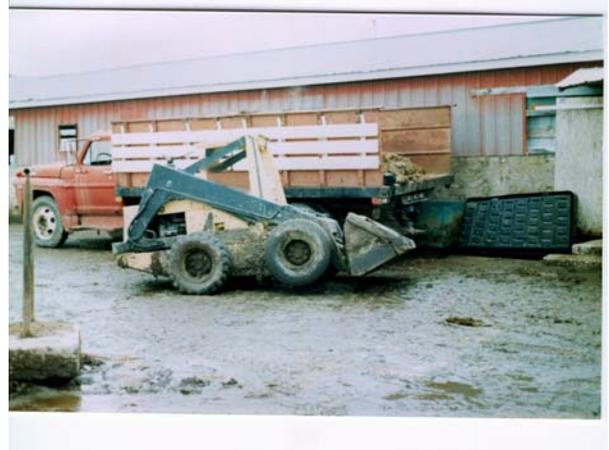
Figure 1

On May 27, 2001, a 67 -year old male farmer died from injuries sustained when he was crushed between the lift arm and the window frame of a skid-steer loader. The skid-steer loader was being used to pick up the manure cleaned from stalls. The witness to this incident worked inside the building scraping manure from stalls to a bay door. The victim had been clearing the piles of manure away from the bay door and loading the manure into a stake truck for about an hour. The truck was located on a concrete pad near the barn. The side safety screens on the skid-steer loader had been damaged during a fire and had not been replaced. Three tires on the loader were conventional truck tires; a skid-steer tire was located on the right rear of the loader. Foot pedals controlling the operation of the loader arms and bucket were located on the floor near the front frame of the loader. The left foot pedal raised and lowered the skid-steer loader arms, and the right foot pedal controlled bucket tilt. While the victim was loading the manure, the left rear truck tire failed. The victim leaned his head outside of the operator's compartment through the unguarded window opening to look at the flat tire. The bucket was in the raised position. While he was leaning outside of the cab, he apparently activated the left foot pedal, causing the bucket to lower quickly crushing his head between the frame and the lift arm.

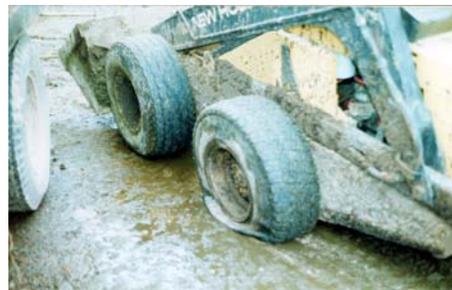
Figure 2

outside of the operator's compartment through the unguarded window opening to look at the flat tire. While he was leaning outside of the cab, he apparently activated the left foot pedal, causing the bucket to lower quickly, crushing his head between the frame and the lift arm. See Figure 2.

The skid-steer loader did not have side shields or a properly working seat hydraulic safety switch. The farm owner recognized the operating hazards of using the skid-steer loader without the side shields, as he had informed family members to keep their bodies within the cab. Skid-steer loader operators are seated in close proximity to the moving lift arms. The farm owner must have believed that he could safely operate the machine without the side screens in place, because he had used the skid-steer in the past without the side screens. The side screens on a skid-steer loader cab are mounted within the frame of the rollover protective structure (ROPS) by a force fit rubber gasket. The side screens and related hardware were damaged in a fire on at the previous owner's property. The gasket material and side screens were not replaced by the previous or current skid-steer owner.

When the left rear tire blew, the victim must have instinctively leaned outside the confines of the cab to look at the blown rear tire. This movement caused him to be inside the lifting arms plane of motion while the arms were in a raised position. Upon leaning to his left, he must have inadvertently stepped on the lift control pedal, lowering the lift arm. Had the side screens been in place, they would have protected the operator from being caught in a pinch point created by the moving lift arms by providing a physical barrier from the plane of motion of the lift arms. The victim would have been prevented from placing any part of his body in the lift arm plane of motion.

- Skid-steer loader owners should ensure that all safety devices and physical safeguards, such as side screens on equipment are in place and operating.
