MIFACE INVESTIGATION: #01MI038

SUBJECT: Maintenance Worker Struck in Head by Exploding Pressurized Tank

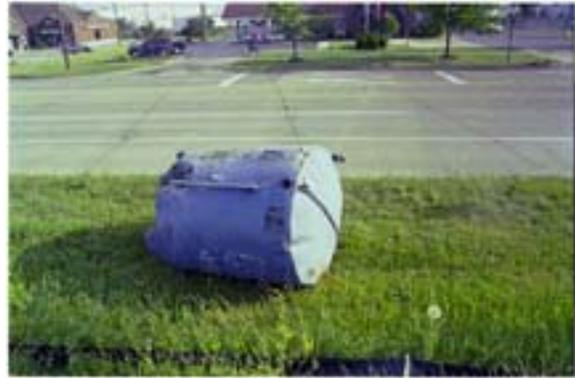
On June 21, 2001, a 39-year old male died when a 500-gallon storage tank he had started to empty of waste oil and water exploded from its base striking him in the head. He had vacuumed the waste oil and water into the tank from a trench on the other side of the plant and transported it with a lift truck to the underground waste storage area for disposal at a later time. He was pressurizing the contents of the tank with air from a compressed airline located just inside the plant to speed the evacuation of the waste oil and water into the waste storage area. The tank

was not approved for use as a pressurized vessel. Fittings on the tank had been adapted for the purpose of connecting them to the compressed airline. The force of the explosion propelled the tank 500 feet in the air over the plant fence and a nearby bank parking lot onto a busy east/west road. This was a maintenance task that had been conducted in this manner for over 6 years. No one witnessed the actual event. Statements from nearby workers and maintenance staff were relied upon to reconstruct what was presumed to have occurred. The deceased was found lying near the place where he had been last seen beginning to drain the tank. Emergency personnel confirmed that he was dead when they arrived at the site.

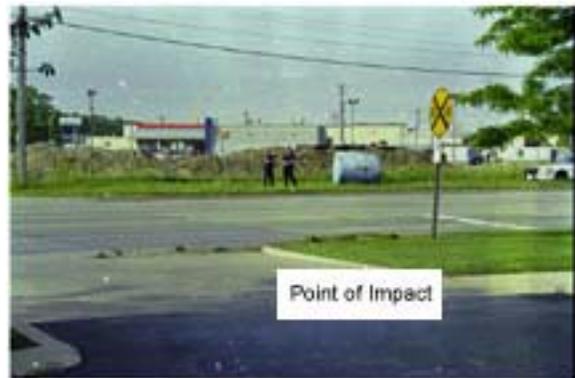
On Thursday, June 21, 2001, at 8:00 am, a noise resembling an explosion occurred at a plastic injection molding plant. At approximately the same time, drivers on a heavily traveled east/west street about 500 feet south of the plant noted a 500-gallon liquid storage tank (6 feet high, 5 feet diameter) land on the road. Someone pushed it off the road onto the curb so it would not interrupt traffic.

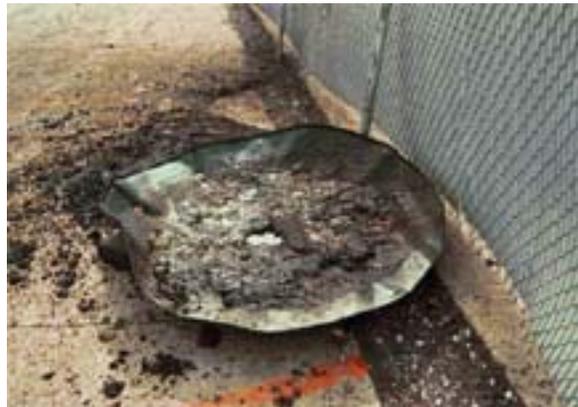
Tank Base Against Plant Fence

The liquid storage tank was not approved for use as a pressurized container. It had originally been used for oil storage, but developed a leak and was painted with "DO NOT USE". The base of the tank had been welded onto a metal device that allowed it to be transported by the forks of the lift truck. These welds did not separate. The top of the tank tore away from its base leaving the base welded to the transport device. Evidence of rust was visible around the base

of the tank. The rust apparently weakened the steel enough for the pressure to cause the rupture at the bottom of the tank above the base.
