MIFACE INVESTIGATION: #01MI061 and #01MI063

SUBJECT: Two Individuals Overcome By Hydrogen Sulfide Gas While Cleaning a Farm Facility Water Well With 28% Liquid Muriatic Acid

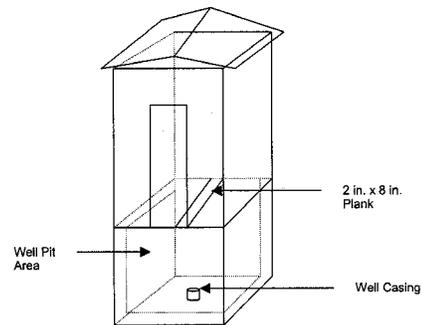
A family member met the MIFACE investigators at the well location on the family farm. The well was approximately 300 ft. from the road, was approximately 150 ft. west of the residence, and was 20-25 ft. downhill from the livestock barn. A 5 ft. x 5 ft. wood shed was built around the well for protection. The shed was approximately 8 ft. tall, had a 30 in. door facing east, had 2 in. x 4 in. studs and had particleboard walls with batt insulation. The well pit had concrete walls. The pit was approximately 4½ ft. deep, was 4 ft. x 4 ft. wide, and had a 2 in. x 8 in. wood plank across the pit opening. At the base of the pit, there was a driven point well with a 2-in. steel pipe and a jet pump. The jet pump was located above ground with one line to the residence and one line to the cattle barn. There were no windows in the shed as per information from the relatives and neighbors. The shed was dismantled prior to the MIFACE visit.

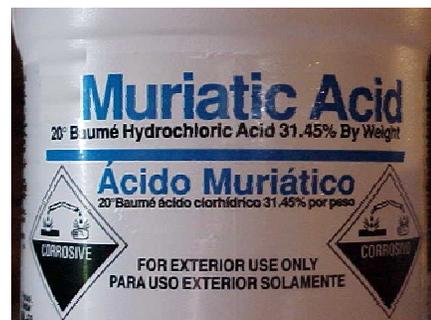
Liquid muriatic acid is easily available and is inexpensive, therefore homeowners frequently use it to clean well screen incrustation. Uninhibited muriatic acid can cause destruction of the well screen and pitting of the drop pipe. The liquid muriatic acid the victim was using did not contain any inhibitors. See Figure 1 for an example of the product used by the victims.

- Private water well owners should not use uninhibited, liquid muriatic acid to clean well screens; owners should explore acid alternatives that are in granular or palletized form, slower dissolving, produce less hazardous fumes and are more environmentally friendly.

Over-the-counter liquid muriatic acid is not recommended for well cleaning by non-professionals. Liquid muriatic acid may not contain inhibitors, increases the potential of blowouts, and can expose both people and the environment to unsafe conditions. If liquid muriatic acid is the only product that can be used to dissolve the incrustation on the well screen, a licensed well contractor should perform the cleaning.
