## MIFACE Investigation #01MI064

Subject: Restaurant Maintenance Worker Wedged between Sump Pump Pipe Support Bar and Sump Pump Crock Rim

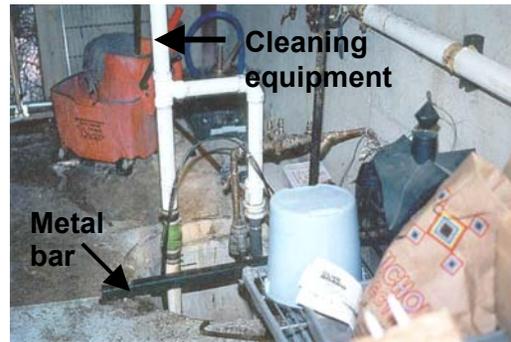
On March 18, 2001, a 54-year old restaurant maintenance worker died of asphyxiation when he became wedged between a metal support bar for sump pump piping and the rim of the sump pump crock. The uncovered sump pump was located in a storage area behind a row of refrigerators in the restaurant basement. The victim used the storage area as an area to hang his coat. After punching out, the victim went downstairs to retrieve his coat. The victim's coat pocket may have contained several pieces of jewelry. The owner thinks that some jewelry may have fallen out of his coat pocket while he was putting on his coat and/or getting car keys. The victim may have thought that some jewelry fell into the open sump pump crock and he attempted to retrieve the jewelry. During the retrieval process, the victim became pinned between the metal support pipe and the sump pump well rim. Another restaurant employee found the victim and called the restaurant co-owner. The co-owner called 911. The victim was found bent at the waist, headfirst in the sump crock with his head in the water. Rescue workers used a reciprocating saw to cut the metal support to free the victim. The victim was pronounced dead at the scene.

The sump pump was located in a 12'x5' storage area behind a row of refrigerators in the basement. The sump pump handles effluent from the refrigerators as well as any peripheral building drainage; the design was a standard basement commercial sump pump. The sump was approximately 6" away from the wall. The crock diameter was approximately 23". The crock had a "lip" of approximately 4 1/2"; the total crock diameter was 28". The crock was approximately 3 1/2 feet deep. The sump pump had one PVC pipe and one copper pipe that carried condensation from the downstairs storage area refrigeration units. Also across the opening of the sump pump was a singular 2 1/4" plastic pipe. The sump pump piping was stabilized by an 1 1/2" metal bar bolted to the cement floor. The sump pump has a high water sensor that signals an alarm when the water rises above the sensor. The restaurant has a keypad at the top of the basement stairs that beeps when the sensor is activated and an external alarm monitoring company is alerted. The sump pump back up system is not electrical.

On the day of the MIFACE investigation, standing water in the crock was approximately 1 foot deep, which according to the owner, was a normal level. On the day of the site visit, the sump crock was uncovered and cleaning equipment was stored in the storage area. The co-owner stated that sometimes a metal grate was placed over the front of the sump crock, but it was not there on the day of the incident.

- Employers should evaluate the workplace to identify any confined spaces and develop and enforce written work procedures for entry into these areas.
- Employers should cover sump crock openings with a solid cover to prevent items and/or people from falling into the sump pump area.
- Employers should develop and enforce written work procedures, including general electrical safety-related work practices.
