## MIFACE INVESTIGATION: #01MI025

### SUBJECT: Delivery Man Struck by Vehicle While Stopped on Roadway to Change Delivery Van Flat Tire

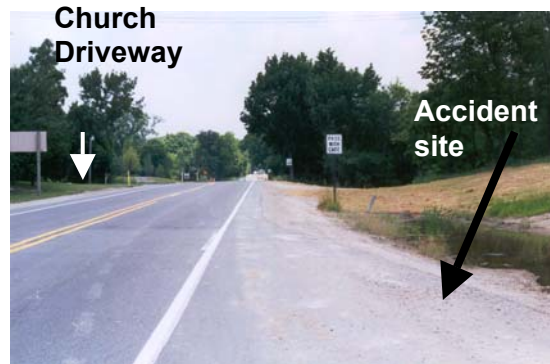
Figure 1

On February 13, 2001, a 49 -year old male died from injuries sustained when he was struck by another vehicle after pulling off a roadway to a paved shoulder to change a blown passenger side front tire. (See Figure 1). It is unknown where the driver experienced the blown passenger tire.

At corner of road/interchange, looking north

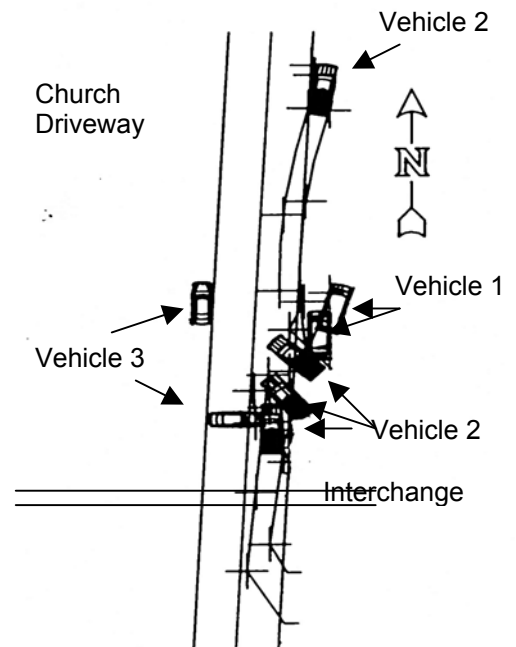
Figure 2

The police report and accident investigation was used to construct the sequence of incidence events. The police report provided the accident drawing, MIFACE labeled the vehicles. The accident drawing is labeled below as Figure 2.

Vehicle 2 was traveling northbound at approximately 54 mph. Vehicle 3 was traveling southbound, and had slowed to approximately 14 mph. Just south of where the delivery van was parked, Vehicle 3 appeared to make a u-turn to travel north. When Vehicle 2 saw Vehicle 3 begin to make the u-turn, Vehicle 2’s driver slowed Vehicle 2’s speed to

approximately 35 mph. Vehicle 2 was unable to avoid being struck by Vehicle 3. Vehicle 3, while making the u-turn, struck Vehicle 2's driver's side door. The collision caused Vehicle 2 to uncontrollably slide to the right, toward the delivery van. Vehicle 2's passenger side truck bed struck both the victim who was standing at the rear of the delivery van on the driver's side. Vehicle 2 continued to slide northbound for approximately 80 feet, coming to rest facing north on the shoulder of northbound lane. Vehicle 3 spun and came to rest facing north on the southbound lane shoulder. One of the drivers involved in the collision called 911, and emergency personnel arrived shortly thereafter. The victim was pronounced dead at the scene due to injuries sustained at the crash site.

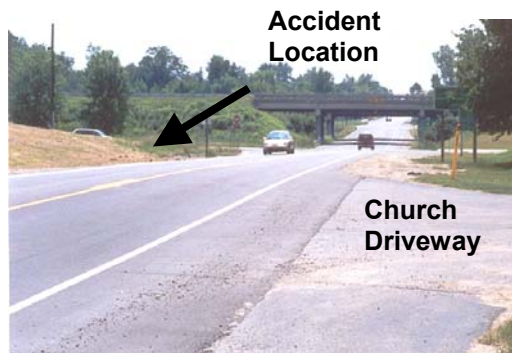
Figure 3  
Looking south

In this incident, the victim stopped on the wide, paved shoulder to change the tire just north of a busy intersection. Although the shoulder was a paved, even shoulder, there was a “safer” location to pull over to change the tire. Just north of his selected location, on the west side of the road, was a church. The driver should have turned into the church’s paved driveway and removed himself completely from the roadway. See Figure 3.

- When changing a tire, choose a safe location out of the flow of traffic. To alert other drivers, use hazard warnings, such as emergency flashers and flares or reflectorized triangles.
