MIFACE INVESTIGATION: #02MI016

SUBJECT: Rig Hand Entangled In Rotating Drive Shaft While Hanging Light in Rig Substructure

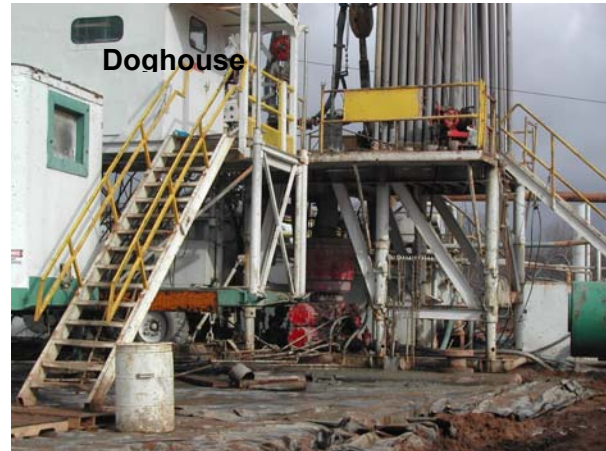
Another Company Oilrig – Not the rig involved in the incident

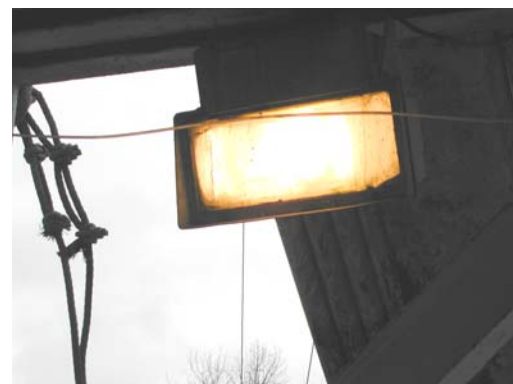
Figure 4

and a 6-8 foot flexible cord, which was to be plugged into a receptacle located on the doghouse side of the derrick. An example of the light the victim was hanging is shown in Figure 4. Another worker handed the light to the victim while he was in the substructure area, and walked away.

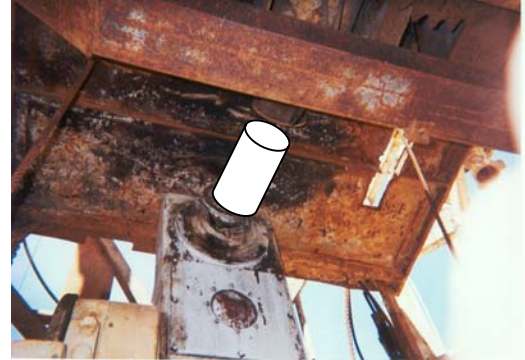
To mount the replacement light, the victim was looking to the south, and was attaching the light to the angle iron in the southwest corner of the substructure. The victim was instructed to place the light on the bottom of the beam approximately 12" below the rig floor. The victim did not use a ladder to climb up so he could hang the light; he climbed on the winches/steel mounting plates. When he climbed on the winches and/or steel plates, the drive shaft was located approximately 2-3 feet to his left and 2-3 feet above his head. Figure 5 shows the prior setup without the drive shaft attached. The white cylinder represents the drive shaft location when installed.

One possible scenario is that the light cord may have been thrown over the victim's shoulder and got caught up on drive shaft, catching victim's clothing and pulling victim into drive shaft, hip first. Another possible scenario is that the victim lost his balance while standing on the mounting plates/winches and when attempting to try to regain his balance, his clothing was caught in the rotating shaft. The light fixture was found in the northwest corner of the substructure; the glass lens was not broken, but the power cord was ripped out.
