MIFACE INVESTIGATION: #02MI040

SUBJECT: Truck Driver Killed When Front-End Loader Secured by Chains on a Lowboy Trailer Broke Free and Rolled Onto Cab

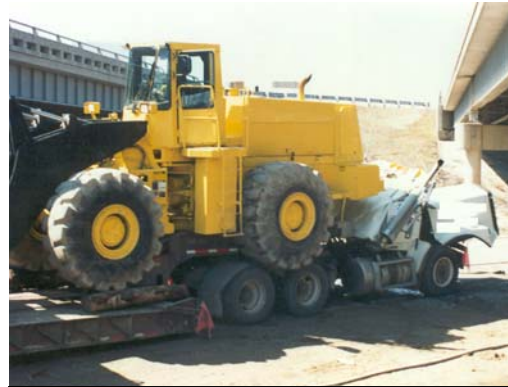
On April 10, 2002, a 56-year old truck driver with 22 years of experience died when a front-end loader weighing between 60,000 and 65,000 pounds that was being transported on a 50-ton lowboy trailer broke free from its securing chains and rolled onto the cab crushing him. The loader transmission was in neutral and the parking brake was set. The victim used at least four 3/8-inch chains rated at 6,600 pounds (the exact number is unknown) to secure the loader. Five binders were found at the scene. One chain appeared to be improperly attached to the loader's maintenance ladder, one chain appeared to be attached to an attachment point on the loader. The remaining chain attachments to the loader are unknown. If four chains were used, the load exceeded the aggregate working load limit of the chains. Also unknown is where each of the chain hooks and/or binder hooks were attached to the trailer. Based on the police report of the incident, at least one chain hook/binder was improperly attached to the trailer bed. One chain appeared to have an oversized hook. During transport, the driver stopped suddenly between two bridges. Skid marks from the truck were present on the roadway. It appears that a sudden stop caused sufficient force on the chains to break them. The loader rolled forward over the 5th wheel and onto the top of the truck cab. The cab was crushed, and the driver was declared dead at the scene.

Figure 1. Loader on truck cab

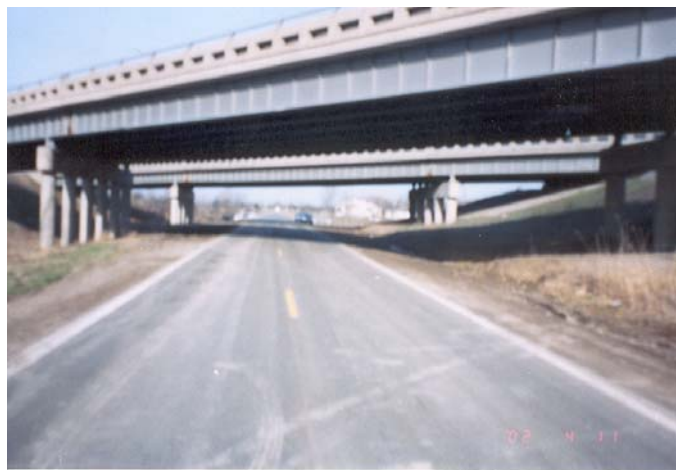
The loader was transported on a 2-lane paved, flat roadway that was in good condition. The speed limit was 55 mph. On the day of the incident the investigating police could not detect an obstacle that could have impaired the driver's vision. The overpass was measured at 17 feet 2 inches above the ground; the height of the truck with its load was 14 feet 1 inch.

Figure 2. Road where incident took place

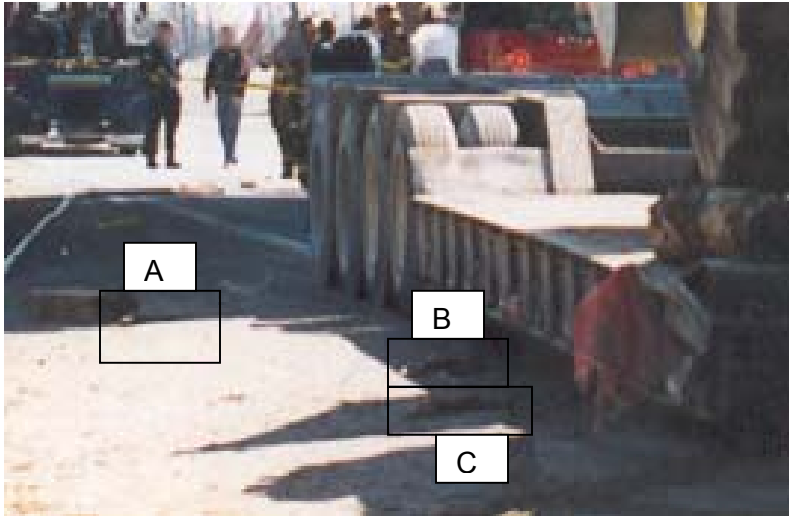
Police noted several chains and binders on the ground on each side of the trailer. The police located three ratchet binders and one chain on the passenger side of the truck's trailer. Figure 3 shows the chain and binder locations on the passenger side. One binder with a broken hook was found at the rear of the trailer (Box A). One binder/chain with a broken chain link were found at the middle of the trailer (Box B). One binder was located at the front of the trailer (Box C). Figures 4-5 show a close-up view of the binder with the broken hook noted in Figure 3, Box A.

Figure 3. Passenger side, Binders and chains marked in Boxes A-C

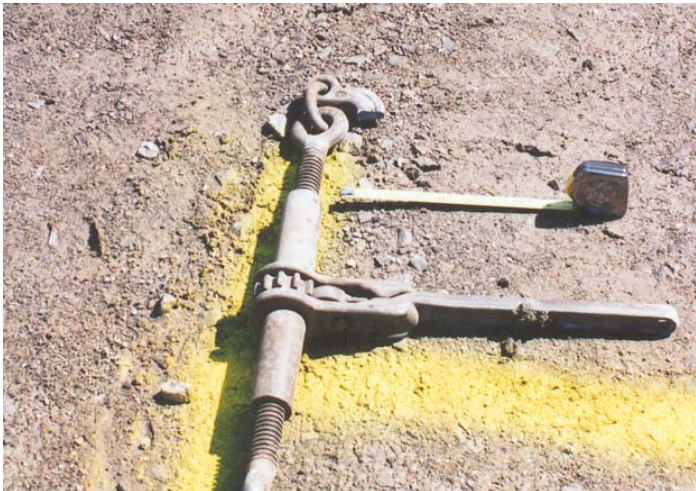
Figure 4. Broken binder hook, passenger side

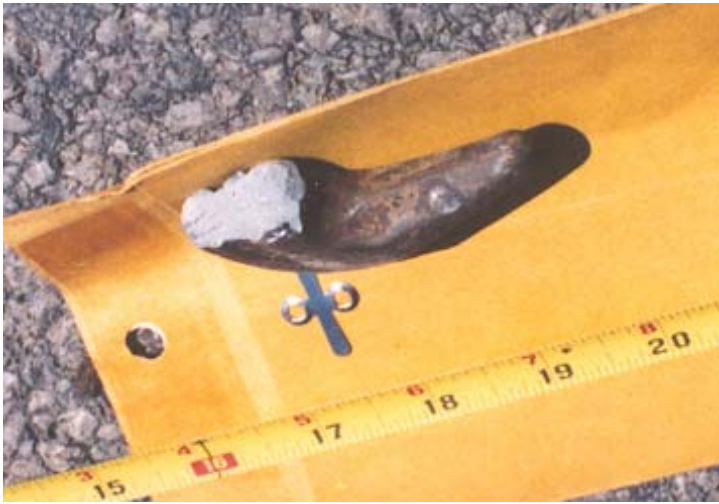
Figure 5. Broken hook, passenger side

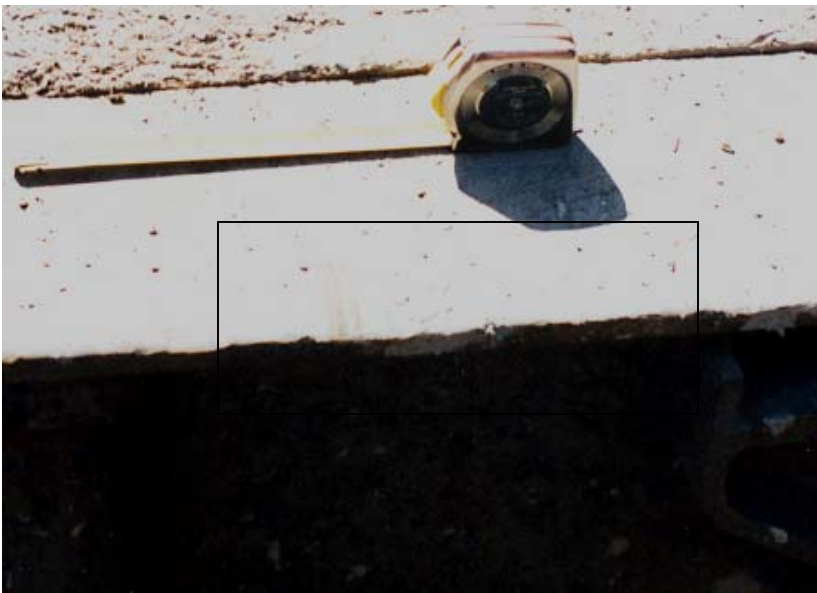
During their investigation, police found fresh scratches on the middle of the trailer decking. There were no fresh marks or scratches on the "D" rings. The box in Figure 6 outlines the chain or binder marks.

Figure 6. Chain or binder marks on trailer

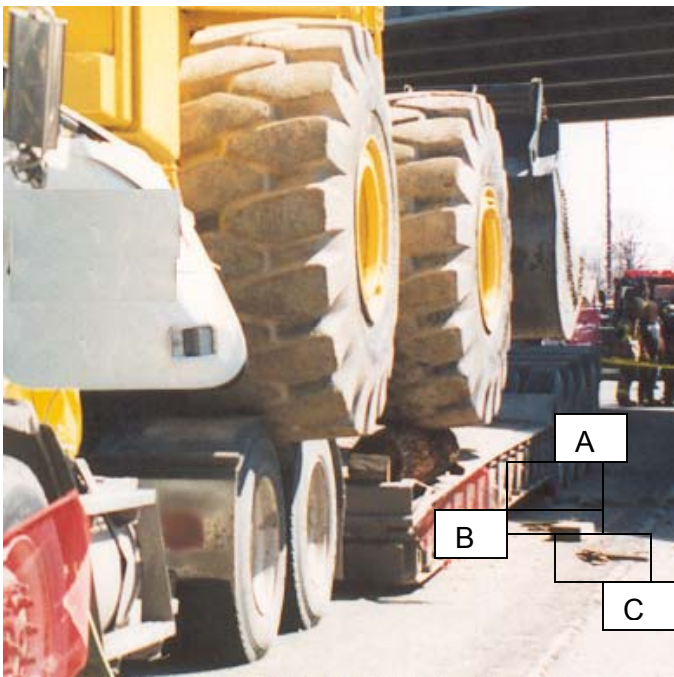
On the driver's side of the vehicle, Figure 7 shows the chains and binders found on the ground. One long chain was found at the rear of the trailer. (Box A and Figure 8) Another chain and binder were located at the middle of the trailer (Box B, and Figure 9). A binder was found toward the front of the trailer (Box C).

Figure 7. Driver's side view of chains and binders. Binders and chains marked in Boxes A-C

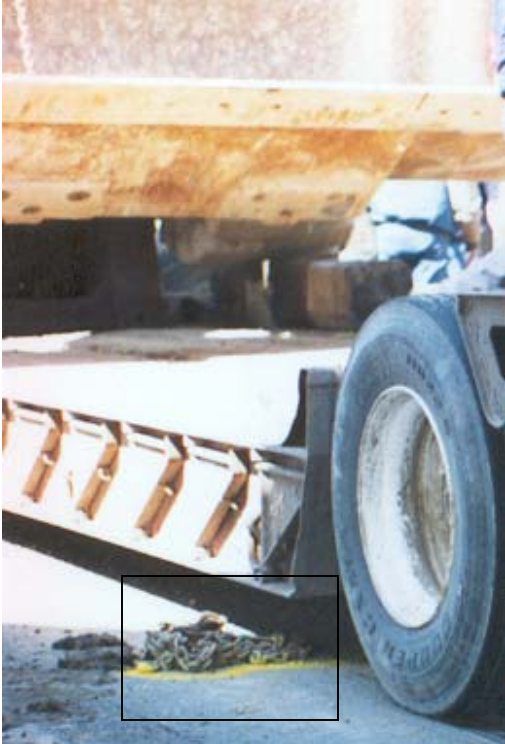
Figure 8. Long chain at trailer rear on driver's side

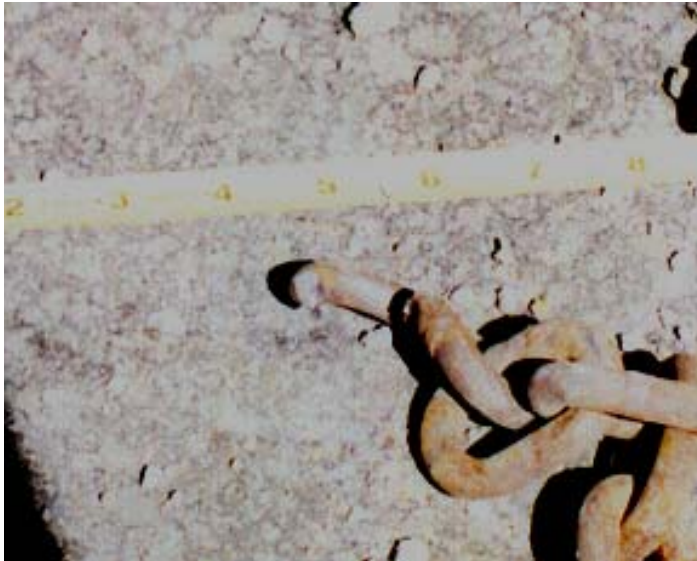
Figure 9. Broken chain, middle of trailer, driver's side

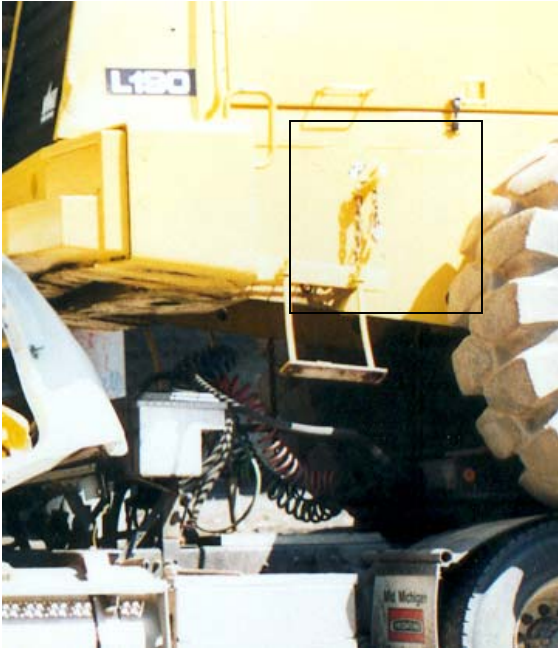
used for securing the loader or if they were used earlier and prior and were not taken off the loader prior to transport. One chain is attached to an attachment point on the loader (See Figure 12).

Figure 12. Chain located on loader, driver's side

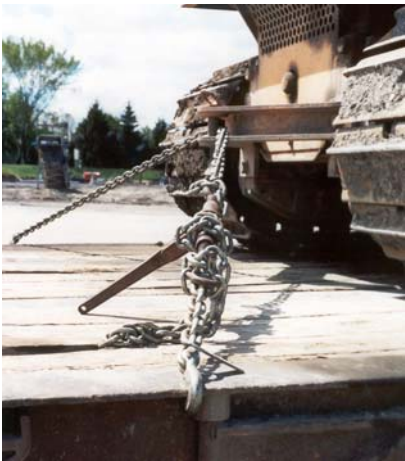
During the MIFACE visit, the company representative arranged for a lowboy trailer that was loaded with a piece of heavy machinery to be driven to the company headquarters so the MIFACE representative could see how a load should be secured. The loader blade was retracted and wedged against the trailer end. The individual who secured the load on the trailer stated he was trained by the victim and also by a trade association representative on proper load securement procedures. Figures 13 and 14 show that the loader was not properly secured on the trailer bed. Figures 13 and 14 were taken looking down the driver's side of the trailer. Figure 13 shows that one of the chains used to secure the load is improperly attached to the trailer bed. Figure 14 shows proper attachment to the "D" ring, but improper loader attachment.

Figure 13. Improper attachment of loader to trailer bed

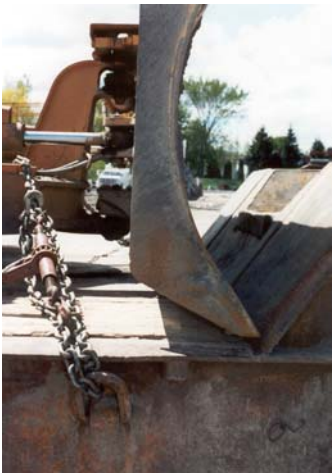
Figure 14. Proper attachment to "D" ring

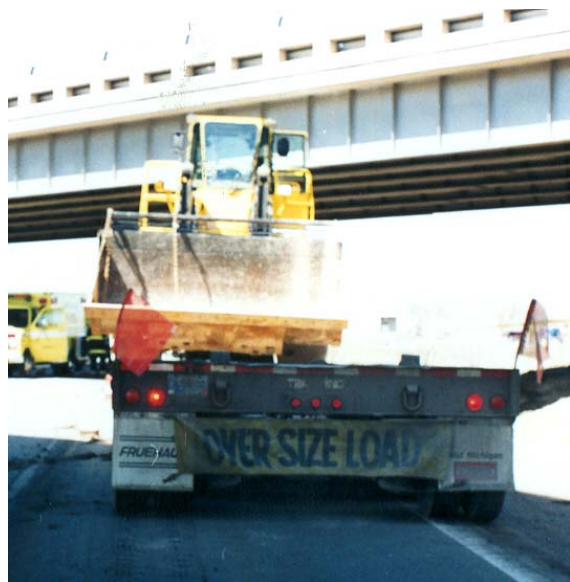
The load was not adequately secured against longitudinal (forward/rearward) and lateral movement. See Figure 15. Protecting against longitudinal movement insures the cargo remains on the vehicle and does not penetrates the vehicle's front-end structure. Protection against lateral movement insures the load does not shift sideways in transit.

Figure 15. Lateral movement of loader

- Companies should require and train employees to use manufacturer identified cargo attachment points and "D" rings on the trailer using the appropriate number of tiedown assemblies.

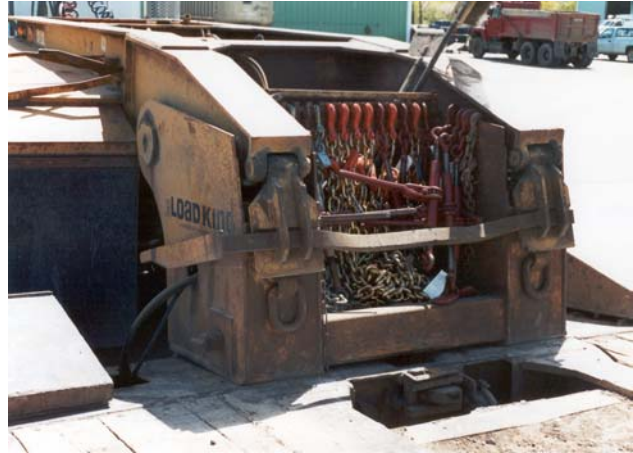
Company personnel indicated that the company has upgraded from 3/8-inch chains to 1/2-inch chains. See Figure 16. The entire tiedown assembly is only as strong as its weakest component. When upgrading, the company must take the next necessary step to ensure that the chain upgrade does not exceed the working load limit of any of the other components of the assembly, such as the hooks, tensioner, “D” rings, equipment attachment points, etc.

Figure 16. Storage area holding 1/2 inch chains

- Companies should ensure that consistency is maintained with the working load limits of all components of a tiedown assembly.

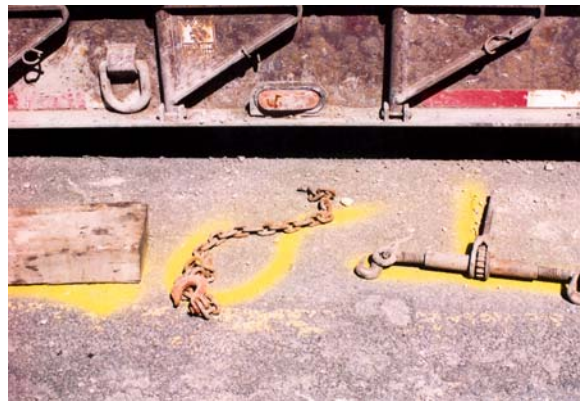
On the day of the incident, it appears that the victim used a grab hook with a throat too big for the 3/8-inch chain link. See Figure 17. The chain links would not fit securely inside of the throat and could possibly slip during transport.

Figure 17. Oversized hook, driver's side

- Companies should ensure all components of a tiedown assembly are inspected for defects and correlate in size while securing each load.

FMCSA Rule 393.104 states that all vehicle structures, systems, parts, and components including vehicle tiedown anchor points used to secure cargo must be in proper working order when used to perform that function with no damaged or weakened components that will adversely effect their performance for cargo securement purposes, including reducing the working load limit and must not have any cracks or cuts. Company personnel indicated that they routinely check the chains for stretched links by laying the chain out and measuring. According to a company worker, chains normally don't stretch; they break. The workers do not routinely check for damaged chain links, damaged transport vehicle anchor points, or damage to the anchor points on the load. MIFACE recommends that the company require drivers who transport loads to check all components of the tiedown assembly during securement to ensure all components are in proper working order.
