MIFACE INVESTIGATION: #02MI060

SUBJECT: Millwright Dies from Fall Off Ladder

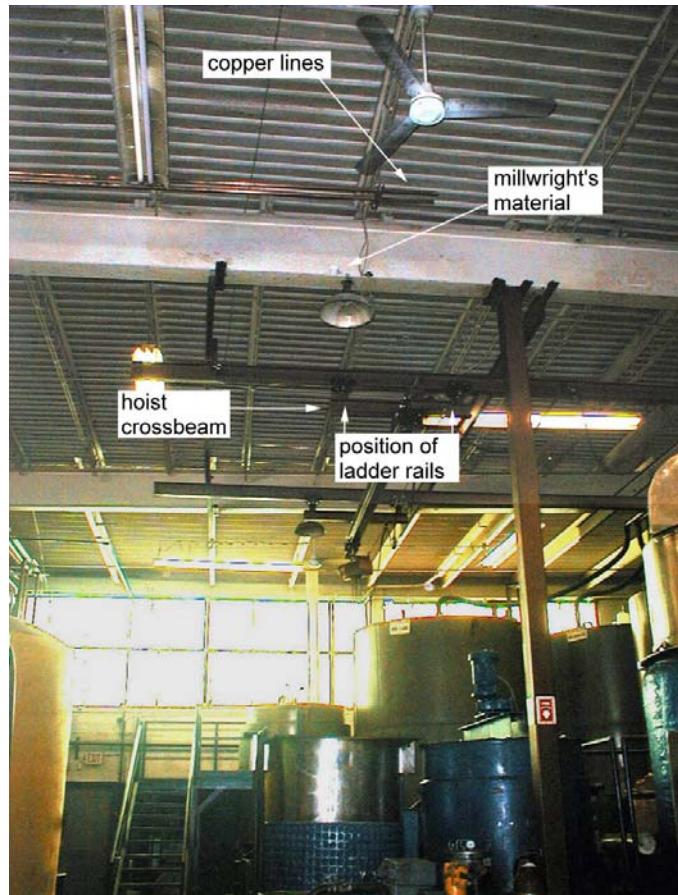
Figure 1

The victim started work at approximately 7:00 a.m. and had been working less than one hour when another employee working nearby heard a noise and went to investigate. He found the victim unconscious on the floor next to his ladder. The extension ladder was standing upright, leaning against a hoist crossbeam behind the area where the victim was working, not on the building I-beam closer to where he had placed his material. The container of material the victim had been using to connect the pipes was on the building I-beam (Figures 1 and 2).

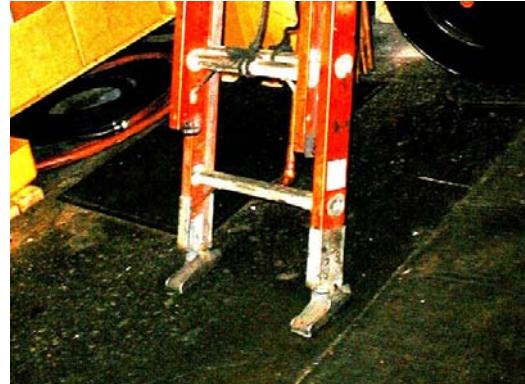
Figure 3

On the day of her visit, the MIFACE investigator was not able to examine the floor where the event occurred because containers were stored in the area. The extension ladder belonged to the victim and appeared to be in good condition (Figure 3). It was a fiberglass extension ladder with aluminum rungs. According to the Technical Director, the area around the ladder was clear at the time he was working there.

However, on the nearby floor, there was evidence that the products of the manufacturing process, lubricants and die release compounds, had been absorbed into the flooring surface. The MIOSHA officer who investigated the fatality shortly after it occurred indicated in his report that "a dark film of this product is on the ladder's safety feet, on the aluminum rungs of the ladder, and soles of shoes/boots worn in this area".

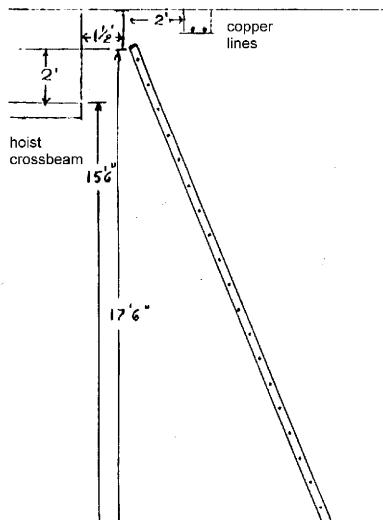
Diagram 1

Reconstruction of the probable scenario indicated that the ladder had been leaned against the I-beam and had slipped and fallen to the hoist crossbeam causing him to lose his balance and fall to the floor (Diagrams 1 & 2). Marks were apparent on the ladder that matched where it would have fallen to the hoist crossbeam in such a scenario.

Ladders should be lashed or otherwise securely attached to ensure they will not slip. Slip resistant feet are not an acceptable substitute for holding a ladder in place that is used upon slippery surfaces.
