MIFACE INVESTIGATION: #02MI090

SUBJECT: Journeyman Pipefitter Killed When Struck in Head by Grooved End Cap under Pressure

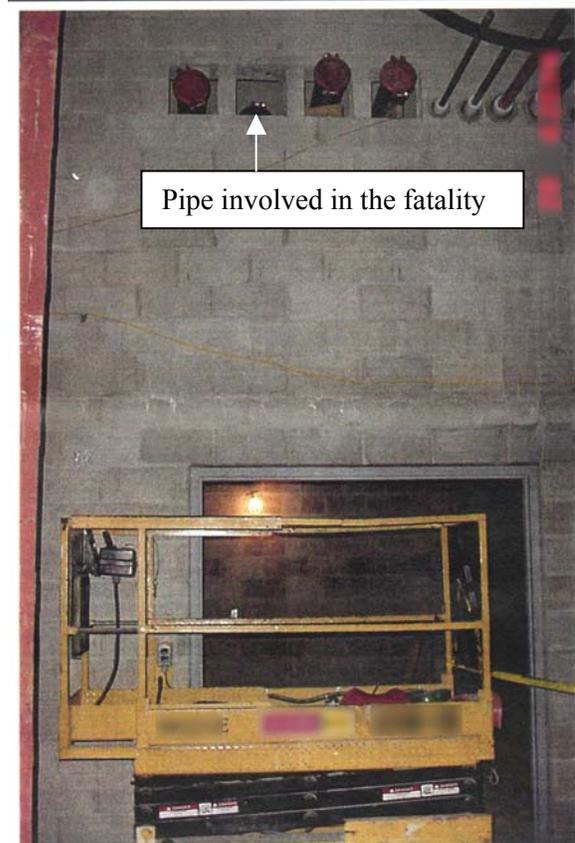
Figure 1 Pipes and Scissors Lift

Figure 1 is a photograph of the pipes on which the men were working with the scissors lift (shown in the retracted position) below. The second pipe from the left is the pipe involved in the fatality. It was recessed into the wall opening from the force of the end cap exploding off of it.

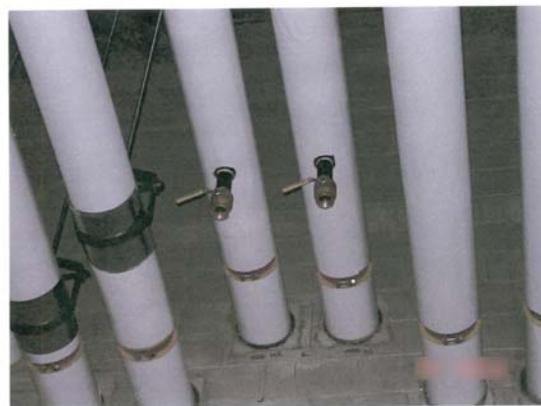
Figure 2 Closed Pressure Relief Valves

The pipes had been pressurized previously with air to 100 psi to test for leaks by the pipefitter. To pressurize the pipes, a test header apparatus was connected to a valve in each of the pipes. The apparatus consisted of a pressure gauge attached between lines connected to the valve on each pipe and a compressed air cylinder. The pipes were pressurized in a separate room approximately 50 feet from where the workers were working. After pressurizing the pipes to the desired psi, the valves were closed and the apparatus removed. Figure 2 shows the pipe valves in the closed position.

Part of the victim's responsibility would have included bleeding the air from the pipes before he and his partner removed the caps. The usual practice was to bleed the air from the pipes after 24 hours. These pipes had been pressurized longer than 24 hours before the incident, but there was some question regarding when he had originally pressurized them. These pipes may have been pressurized for three weeks.

- Develop a specific standard operating procedure for the task including tagging the valves with time and date of pressurization.

Attachment 1 of this report is an example of the type of standard operating procedure developed for this task. Apparently it is not unusual for an air test to be left on for several days. Because the air test apparatus was removed, it would have been appropriate to tag the lines as a reminder that they were pressurized. A red tag on the lines would have been a reminder to the crew that the lines were still under pressure.

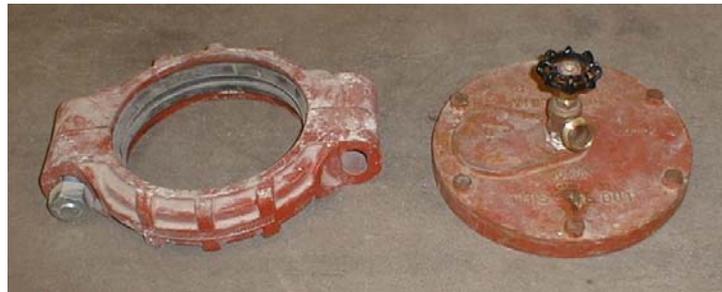
Figure 3 Coupling (left) and retrofitted grooved cap

The victim would have been the person to depressurize them. As the pipefitter loosened the bolts on the coupling in front of him in preparation for removing the end cap, the 5-pound, 6-inch diameter cap exploded from the end of the pipe. It struck him in the face with sufficient force to push him over the rail of the scissors lift. He fell 14 feet to the concrete floor below onto his head. When his co-worker heard the noise, he turned to look,

The cap that was used to blank the pipes was referred to by several names. It was called a grooved cap, or Vic cap, or grooved plug. These names describe a method of blanking a pipe that consists of bolting a coupling with a gasket in which the cap or plug is seated onto the end of the pipe. The two pipes on the right in Figure 1 are shown with an end cap attached. Figure 3 shows a coupling and a grooved cap retrofitted with a pressure relieving valve. The caps used at the time of the incident did not have pressure relieving valves.

- All grooved caps were drilled, tapped and a pressure relieving valve was added in the center of each.
- Pressure piping testing procedures and lock out tag out procedures for the testing were written and distributed to company workers. They included an Inspection Test Report that must be signed off by the job superintendent and the mechanical inspector. The company's written procedures are included as Appendix 1.

- Use an end cap that remains attached to the pipe during loosening as the pressure is relieved and prior to removal, or outfit the end cap with a pressure relieving device.

The employer's retrofit of the grooved caps the company now uses was one way to ensure a cap would not be allowed to explode from the end of a pressurized pipe. There are other fittings such as blind flanges that can be purchased to blank a line that stay attached to the pipe until the pressure is bled off as they are being removed. Whichever method is used to guard against a cap exploding from the end of a pressurized line, the most important control is to make every effort and plan to ensure the line is depressurized first.
