## **MIFACE Investigative Report #02MI120**

### **Subject: Farmer Killed When His Tractor Leaves Public Road Shoulder and Overturns Into a Ditch**

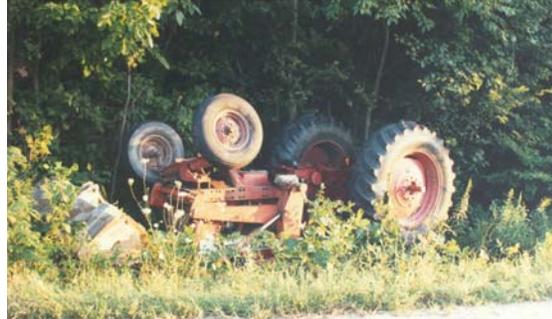
On August 31, 2002, a 70-year old male part-time farmer was fatally injured when his 30 year old Farm-All 656 tractor equipped with a front-end loader rolled over on top of him while traveling on a public road. The tractor was not equipped with a roll-over protection structure (ROPS).

Figure 1 – Tractor overturn view from road

- Tractors should be equipped with roll-over protection structure (ROPS) and seat belt; the local county extension agent, local equipment dealer or equipment manufacturer should be contacted to see if a retro-fit ROPS/seat belt system is available.
- Equipment operators should not consume alcohol before operating the equipment.

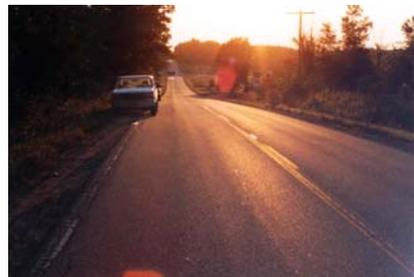
Figure 2 – View from hill crest

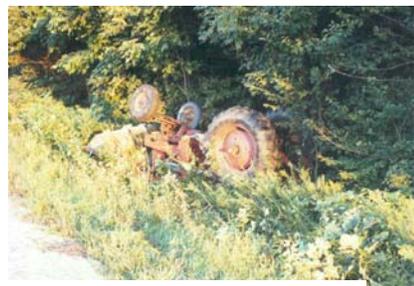
To get to the neighbor's barn, the victim traveled on a fairly heavily traveled, paved, asphalt, 2-lane road that went up a hill. The road had a narrow, paved shoulder. Hidden by grass/weed growth approximately 5-6 feet on the right shoulder was a steep 3-foot ditch. He had traveled eastbound up the hill approximately 500 feet when the tractor wheels left the right shoulder (See Figure 2). He attempted to re-enter the roadway but was unable to do so and entered the ditch. The tractor flipped over, probably striking the victim as it overturned (See Figure 3).

Figure 3 – Shoulder/ditch overgrowth

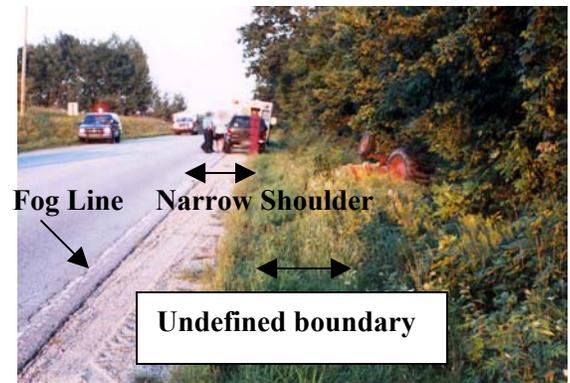
Figure 4

When MIFACE researchers visited the incident site and viewed the police photographs of the incident, several observations about the roadway were noted. See Figure 4.

- The gravel shoulder was narrow, which may have caused the victim to travel with half of the vehicle's tires on black top and the other half on a gravel surface. This could have reduced his ability to maneuver the tractor.

- The ditch edge was unable to be seen due to the overgrowth in the ditch and the extent of the shoulder mowing. The shoulder/ditch edge could be defined with appropriate mowing.

- The white edge or fog line that help travelers stay on the road at night was worn and faded, thus it may have been difficult for the victim to get a good visual orientation separating the road from the shoulder areas.

- There were no delineator posts/shoulder edge marking for the roadway. These devices could be used along the shoulder of the road to: mark hazards such as ditches, establish the maximum safe area that a vehicle could travel onto that shoulder, and, provide a line of visual perspective that shows where the shoulder ends and where the hazard, such as the ditch slope, begins.
