MIFACE INVESTIGATION: #02MI151

SUBJECT: Farm Laborer Killed When He Became Entangled in an Unguarded PTO Shaft

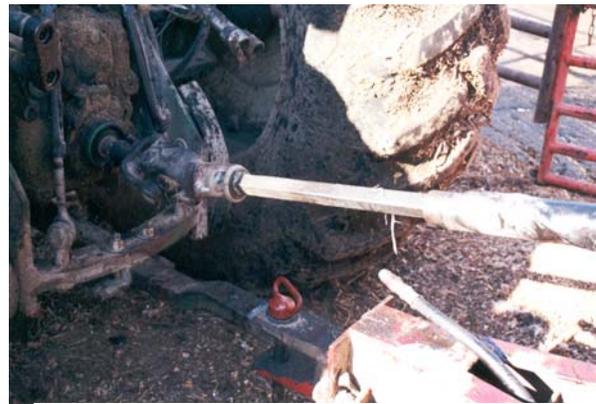
On November 11, 2002, a 45-year old male farm worker was killed when he became entangled in an unguarded rotating power take off (PTO) shaft at the tractor connection (See Figure 1). The mixer had undergone repair and its u-joint and PTO shaft were unguarded. The tractor PTO lever was located on the operator's right side while seated in the tractor. The mixer had a moveable scale that was attached to a stationary arm that could be moved to face either side of the mixer. The victim loaded the mixer with supplements and then had driven the tractor/mixer to the bunker silo area to add haylage to the supplements. He drove the tractor into the bunker area from a north to south direction instead of his usual approach, which is in a south to north direction. He had dismounted from the tractor and left the tractor running; it is unknown if the PTO was engaged or disengaged when he dismounted. He was working alone and the event was unwitnessed. His left hand/arm became entangled in the rotating PTO. His clothing was ripped off and his left arm severed at the shoulder. Another employee found the victim with his head by the driver side rear tractor wheel and his feet facing the mixer. This employee turned off the tractor and contacted another employee for help. The second employee ran to assist the victim; when the second employee determined there was nothing he could do, he called the farm owner to obtain the exact farm location address and then called 911 with this information. Emergency response arrived and the victim was declared dead at the scene.

Figure 1 – Unguarded PTO Shaft

- All rotating shafts, including PTO drivelines, should be covered by shields/guards in good condition to prevent worker contact with rotating parts.
- Tractor operators should engage/disengage the PTO while seated in the tractor operator seat.
- Loose or frayed clothing that can get caught in machinery should not be worn.
- Employers should establish a safety plan that includes a farm emergency plan that identifies emergency responsibilities of individuals working on the farm, an emergency contact list, and farm location by the telephone.

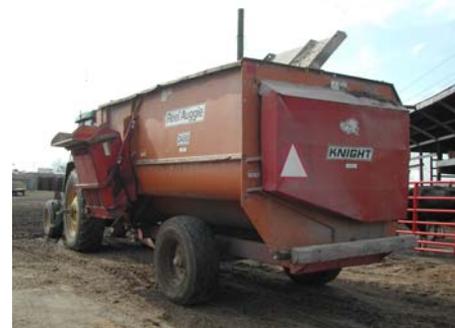
The Knight brand of Auger-Mixer wagon used by the farm operation was a Reel Auggie 3450 tow type feed mixer. It was purchased new in 1996 and was used to mix feed for the dairy cows (See Figure 2). All safety decals were present and readable on the mixer. The mixer had 2 hatches that could be opened to load the mixer from the top with feed. The top of the mixer on the auger side (low side) was 7'3". The top of the mixer reel side (high side) 8'6". The mixer is equipped with a scale mounted on a stationary arm. The scale is capable of pivoting side-to-side to measure feed weights (See Figure 3). The scale is approximately 6 feet off of the ground. The operator's manual stated that when loading hay, it is helpful to have the PTO engaged and the mixer knives running during the loading procedure when hay is added to the mixer. The manual also recommends that the hay be loaded on the auger side (the low side of the mixer) to facilitate mixing of the hay. When loading hay, the manual also recommends that the mixer should be running at least at $\frac{2}{3}$ to $\frac{3}{4}$ rated speed.

Figure 2 – Knight Brand of Auger-Mixer Wagon

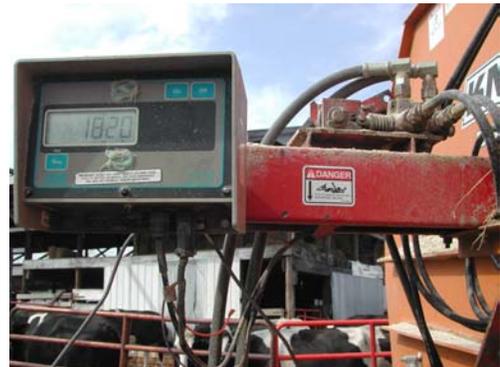
Figure 3 – Mixer Scale

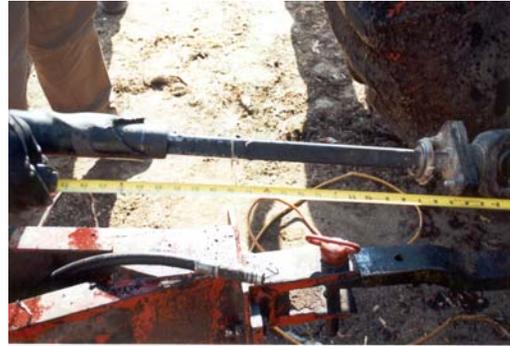
The farm owner indicated that the mixer had previously failed due to a "bad" universal joint of the PTO driveline shaft. The mixer was sent out to a farm equipment repair shop to be fixed. When the mixer was returned, it did not have a PTO shield. Several days later, the farm owner obtained a shield, and instructed the victim to place the shield on the PTO. The victim did not place the shield on the PTO – he replaced the PTO shaft with an alternate shaft that did not have

PTO shielding. The police report of this incident indicated that the alternate PTO shaft was 50 inches in total length. The PTO drive shaft closest to the tractor to 20 inches back to the feed mixer was not shielded (See Figure 4). The mixer's universal joint that connected to the drive shaft housing was also not covered with a protective housing.

Figure 4 – Unguarded PTO shaft

- All rotating shafts, including PTO drivelines, should be covered by shields/guards in good condition to prevent worker contact with rotating parts

A total shielding system for a PTO driveline includes a tractor master shield, the PTO driveline shield and an implement shield. Exposed rotating shafts are hazardous situations that can cause serious injury or death to workers. Properly designed guards and/or shields should cover any rotating shafts that a worker may be exposed to. In this incident, the PTO shaft was unguarded from the point where it was connected to the tractor to the mid-point of the shaft. As a result, one half of the rotating horizontal shaft between the tractor and the mixer was exposed (See Figure 8).

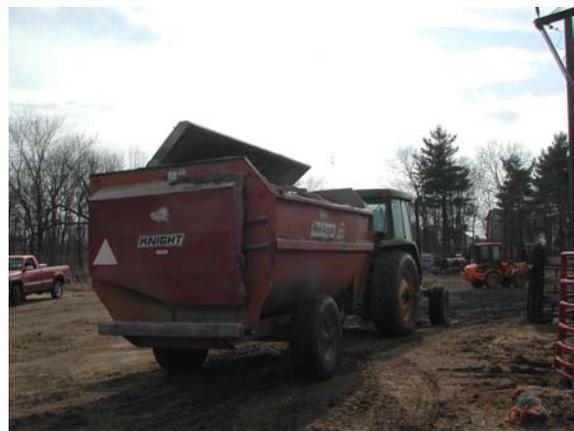
On the day of the incident, the victim drove the tractor so it entered the bunker area from the north instead of his usual approach, which is from the south. The farm owner stated that other employees said that they had seen the victim enter the bunker area from the north prior to this incident as a “change of pace”. This positioning of the tractor/mixer had several work practice implications: (1) the auger side of the mixer and the scale face were directed to the feeding/milking area rather than facing the bunker silos, (2) the scale face would need repositioning in order to be seen from the bunker silo side, (3) if standing on the ground, access to the PTO lever was by reaching across the unguarded PTO shaft instead of around the tractor bumper. (See Figure 5 for a reenactment of the position of the mixer/tractor). Pictures taken at the incident site by the sheriff department showed the hatch open as reenacted in Figure 5. Sheriff photographs taken at the time of the incident showed that the mixer was very close to the milking/feed lot fencing and that it would be difficult to load the feed with the tractor loader on the auger side. It is unknown if the victim was attempting to load the mixer from the reel side facing the bunker or the auger side facing the milking/feed lot. The pictures also showed two pitchforks leaning against the fencing. It is unknown if these pitchforks were being used by the victim.

Figure 5 – Tractor/mixer facing south instead of north

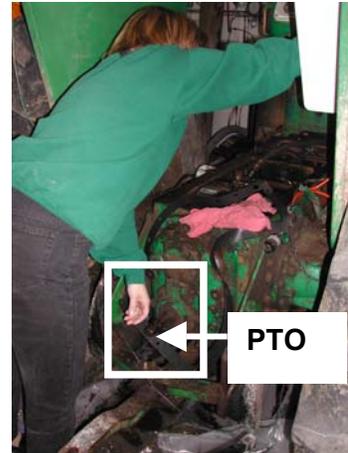
1. The victim did not engage the PTO prior to dismounting from the tractor. While standing on the ground, he reached across the unguarded PTO and attempted to engage the PTO with his right hand. A possible position of the victim is illustrated in Figure 6. To push the PTO lever forward from this position may have caused him to be off-balance once the PTO engaged. After engaging the PTO, he may have lost his balance and while trying to recover, his hand and/or a piece of his clothing became caught in the unguarded, rotating PTO. A similar scenario is that he successfully activated the PTO and while moving away, the position of his left arm and/or piece of clothing may have been near the PTO and became entangled in the unguarded shaft. Figure 6 shows the protective shield on the tractor, behind the PTO lever that was installed at the repair shop. At the time of the incident, the shield was not present.

Figure 6- Reaching for PTO lever

- Tractor operators should engage/disengage the PTO while seated in the tractor operator seat.

In this incident, the operator manual for the mixer recommends that the mixer be in operation while loading haylage. It is recommended that if a tractor operator must make any operational maintenance inspection or repair to an implement or needs to go near a rotating PTO shaft, an operator should disengage the PTO shaft from the operator's seat in the tractor, not reaching around the wheel fender. When the operator needed to turn the scale around so he could view it while loading haylage, he should have mounted the tractor, disengaged the PTO from the operator's seat, dismounted, moved the scale, then climbed back into the operator's seat to engage the PTO again. A safety "good rule of thumb" is to stay at least your height away from a rotating driveline.

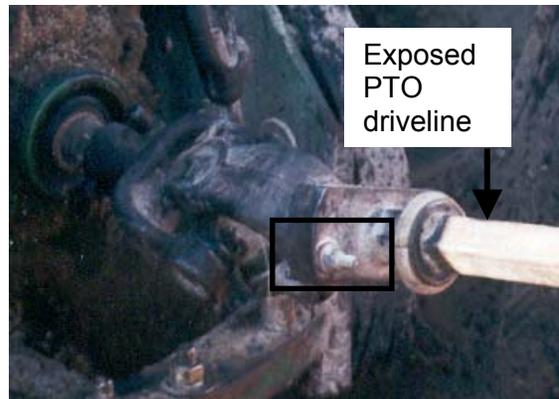
Figure 8 – Exposed Bolts and driveline of PTO shaft

It is not known exactly how the victim became caught in the PTO shaft. The master shield should be kept in place at all times. A master shield should be removed only when required for hooking up special equipment with equivalent shielding. The PTO tractor stub shaft guard should be placed back on the tractor whenever PTO driven equipment is not being used. A guard covering the PTO may have prevented the victim from becoming entangled in the moving shaft.

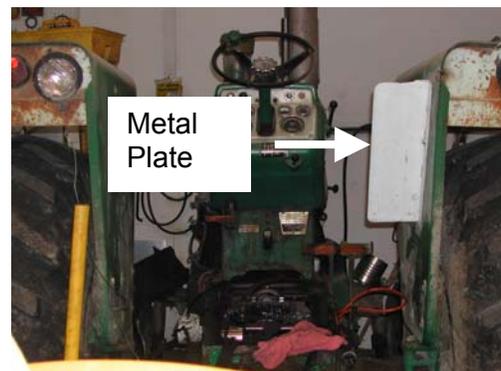
Figure 9 – Metal Plate installed at repair shop

Note: since the accident, while the tractor was in the repair shop, the farm owner installed a metal plate so that the PTO lever could not be engaged from ground level, only from the tractor operator's seat. See Figure 9.
