MIFACE INVESTIGATION: #02MI208

SUBJECT: Laborer Electrocuted When Antenna on Top of Steel Pole Building Contacts 14400-Volt Energized Line

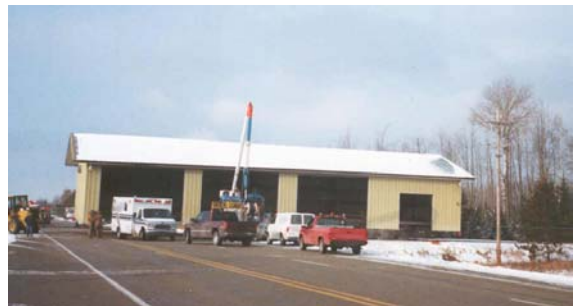
Figure 1. Incident Scene

On December 5, 2002, a 48-year-old male laborer was electrocuted when a county road commission steel pole-building antenna contacted an energized 14,400-volt overhead power line while the building was being relocated via a state highway. An electric company lineman, a cable company employee, road commission employees and a police escort were on site. The building was positioned on three dollies, two steer dollies at the “rear” of the building and one dolly at the “front” of the building that hooked to the tow vehicle. The lineman dropped the neutral wire

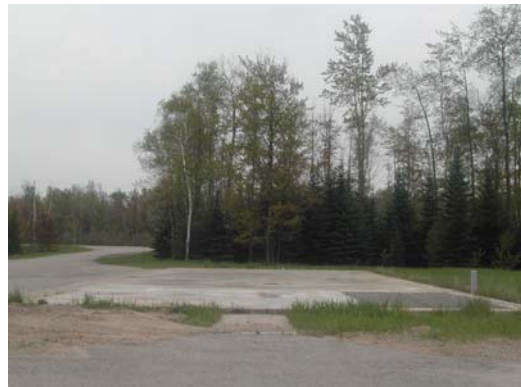
Figure 2. Original building location

The company was contracted by the county road commission to move a steel pole building (40-feet-wide by 100-feet-long) that acted as its maintenance garage, from one location to another location along a 2-lane state paved highway. The original location of the building was approximately 50-100 feet away from the state road. The building was located on a concrete slab. A compacted dirt driveway led to the pole building location. There was an estimated elevation change of approximately 4-6 feet from the building location to the state road. (See Figure 2)

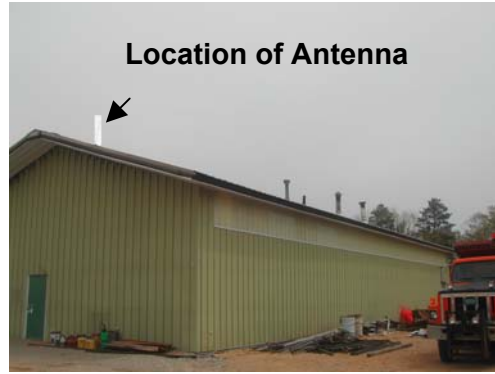
Figure 3. Pole building

The building had 4 ventilation stacks on the roof that

did not extend beyond the roof peak. An antenna with a rubber tip used for 2-way radio communication was also present on the building roof. The estimated height of the antenna was 30-36 inches. (See Figures 3 and 4).

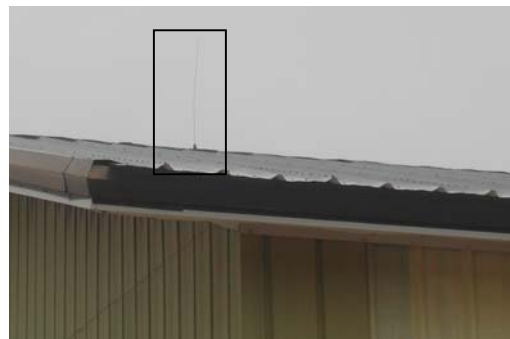
Figure 4. Antenna on building roof

This highlights and emphasizes the role of effectively communicating hazards to all individuals involved in operations around energized electrical power lines. It is unknown if the utility lineman observed the antenna on the building roof until it contacted the overhead wire. A communication protocol between the utility company and moving company owner directing his employees was not established and may have played a role in this incident. MIFACE recommends that utility companies review company policy for communicating with individuals prior to work that will be performed within the vicinity of an energized overhead power line and the documentation procedures of this communication. Documentation of the communication

MIFACE recommends that a standard operating procedure be developed to guide the assessment of hazards that may be presented by a building before a building move. This procedure should be implemented regardless of the height of the building. At the time of the MIFACE researcher visit, the company only accessed the roof of the building was less than 18 ½ feet when raised. If the owners had accessed the roof of the building involved in the incident, they may have seen the building antenna and taken steps to remove it or build a skip board to protect personnel and the building from potential electrical contact. A standard operating procedure that incorporates a full perimeter building assessment regardless of the height could detect additional building projection hazards that may alter the height or width of the building and identify additional measures that may be required to safely move the building.

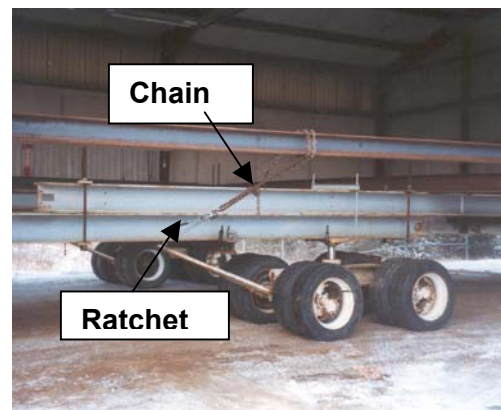
Figure 5. Rear Steer Dollies under building

Approximately one month prior to the move, moving company employees began to prepare the building for transfer. The building was raised and steel support beams were fabricated and installed. The dollies used to carry the building were positioned. Two tandem axle dollies were at one end of the building (referred to in this report as the “rear steering dollies”). (See Figure 5). The rear steering dollies had a metal ratchet with steel chain wrapped around one of the steel beams. A tandem axle dolly with a trailer-type tongue was placed at the opposite end of the building (“front”) to hook to a front-end loader (tow vehicle). When the building was raised

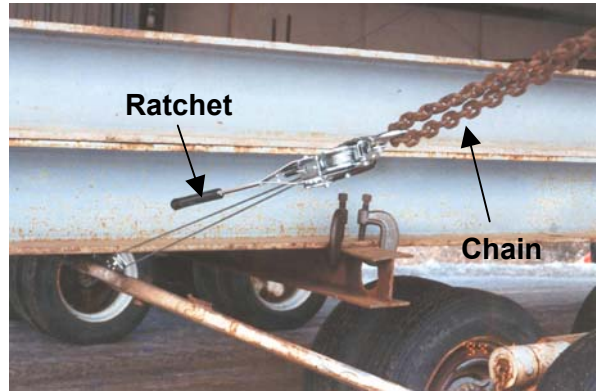
Figure 6. Rear steering dollies ratchet and chain

The victim and coworker had worked together in the past and for this move, had practiced using the two rear steering dollies in tandem. They had to simultaneously ratchet the chains on the rear steering dollies to turn the dolly wheels to successfully turn the rear of the building. (See Figure 6). The company owner stood near the end of the building that was attached to the front-end loader and was responsible for telling the victim and coworker at what point they needed to begin turning the rear of the building.

The tow dollies used may be operated in areas both with and without an overhead electrical hazard. The ratchet handles should have an insulating material such as fiberglass or rubber placed on them to provide additional operator protection.

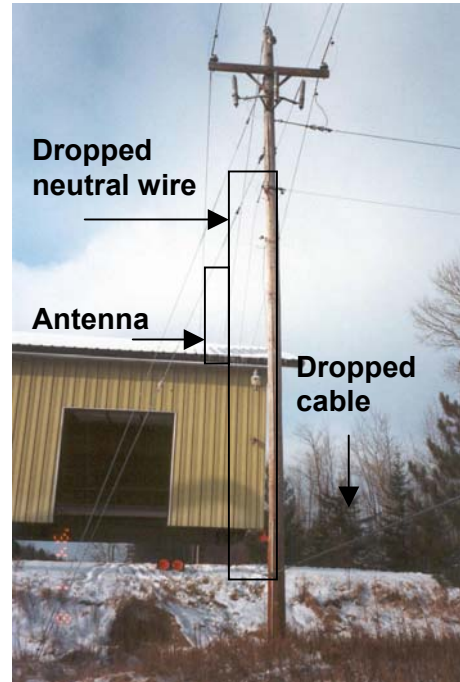
Figure 7. Building position and dropped utility lines

After dropping the neutral and cable lines, the building move continued. Approximately 75 feet of the building had passed under the energized overhead line. (See Figure 7) The owner, by 2-way radio, instructed his employees to go under the building to adjust the steering mechanism on the rear steering dollies with approximately $\frac{1}{4}$ of the building still under the power lines. As they adjusted the steering, the building continued to move and the rear steer dollies went over cable's plywood crib. The 30-36 inch antenna protruding up from the peak made contact with the energized 14,400-volt line. The owner saw a flash of light near the front tandem axle dolly. Both the victim and his coworker under the building adjusting the rear steering

dollies provided a path to ground for the voltage. It is unknown if the workers were holding onto the ratchets or in contact with the building when they became a path to ground. Both workers broke contact by falling to the ground.

dollies. A safe distance could not be maintained due to the height of the building. The company must train their personnel and enforce a policy that no one must be within 10 feet of a structure when under an energized overhead power line.
