## MIFACE INVESTIGATION: #03MI029

### SUBJECT: Co-Owner of Metal Forge Shop Dies When an Ejected Piece of Steel Used as a Stop Block in a Full Revolution Press Strikes Him in the Chest

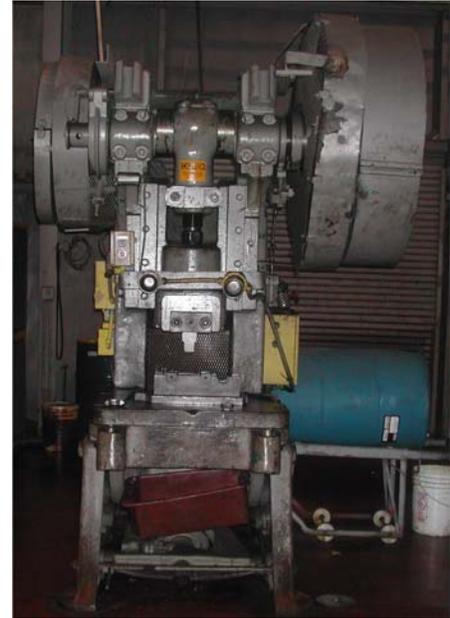
Figure 1 – “Bender” press

The company did not have any manuals for the “bender” press. The “bender” did not have a serial number or other identifying information. The company co-owner estimated that the press was manufactured sometime between 1940 and 1950, and was an approximately 8-ton press. The “bender” was normally used to bend metal, specifically press drag links. The “bender” was a full revolution press. It consisted of a moving slide (ram) guided in a definite path by the press frame and a stationary bed. The lower die was attached to the press’s base plate, the plate attached to the top of the stationary bed having drilled holes to T-slots; the upper die attached to the ram. The “bender” did not have an interlocked press barrier guard attached to the press frame or bolster. There was a metal mesh guard at the rear of the press. (See Figure 1 on page 1) The press did have a barrier guard when used as a “bender”; the barrier guard was impractical for the boot cutting operation and was not installed on the press for this job.

- Install an electrically integrated safety block and barrier guard to permit safe work operations.

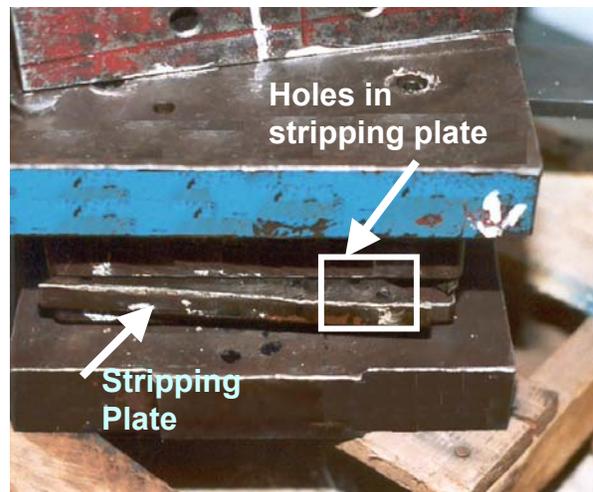
The victim installed the upper and lower dies on the “bender” press to trim the rubber boot. Figure 2 shows the die set used in the rubber boot trim operation. Attached to the bottom die was the stripping plate. The stripping plate was attached by four springs to the bottom die. When the press is activated and the upper ram moves downward and comes into contact with the stripping plate, the stripping plate goes down with the ram, but doesn’t touch the bottom die. In this way, excess boot material can be stripped without damaging the product and die.

Figure 2- Die set for rubber boot

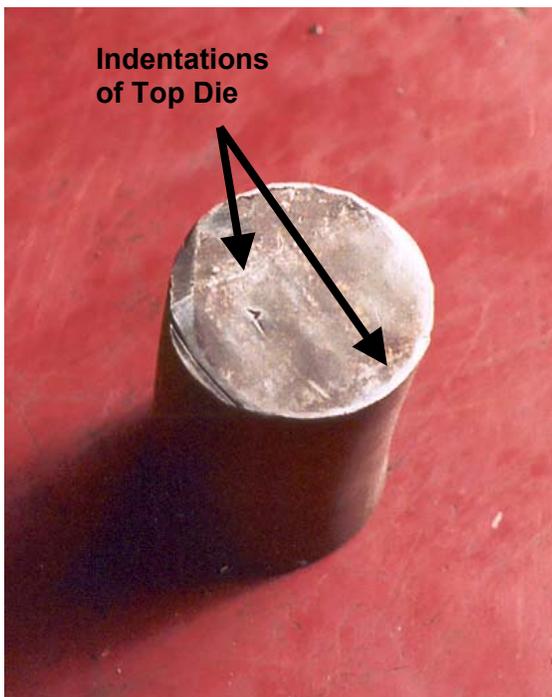
installed the sharpened dies. It appears the victim had placed a cylindrical piece of solid steel 17/8" in diameter and 4" long on the top edge of the stripping plate, nearest to him (See Figure 3). He was using the steel as both a measurement tool for the die and as a stop block to ensure that the top ram would not go down too far (bottom out) on the lower die pins.

A stool was located in front of the press. The victim activated the press with the piece of steel on the stripping plate. It is unknown if the victim was seated on a stool in front of the press when the incident occurred; if seated on the stool facing the press, he had a good view of the ram movement. He may have noticed the steel on the stripping plate and tried to remove it (there were cuts on his right hand). Under normal operation, when the ram comes down, the stripping plate will depress evenly. At the time of the incident, when the ram came down and contacted the piece of steel on the front side of the stripping plate causing the stripping plate to depress unevenly - the front side was lower than the back side of the stripping plate. Figure 3 and Figure 4 show the force of the dies on the stop block. Figure 3 shows the mark on the chunk of steel where it was contacted by the upper die. Figure 4 shows the pinch mark where the steel was placed on the edge of the stripping plate and indentations on the steel that matched the holes on the stripping plate.

Figure 3. Indentations from top die on steel used by victim

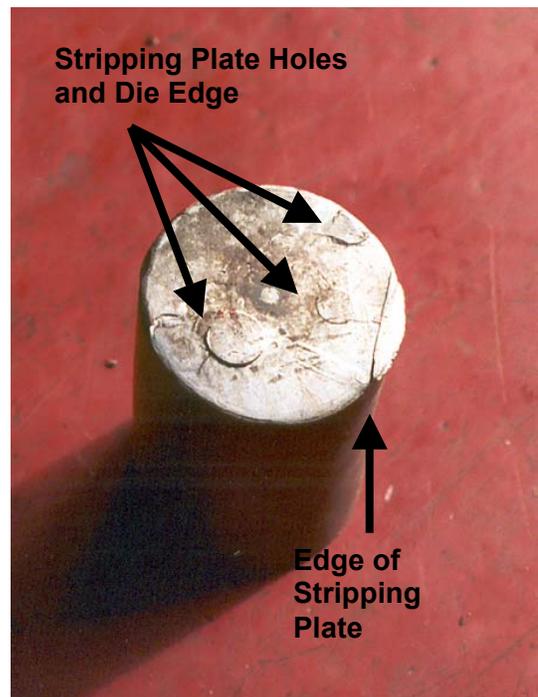
Figure 4. Indentations from stripping plate on steel used by victim

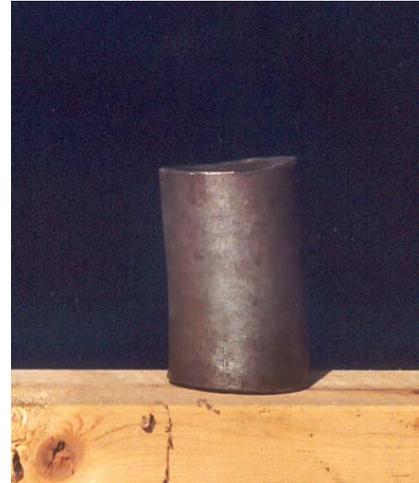
Because of the location of the piece of steel on the stripping plate and the downward force of the ram, the chunk of steel was propelled from its position on the stripping plate at a high velocity away from the press, toward the victim. Figure 5 shows the deformation of the cylindrical piece of steel caused by the force of the press. The piece of steel struck him in the chest. The co-owner was working approximately 20 feet away. He heard two bangs; heard the victim yell and looked over to see the victim on the ground. The co-owner provided CPR while the office worker called 911. Emergency response arrived and transported the victim to the hospital, where he died of his injuries.

Figure 5. Side view of cylindrical steel piece used by victim as stop block
