MIFACE INVESTIGATION: #03MI066

SUBJECT: Farmer Dies When He Is Crushed Under Overturned Tractor in Ditch

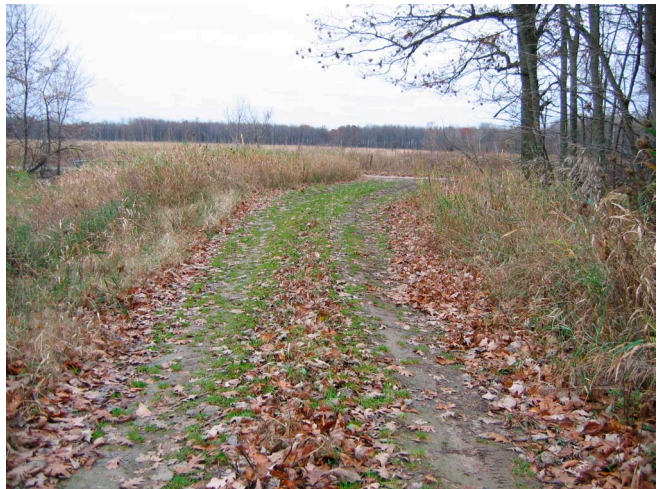
Earlier in the day, a family member visited him around noon and the victim spoke about going out later that day to disc the soybean field. This family member left approximately one hour later. Sometime after the family member left, the victim traveled to the site of the field, which was approximately one-half mile from his home. This road was a dirt road with soft shoulders. On one side of the road was a 6- to 8- foot, steeply cut ditch that contained water. To travel to the field from the dirt road, the victim traveled a private "2-track" road. The width of the 2-track road was approximately 25 feet. See Figure 2.

Figure 2. View driving from field down 2-track road to main road
