MIFACE INVESTIGATION: #03MI067

SUBJECT: Farmer Dies When He Was Pinned Between the Tractor Seat and a Tree in a Ditch Near His Soybean Field

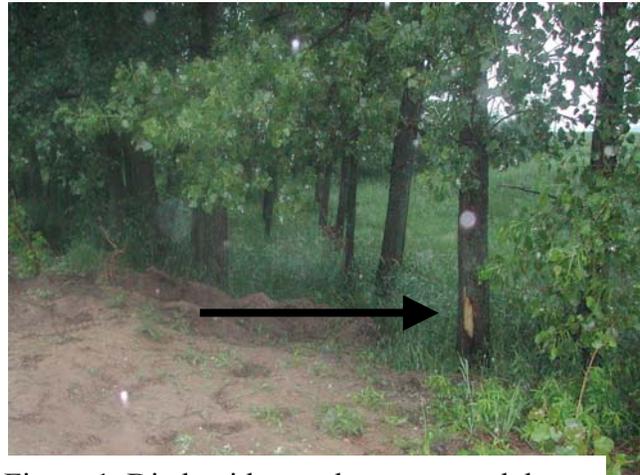
On June 14, 2003, a 57-year-old male farmer was killed when the Belarus tractor, Model 220 he was driving entered a ditch on the north side of a soybean field and he was pinned between the tractor seat and a tree in the ditch. (See Figure 1) The tractor was equipped with a cultivator at the rear and a front-end loader. He may have been moving dirt near the edge of the ditch when he entered the ditch. The tractor entered the ditch and the tractor tipped on its right side into a tree. A family member had lunch with the victim. The family member left to cut the grass in front of the barn and the victim took the Belarus tractor to till the field and nearby garden. The family member saw the victim drive the tractor behind a silo and into the plowed soybean field. When she didn't see him after about a half an hour, she went looking for him. She saw him pinned against the tree in the ditch. Emergency response was called and he was declared dead on the scene. He died from a crushing injury to his chest.

Figure 1. Ditch with tree that was struck by victim

The responding police agency observed the tractor tire tracks go past the silo on the two-track road into the plowed field to the north. The tracks then made a left turn toward the west and into the ditch with trees in it located on the north side of the plowed field. The police report stated that it appeared as though the front bucket of the tractor was down, possibly moving dirt towards the northwest when the tractor went over the edge of the field.

A good rule of thumb is to stay back from the edge of the ditch as far away from the bank as the ditch is deep. The weight of the tractor could cave the bank in if too close to the shear line. It does not appear that the ditch bank caved in, but the victim was operating the tractor too close to the ditch according to the police report, thus allowing the tractor to enter the ditch.

- When mowing or planting, leave a visual cue to identify the edge of drainage ditches or other land depressions.

Mow away from the edge of the ditch and leave the tall grass as a marker. The tall grass boundary from the edge of the ditch should be at least equal to the depth of the ditch. If possible, when equipment movement occurs between the crop field edge and a depression such as a ditch, make a best effort to have a 12-20 foot access area (path) to accommodate equipment movement. It is unknown how well the ditch was defined at the time of the incident.

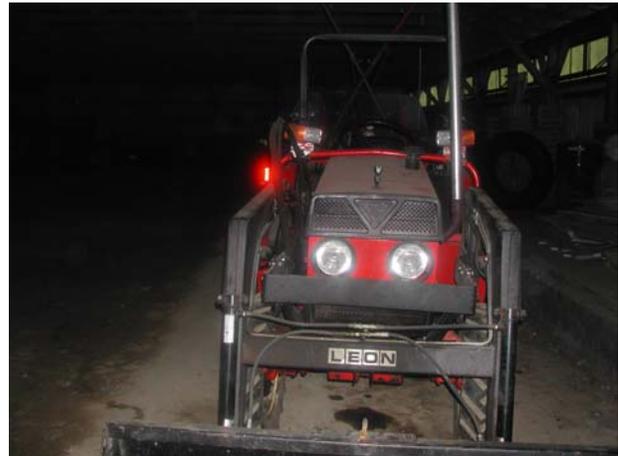
The victim was very familiar performing work with the Model 220 Belarus Model tractor according to his spouse. The tractor was stored in a shed/barn near the soybean field. The tractor had a wide front wheel configuration and was equipped with a roll over protection structure and a functioning lap belt installed by the manufacturer. (See Figure 2) The tractor also had rear counterweights. He had purchased this 4-wheel drive tractor in new condition seven years prior to the incident. All operating controls were labeled and in apparent normal operating condition. At the time of the incident, the tractor was equipped with a front-end loader and a cultivator attached to the rear of the tractor. The wife reported that the tractor did not have any brake trouble, but that the 4-wheel drive train unit had been recently repaired.

Figure 2. Belarus tractor driven by victim

The police tested the tractor brakes, accelerator, gear shifter, and front bucket. All were determined to be fully functional. The police drove the tractor into the shed where it was parked.

- If the front-end loader is not to be used for an extended period, the loader should be removed from the tractor if equipped with a “quick detach” loader mechanism.

When performing field operations, remove the front-end loader from the tractor. The loader, while they easily handle moving materials, can make the tractor harder to handle, reduce your visibility, wastes fuel and changes the tractor’s center of gravity making it easier to roll over to the side. Newer tractors offer loaders with a quick disconnect capability with self-store pins and couplers. Check the loader’s operating manual for specific removal instructions.

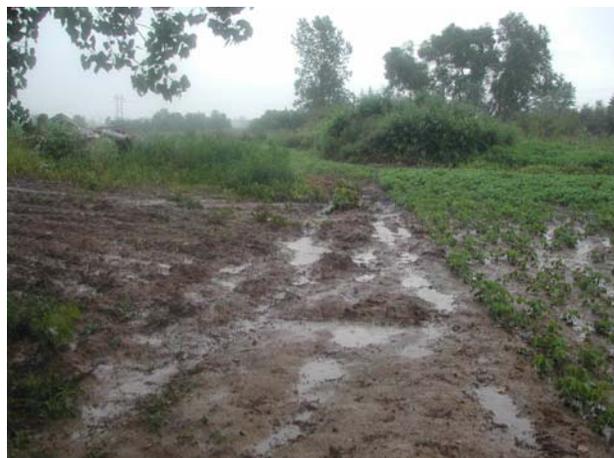
Figure 3. Path to garden around silo/behind barn

The event was unwitnessed. His wife said she started to cut the lawn and the victim took the tractor to the garden to begin cultivating the field and garden. He used the 2-track dirt road to go around a silo and onto the plowed field located to the north of the silo and shed. He was traveling forward when the incident occurred. (See Figure 3) He was not wearing the seat belt at the time of the incident.
