MIFACE INVESTIGATION: #03MI098

SUBJECT: Farmer Dies When Pinned by Flail Mower

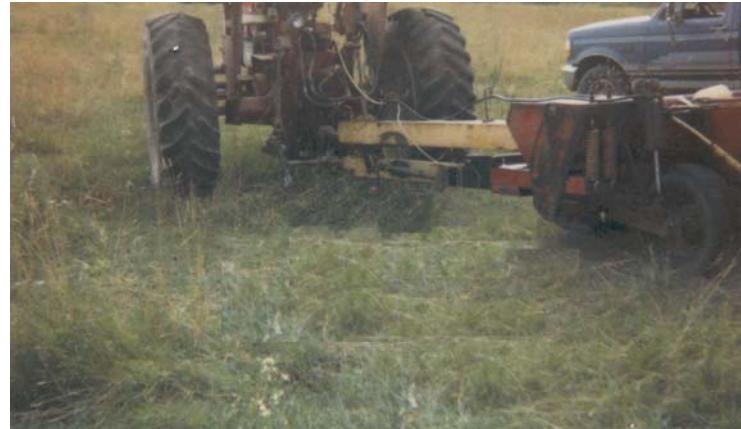
Figure 1. Incident scene

On July 17, 2003, a 73-year-old male cattle farmer was killed when he was pinned beneath the front of a flail mower. He had been clipping pastures on a Farmall International 706 fast hitch tractor with a MC rotary sythe (flail mower) attached. When moving from the field he had just cut, he placed the flail mower in a locked upright position. The next pasture he was going to cut was protected by a ribbon electric fence. He traveled along a two-track road, through a wooded area and approached the field he was preparing to mow. To enter the field protected by the electric fence, the victim normally dismounted the tractor, pulled up the fence posts, laid the posts on the ground, and drove the tractor over energized wire. On the day of the incident when he did not return home, his wife went looking for him. When she found him, she drove home and called for emergency responders. Emergency responders found the tractor contacting the electric wire approximately eight feet from the fence line. The fence posts were not pulled up. The flail mower was locked in the upright transport position. The tractor was in neutral, the parking brake was not set, and the PTO was not activated. It is unknown how the victim became pinned beneath the mower. The victim was declared dead at the scene.

It appears from pictures taken at the scene of the accident that the flail mower is off to one side of the tractor. He was found face down with the mower on top of him. The victim was pinned by the steel roller that was approximately 4" off of the ground. Emergency responders found the victim pinned face down underneath the wheel and mower frame.

- All tractor operators should follow safe equipment shutdown procedures as described in the operator's manual.

Tractors will travel forward downhill if parked on an incline without an effective braking device and the vibration created by a running engine may increase the possibility of initiating the forward motion. Tractor operators can prevent tractors from rolling by disengaging the transmission, shifting the tractor into neutral, locking the brakes and turning off the engine before dismounting. General shutdown procedures for a tractor are: disengage the PTO, lower equipment attachments to the ground, place the transmission into neutral or park, set the brakes turn off the engine and remove the key. Whenever possible, the tractor should be parked on level ground. Although the grade was slight (5-10%), the tractor could still move downhill and did.

In this instance it is unknown if the victim fell from the tractor prior to tractor movement or was on the ground when the tractor began to roll. If the brakes had been locked prior to any action of the victim, this death may have been prevented.

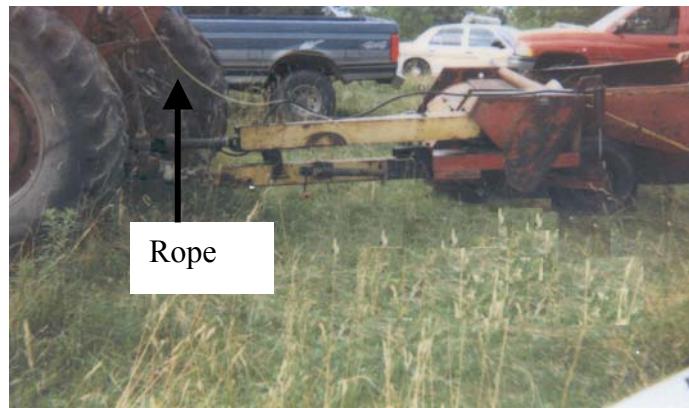
Figure 2. Rope attached to pin for flail mower

The flail mower had a pin on its swing arm that was attached to a rope. This rope was attached to the tractor, on the operator's left. The pin locked the mower in a transport position behind the tractor.

The rope was a part of the mower, not an aftermarket addition. The rope was attached to the tractor, according to his son, to allow the pin to be released directly from the tractor instead of having to dismount/mount the tractor. This pin was difficult to remove. (See Figure 2)

The son indicated that the mower was old and rusty, and that it was possibly not used for two years. The equipment was stored outside. He stated that it was hard to pull out the pin. All machine components should be checked periodically to ensure that they are in proper working order. Maintenance and servicing equipment is a prerequisite to a properly working, functional machine.

- Owner/operators should maintain equipment in good operating condition.
