MIFACE INVESTIGATION: #03MI103

SUBJECT: Farmer Dies When Tractor With Front-End Loader Overturns In Ditch and Pins Him

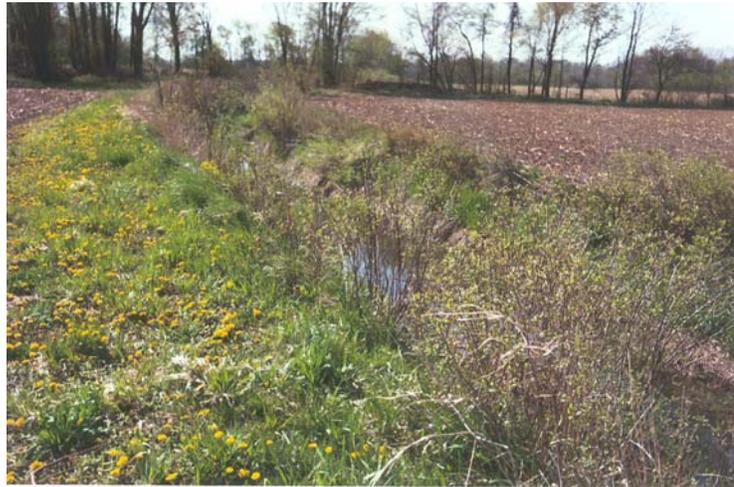
On July 28, 2003, a 77-year-old male farmer was driving a 1954 77 Oliver tractor equipped with a front-end loader with 12-inch bucket tines to a woodlot on his property. He was carrying a salvage flail mower chained to the loader. The tractor was not equipped with a roll-over protection structure (ROPS). He traveled east along a lane between his cornfields to the back of his property and made a right turn (south) around a 10-foot deep by 15-foot wide drainage ditch. There was a variable width path to the wood area on the east side of the ditch (See Figure 1). It

Figure 1. Access path/ditch leading to woodlot

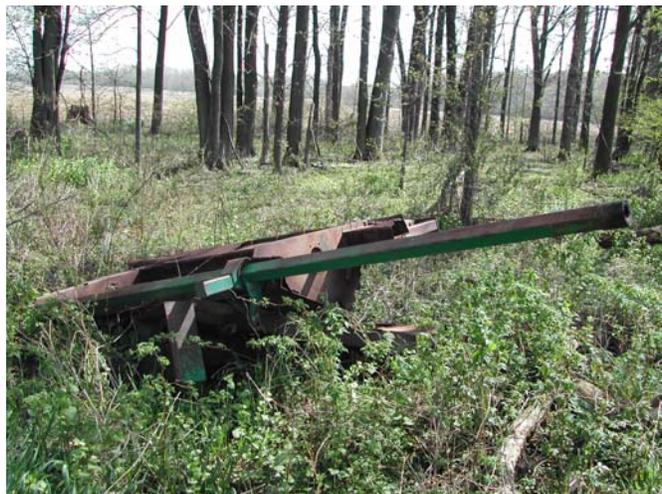
Figure 2. Salvage flail mower in woodlot

MIFACE estimated the salvage flail mower to exceed 700 pounds (See Figure 2).

Front-end loader buckets are not designed for carrying the large and heavy pieces of equipment, such as the flail chopper. Although a manual for the flail chopper was unavailable, the chopper's size and weight was close to exceeding the capacity of the tractor and made the tractor unstable even though the victim was driving slowly. It is unknown if the victim set the tractor wheels at the widest recommended setting, since a manual was also not available for the tractor and MIFACE was not able to see the tractor. The victim's wife indicated she did not think that extra ballast was added to the rear of the tractor to give the tractor extra stability. The ballast would counterbalance the extra weight on the front of the tractor and help prevent an overturn. Additionally, overloading a front-end loader on a tractor can cause instability and steering difficulty.

- Use equipment properly – front-end loader bucket isn't designed to carry a flail chopper.

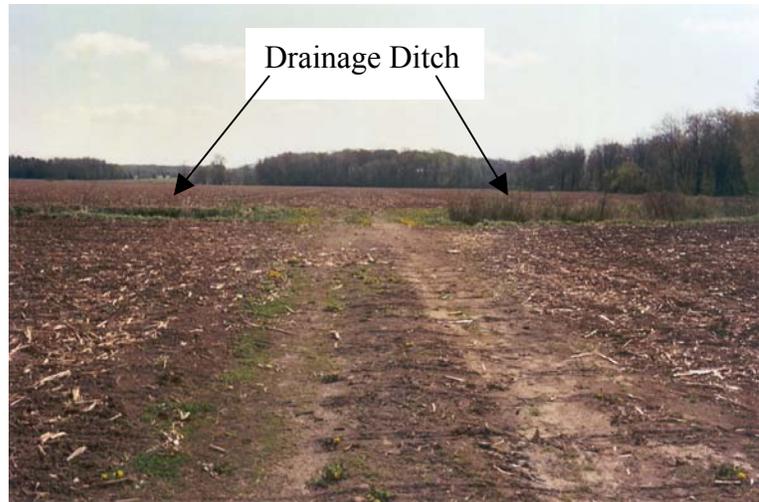
Figures 3-5 show the path he drove to the woodlot. Before transporting the flail chopper to the woodlot, he chained the chopper to the front-end loader/tines. He traveled down a wide lane between cornfields. This lane terminated into a cornfield and the woodlot was to the operator's right. The drainage ditch was to the victim's right and left.

Figure 3. Access lane between cornfields

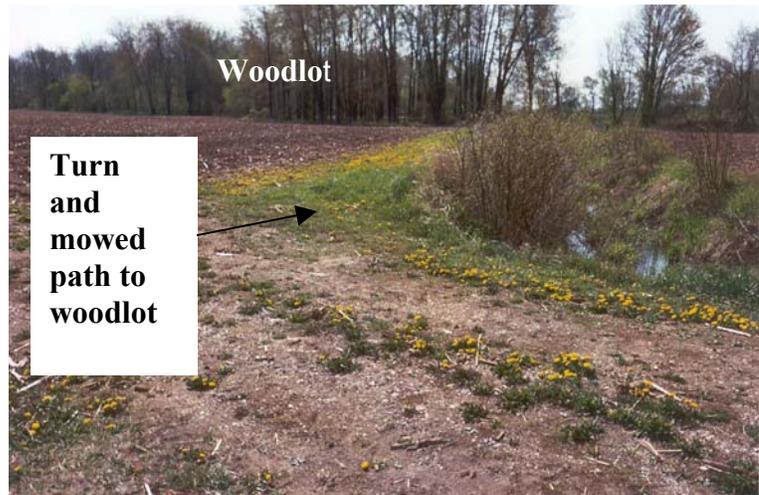
Figure 4. Lane ending at cornfield and turn to woodlot

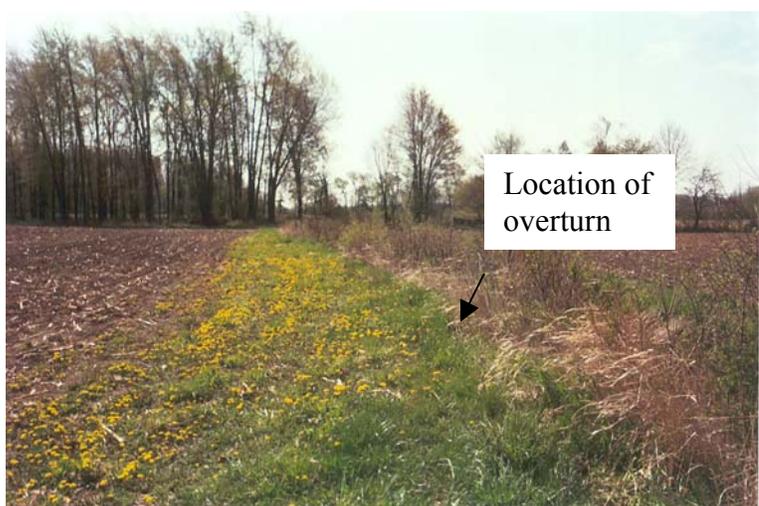
There was a mowed path that directly abutted another cornfield. This mowed path led to the woodlot. This path narrowed as it approached the woods. It was approximately 6-7 feet wide as it entered the woodlot. The distance from the planting row to the edge of the mowed path was approximately seven inches. The victim's wife thought that this was similarly planted at the time of her husband's death.

Figure 5. Mowed path to woodlot

The outside row of corn was planted approximately six inches from the edge of the access path to the woodlot. This limited distance between the edge of the field and the path further narrowed

- Establish crop- planting limits/boundaries to maintain farm machine access roads to other fields/areas.

the maneuvering room the victim had to travel to the woodlot due to the presence of the growing corn plants along the outside planting row. A planting boundary should be established so that the outside planting row does not impinge on an access road to other fields/areas.

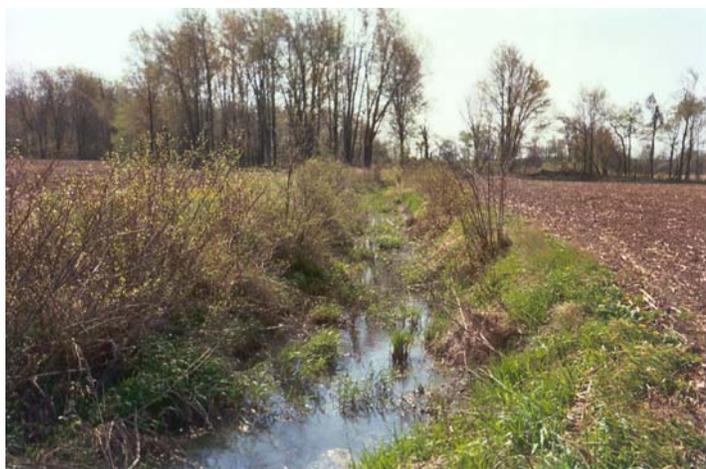
Figure 7. Undefined ditch edge

Mow away from the edge of the ditch and leave the tall grass as a marker. The tall grass boundary from the edge of the ditch should be at least equal to the depth of the ditch. If possible, when equipment movement occurs between the crop field edge and a depression such as a ditch, make a best effort to have a 12-20 foot access area (path) to accommodate equipment movement. It is unknown how well the ditch was defined at the time of the incident. The path, as shown in Figure 7 has tall grass and shrubbery at the very edge of the ditch and growing up from the sides of the ditch, making it difficult to determine the ditch edge.

- When mowing or planting, leave a visual cue to identify the edge of drainage ditches or other land depressions.
