MIFACE INVESTIGATION: 03MI146

SUBJECT: Electrician Dies From Being Pinned Between Iron Pipe and Articulated Boom-Supported Aerial Work Platform Control Panel

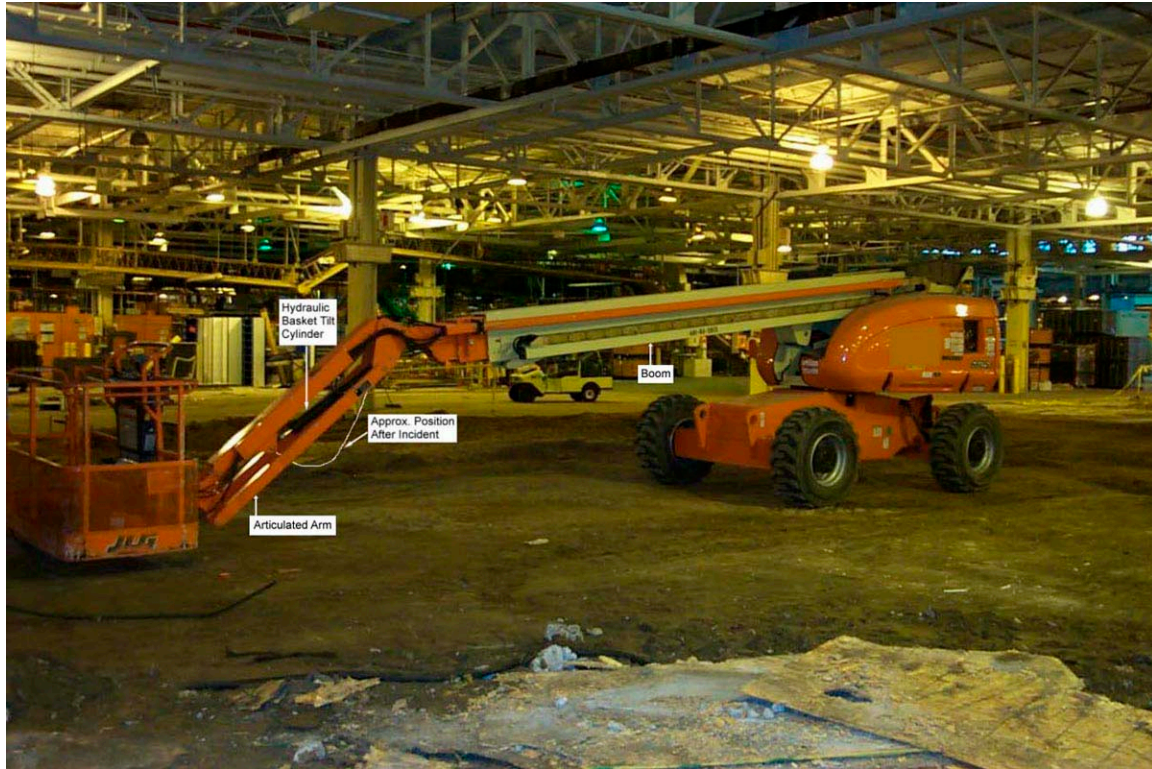
Figure 1. JLG Model Similar to One Involved in Incident

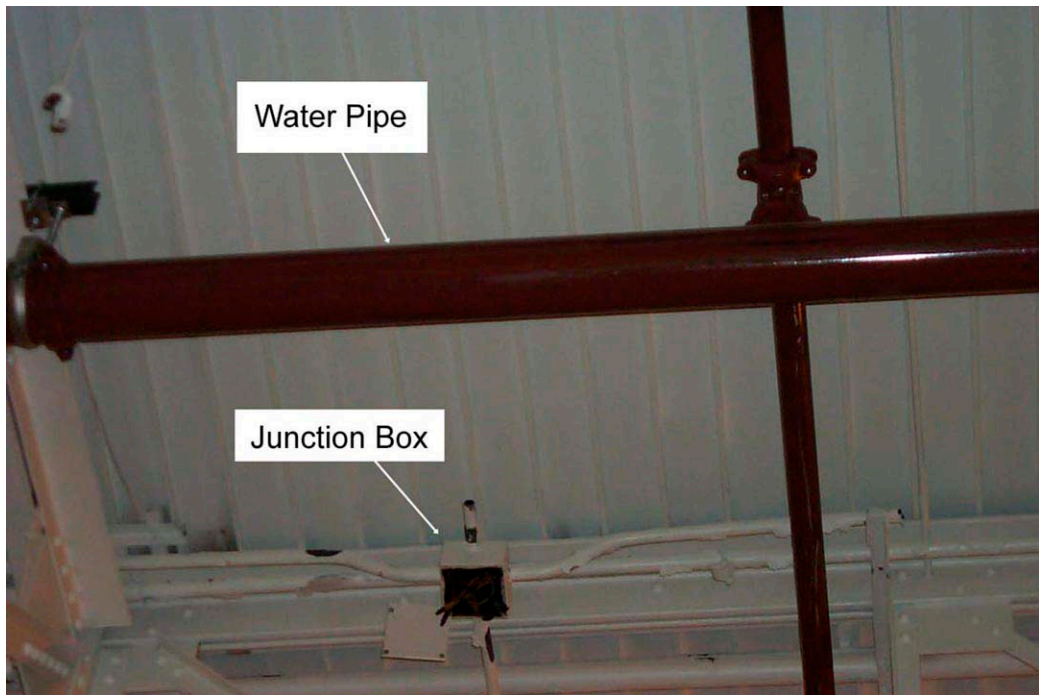
Although no one observed the events immediately preceding the incident, it appears that the decedent was close to the junction box he was trying to access near the plant ceiling but could not quite reach it. As he attempted to reach it, either the controls momentarily malfunctioned driving the articulated arm against a roof truss, or he inadvertently continued to operate the tilt controls after the arm had become wedged against the lower side of a roof truss. The hydraulic lift cylinder failed presumably because of excess pressure exerted on it. When the hydraulic lift cylinder failed, the basket snapped backwards toward an iron water pipe causing the decedent to be crushed. Paint from the roof truss and a scrape were found on the articulated arm near the

Figure 2. Junction Box and Water Pipe Involved in the Fatality - Truss is not Visible.

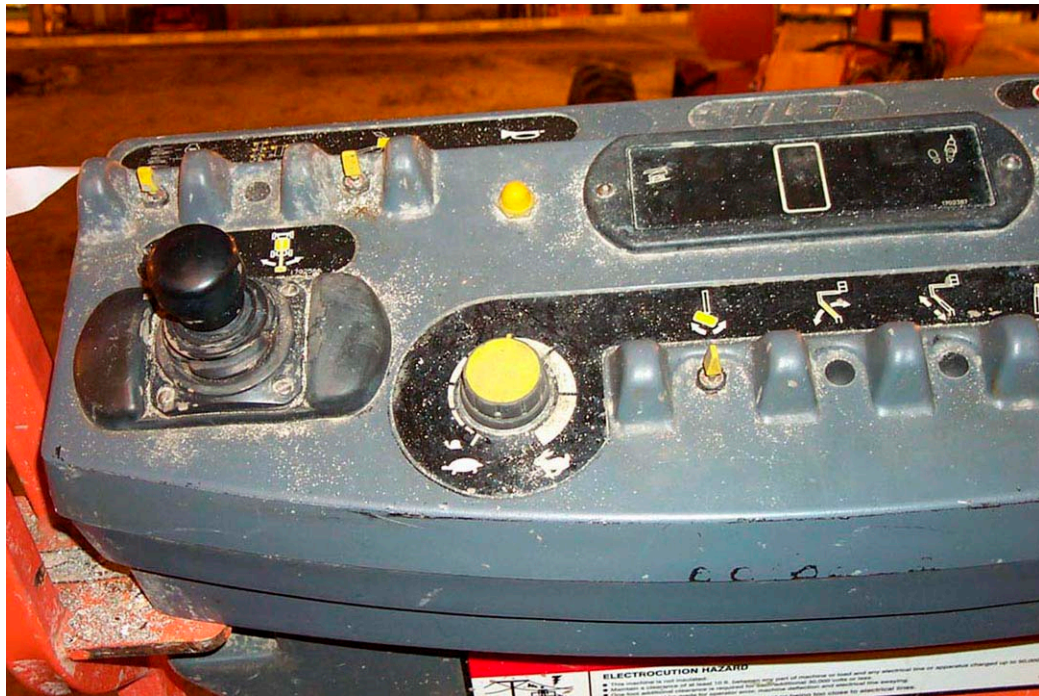
The unit had been rented from an equipment rental company. The decedent's company required a pre-use inspection be conducted and documented on a written form for this type of equipment, but no written inspection form was found for it on this day. Examination of the unit after the incident revealed that the hydraulic basket tilt cylinder located on the boom had failed catastrophically. The hydraulic tilt cylinder was bent into a "C" shape indicating a large amount of pressure had been exerted on the cylinder. The basket controls were found to be in good working order.

Figure 3. Basket Control Panel

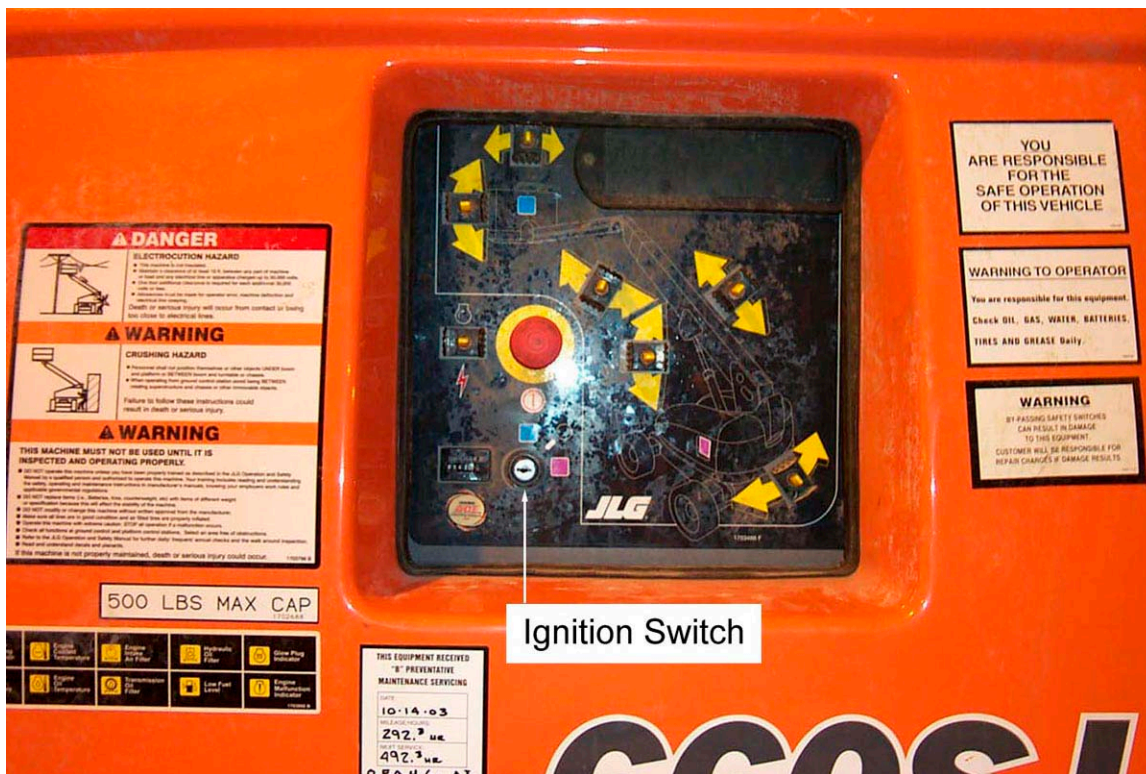
Aerial Work Platforms, Part 32, Rule R408.43209(24) addressed the fact that the key necessary for the ground control panel's emergency control operations was not in the ignition while the employee was operating the equipment.

According to the manufacturer, the unit was designed such that the key in the ignition switch at the ground controls is held captive when the equipment is engaged in either the platform or ground control mode. No key was found in the switch when the workers tried to operate it from the ground. When the unit involved in the incident was tested with a manufacturer's key, it was discovered that the key could be removed in either the platform or ground control mode. Control of the unit had been accomplished with a non-manufacturer key at the time of the incident. Interviews with workers familiar with the operation of the articulated boom-supported aerial work platforms indicated that the ground control captive key feature of the equipment could be easily defeated. Also, they indicated that over time the keys became loose, vibrated out of the ignition switch, and were misplaced or lost.

Figure 4. Ground Control Panel - Taken Immediately Following Incident Illustrating Missing Key

- Tether the key that operates the equipment from the ground controls to the ground control panel.

Because having the key in the ground control ignition in order to operate the work platform apparently is easily defeated and the keys are often missing or lost, tethering the key to the panel

would help ensure it was present in case a ground person would have to gain control of the equipment.

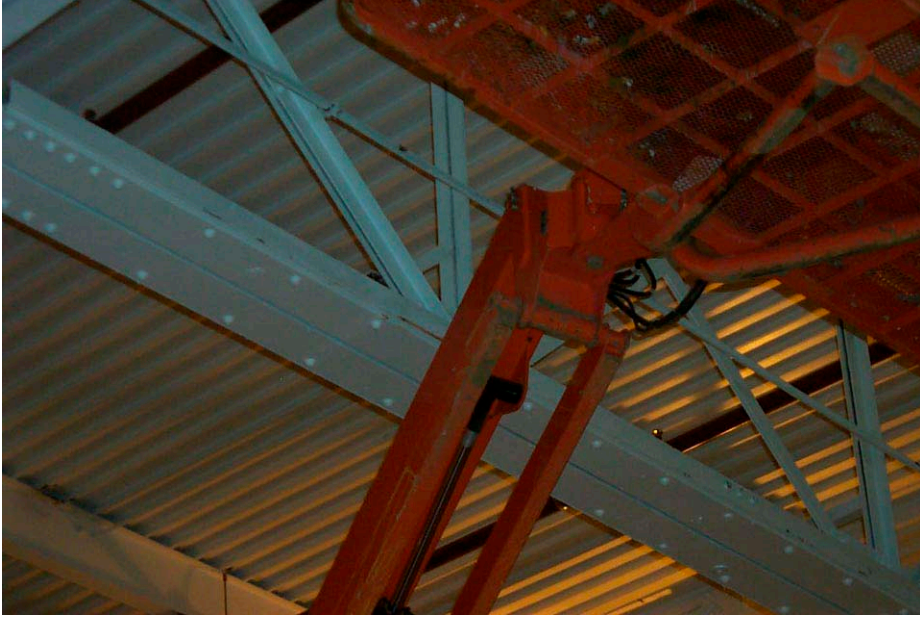
basket. Paint from the articulated arm was found on the truss. A simulation of where the articulated arm contacted the truss is shown in Figure 5.

Figure 5. Simulation of Arm at Truss
