## **MIFACE INVESTIGATION: #03MI202**

### **SUBJECT: Farmer Died When Crushed Between Tractor Steering Wheel and Enclosed Feed Auger**

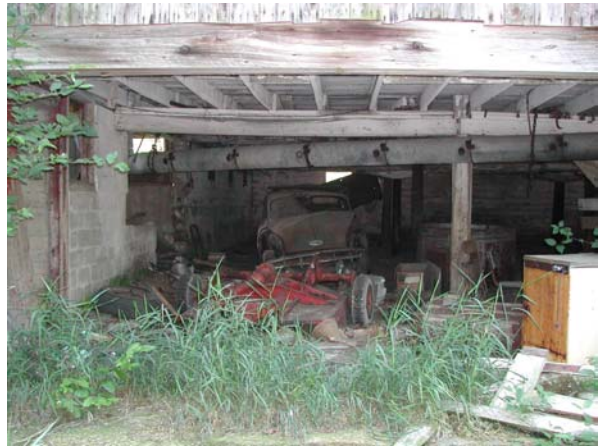
On September 5, 2003, an 87-year-old male farmer died while backing his Oliver Super 77 tractor with an attached 5-foot cut rotary mower into a storage area in a barn (See Figure 1). He placed the tractor in reverse to back the rotary mower into the barn. The sequence of events is unknown. It appears that the left rear tractor wheel tire traveled over a portion of a doorframe on the ground and raised the tractor. This caused the victim to duck his head to avoid the ceiling beam or he did hit his head on the barn beam and then had difficulty engaging the clutch to stop the tractor. At some point, the rotary mower began to jackknife, hit a car also stored in the barn, and continued to the barn wall. The tractor continued in reverse approximately another 12-15 feet. Running the length of the storage area was an enclosed round feed auger which was 71-inches from the ground. The victim, sitting in the tractor seat, was pinned between the enclosed auger and the tractor steering wheel. When he did not return as expected, his wife went to look for him in the fields. Not finding him, she called her son, who found the victim. Emergency response was called, the tractor moved forward, and the victim removed from the tractor seat. He was declared dead at the scene.

Figure 1. Storage area in barn for rotary mower

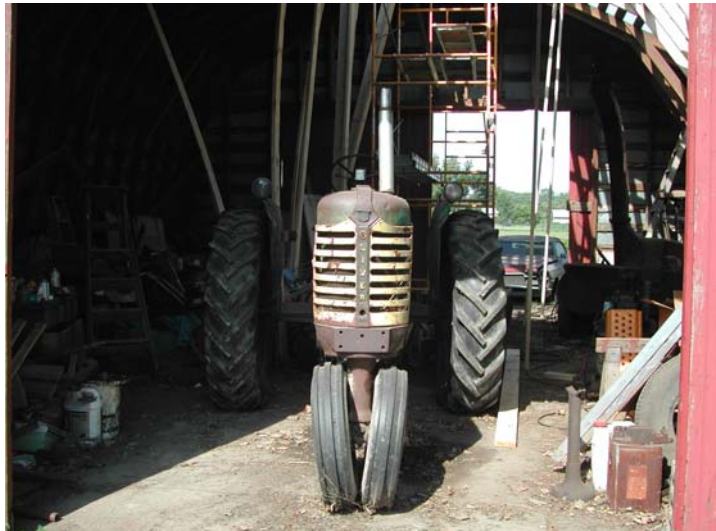
The victim had purchased the diesel Oliver Super 77 tricycle tractor in 1954. (See Figure 2) The victim took care of the everyday tractor maintenance and took the tractor to a local business for major work, such as engine problems. According to his son, the brakes and clutch were working properly at the time of the incident. The victim was very familiar with the tractor's operation, as this had been the tractor utilized for all of the farm work. It appears the tractor clutch pedal was worn smooth from over 49 years of use. The victim's son said the top forward speed for the tractor was 12 mph and that it had two reverse speeds. The distance from the ground to the top of the muffler was 87 inches. The height of the tractor seat was 63 inches from the ground.

Figure 2. Oliver Super 77 tractor involved in incident

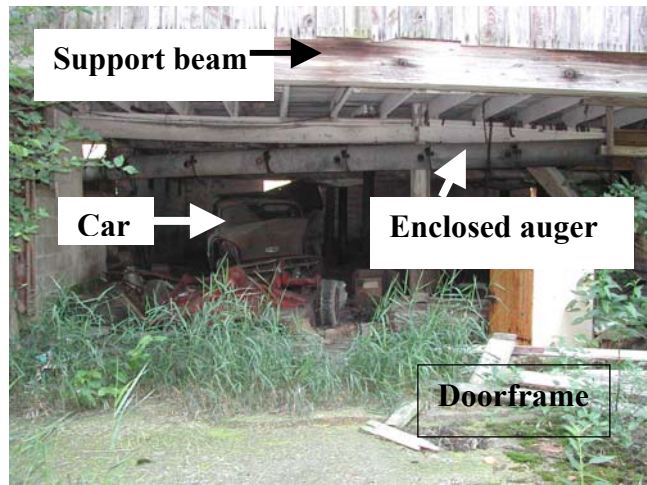
The barn where the victim stored the rotary mower was previously used for his dairy cows and beef cattle. The barn was located on the north side of his residence. The victim stored the rotary mower on the lower level of the barn. The lower level was open the length of the barn. The victim used only one area to store the mower. (See Figure 3) The barn's support beam was 82.5 inches from the ground to the bottom of the beam. Approximately 12-15 feet inside the barn was a round feed auger within in steel enclosure, running along the ceiling of the lower level. The auger enclosure was 71 inches above the ground at its lowest point. Behind the auger enclosure was an old car. On the ground under the barn's support beam was an old, broken doorframe that limited the victim's maneuvering room to a nine foot wide opening to back the rotary mower into the barn's lower level. The grassy area in Figure 3 is the location of a slight incline to enter the barn.

Figure 3. Enclosed auger, doorframe, car, support beam

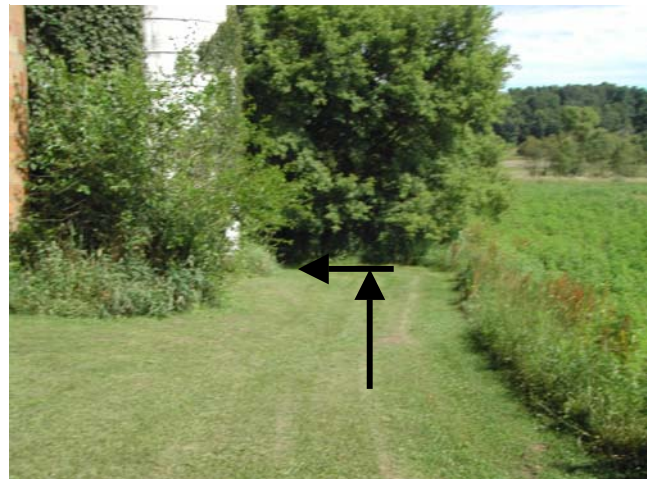
The victim appeared to follow his normal procedure to park the mower in the barn's lower level. The victim drove the tractor/rotary mower down a hill located on the east side of the barn and made a 90-degree turn to the west. (See Figure 4) The entrance to the lower level is on the victim's left. To be able to back the rotary mower into the barn, the victim turned the tractor 90-degrees to the north to an open area so the tractor/rotary mower was oriented in a north-south direction. This open area was approximately 30 feet long from edge of the open area to the barn entrance. (See Figure 5) The tractor was too tall to enter the barn (muffler was approximately 87 inches from the ground, the barn beam was approximately 82 inches from the ground). Therefore, the victim drove in reverse until only the rotary mower was in the barn. His son thought that the victim used visual cues to determine when the mower was within the barn. It is

Figure 4. Path down to barn entrance

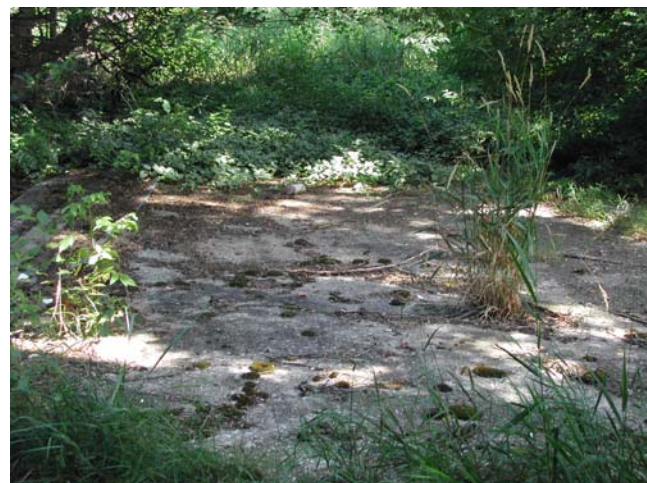
Figure 5. Open area in front of barn entrance

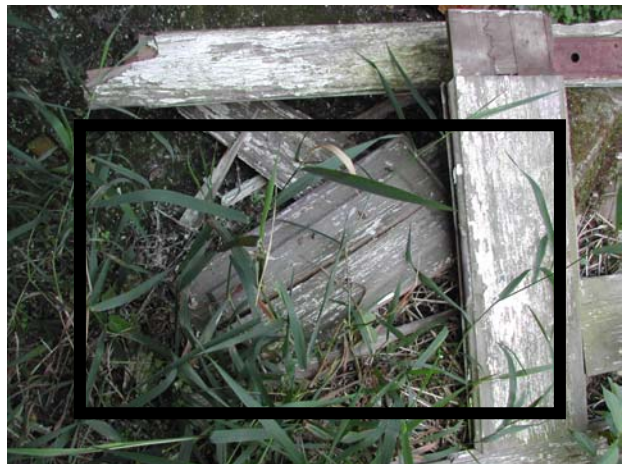
Figure 6. Cracked doorframe

The victim's son pointed out a cracked piece of the doorframe to support this scenario. (See Figure 6) Because this was unexpected, he lost track of his position. His foot may have been on the clutch at this time, since he was near the entrance. Unable to react quickly enough, the victim traveled too close to the barn beam and either was able to duck under the beam or he struck his head against the beam. His foot slipped off of the clutch and the tractor continued in reverse. The tractor muffler scraped the beam as the tractor went under it. (See Figure 7) As the tractor continued in reverse, the mower struck the car parked in the barn causing the mower to jackknife. The tractor continued moving in reverse, and the victim was pinned between the steering wheel and the auger casing. The mower was against the east wall. The tractor eventually stalled.

The broken doorframe limited the maneuvering room the victim had to park the cutter. Keeping storage areas clean, entrances and exits clear, properly storing tools, other items and equipment or materials in their proper storage area, and discarding broken containers and damaged materials are work practices that eliminates clutter and ultimately can reduce the risk of accidents, both to an individual and equipment.

- Keep floor areas where equipment is stored clear of objects that might impede the positioning of stored equipment.

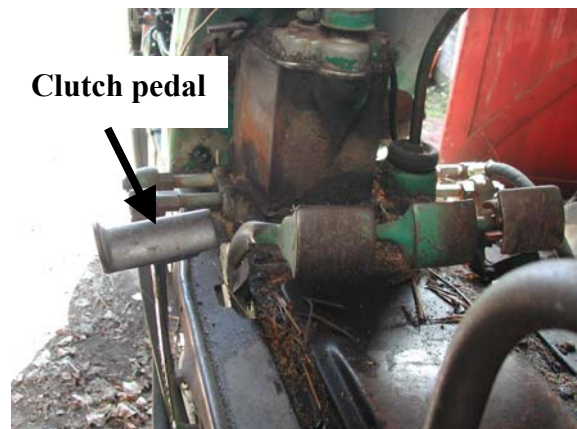
The operation of the Oliver Super 77 tractor clutch makes backing up potentially difficult because of the clutch pedal's relationship to the operator's seat and its lack of aggressive surface. (See Figure 8) A tractor operator's left foot may slip off of the clutch pedal while turning their body when traveling in reverse due to the lack of aggressive tread on the pedal. The tractor's clutch pedal was smooth and may have been a contributing factor in this fatal incident. Newer tractors have incorporated an aggressive surface and, over the years, modified the foot pedal design and placement to increase the operator's ability under routine and/or non-routine working conditions to initiate and maintain contact with the pedal. On older tractors, a possible solution to increase and maintain contact with the foot pedals is to "rough up" (i.e. crosshatch design) the pedal contact surface with a 4-inch portable grinder (See Figure 9). Addition of a non-slip surface, or a rubber pedal cover to the foot pedal surface is another option.

Figure 8. Oliver Super 77 clutch pedal

- Consider adding roughness to smooth clutch or brake pedals by using a 4-inch portable grinder or welding a bead of metal, or cover the pedal with a non-slip surface for added foot pedal control.

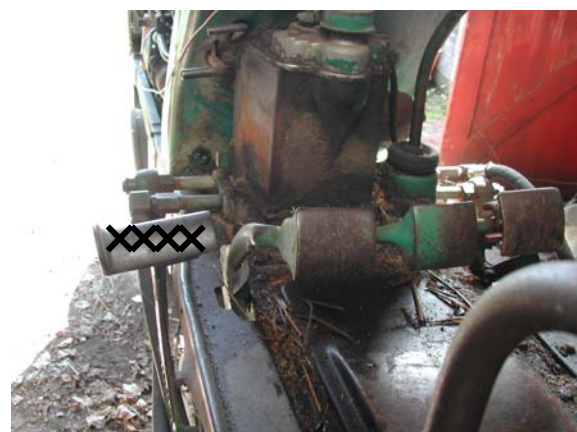
Figure 9. Crosshatch design on clutch pedal
