MIFACE INVESTIGATION: #03MI022

SUBJECT: Indoor amusement manager killed when struck by a moving roller coaster

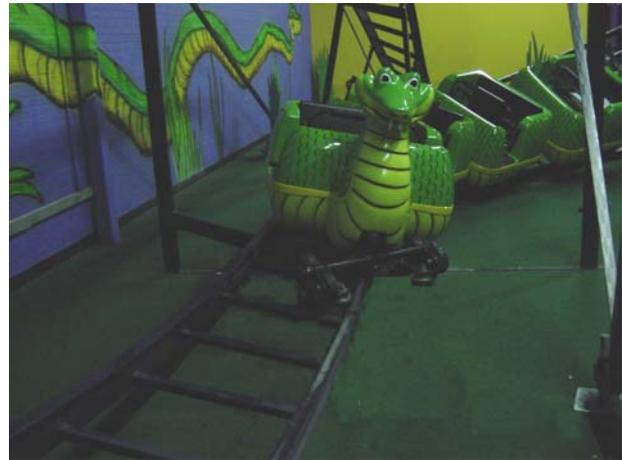
On March 1, 2003, a 43-year old male amusement manager of an indoor restaurant and game room facility was killed when he was struck from behind by a moving 5-car roller coaster. The victim entered the fenced roller coaster area near the end of the ride circuit. The ride operator had completely loaded the cars and the ride was approximately half way through one track circuit. It is thought that he was looking at a structural area previously identified by a building inspector as needing a support plate on the floor. The roller coaster operator did not see the victim enter the area or see the coaster strike the victim. When the roller coaster came around the track curve, it either struck him or a piece of the front roller coaster car caught on a piece of his clothing and dragged him on the track. (See Figure 1). The coaster ran over the back of the victim's neck and derailed. 911 was called and emergency response arrived. The victim was declared dead at the scene.

Figure 1. Derailed roller coaster

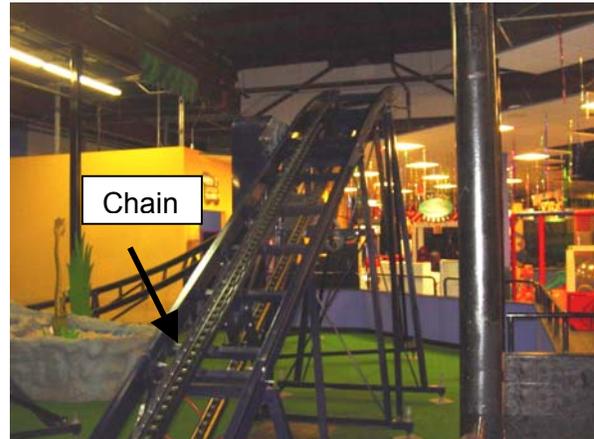
The company leases this 5-car roller coaster from the manufacturer. The coaster is designated as a free-fall coaster. The coaster is pulled up the lift hill (the first hill), using a chain wound around gears at both the top of the hill and bottom of the lift hill. (See Figure 2) A motor powers the chain loop and it turns the loop of chain so that the coaster can be raised up the lift hill. The chain is grabbed by 2 sturdy hinged hooks (chain dogs) under the track at the bottom of the lift hill. When the ride starts, the motor powers the chain and the chain/chain dogs pull the cars up the lift hill. At the top of the hill, the chain dogs are released and the roller coaster begins its descent down the hill. Once at the top of the lift hill, the coaster travels by its own power along the tracks and cannot be stopped until the coaster enters the chain area again, where brakes can be applied, and the chain dogs hook onto the chain. The chain area begins before the operator's position. An emergency stop is present and was functional at the time of the researchers visit.

Figure 2. First Hill of Roller Coaster

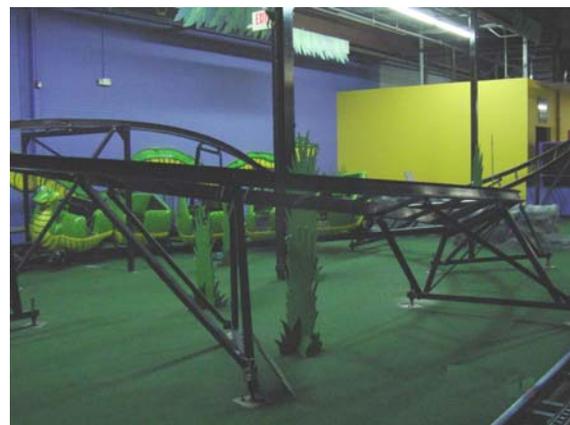
The lead car of the roller coaster has a “python” head design; the other 4 cars follow that theme. The roller coaster runs along a 2-inch dual rail track. The track width is 28 inches, with 24 inches between the rails. At the point where it is believed that the victim was hit by the car, the track was 18 inches off of the floor. The python head is approximately 30 inches tall. The coaster's speed is approximately 10-12 miles per hour, or approximately 24-28 feet per second. The ride circuit begins at the operator station where passengers are seated and secured in the coaster cars. A track circuit begins and ends at the operator's station. The normal ride is three times around the track circuit. (See Figure 3)

Figure 3. Overview of Ride

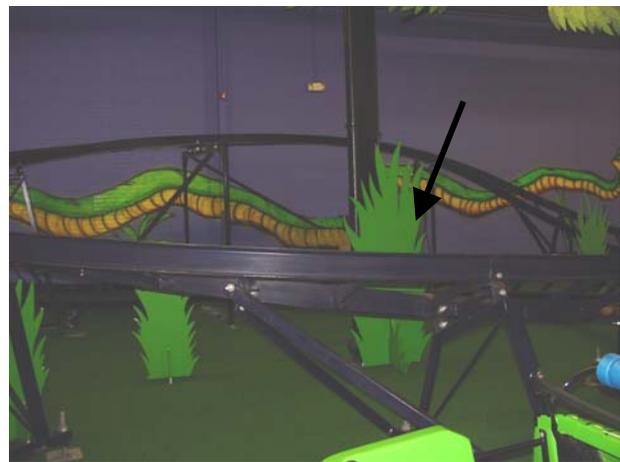
The victim entered the ride area while the ride was running without the knowledge of the ride operator. The ride operator was at the operator station. It is believed that the victim entered through the tunnel area from the back portion of the ride. When the MIFACE researcher stood at the operator's control panel, the location where the victim was struck is hidden by a plant decoration.

It is unknown if the ride operator stopped the coaster at the end of the 3rd circuit, or if the operator let the coaster continue around the track for a 4th time. Patrons on the ride witnessed the death. The location where the victim was struck was at a descent from a hill that curves toward the tunnel area. This location is also the location where the building inspectors indicated the track required the metal floor support plate. Witness statements do not concur concerning the location of the victim. It is thought that the victim was inside of the tracks when he was struck, but he may have been standing along side of the track. It is unknown if the victim was facing toward the approaching coaster or if his back was facing the coaster. As the roller coaster came to the position of the victim, the "Python" head on the first car of the roller coaster either struck the victim or caught on a piece of his clothing. A part of the victim's pant leg near the cuff was ripped. The victim was struck from behind by the first car in the right neck/shoulder area. The victim was run over by the car and dragged approximately 5 feet before the car derailed. The right front wheel assembly of the first car derailed after breaking a 6 inch section of track. The victim's screwdriver was on the floor near the track and a type of screw identical to those found on the roller coaster was found near his shoe.

Figure 4. Approximate Location of Victim

Mirrors positioned strategically in the ride area would help to eliminate blind spots in the ride area for the operator. The blind spots created by the use of decorations used to enhance the ride experience are unavoidable. The ride operator is responsible for ensuring the ride is operated safely; mirrors would allow the operator to have a view of the ride areas that he/she can't see from the operator's station.
