MIFACE INVESTIGATION: #03MI079

SUBJECT: Department of Public Works Employee Electrocuted Attempting to Read a Water Meter Located Behind an Apartment Boiler

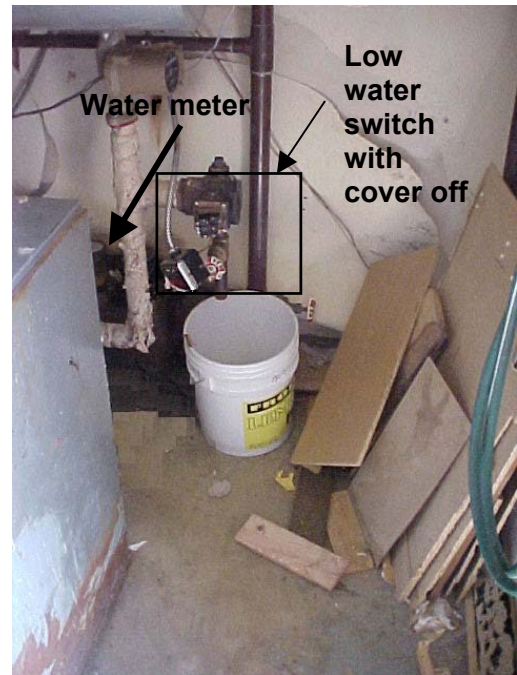
Figure 1. View of area near boiler

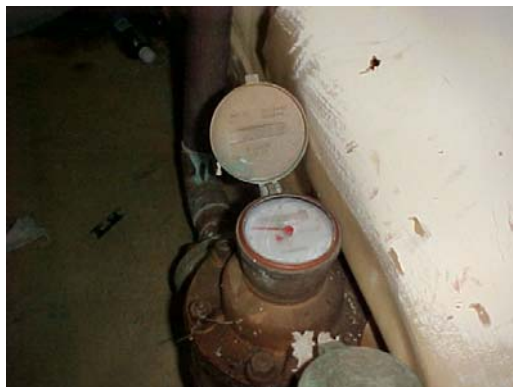
The water meter involved had been installed at the apartment complex in 1972. The water meter is located behind the boiler near the wall at floor level. (See Figure 2) Current building codes would not permit the water meter location to be behind the boiler, however installation in that location was permitted in 1972. The meter was read one time per month.

Figure 2. Water meter at floor level

- **Additionally, city officials should consider a phase-in conversion of direct reading water meters to remote reading meters.**

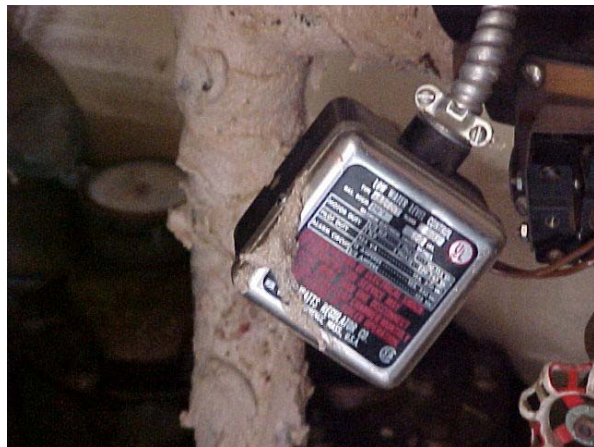
There was approximately 13 inches of clearance between the piping behind the boiler and the water meter. It is unknown if the switch cover was on the switch at the time of the incident or whether the cover was inadequately secured on the switch housing, and the victim knocked the cover off of the boiler's 120-volt low water cutoff switch as he was positioning himself to read the water meter. The victim was a large man, over 250 pounds and over 6 feet tall, which could have made it difficult for him to enter the space behind the boiler to read the meter.

Although exactly what occurred is not known, MIFACE proposes the following scenario based upon the interviews of fellow employees, law enforcement and review of other documents. The low water cut-off switch cover was on the switch but was not properly secured. The victim used the small cigarette lighter that was found under his body to see the water meter face, holding the lighter in his left hand. His back was to the boiler and his chest area was facing the back wall. He may have been using his right hand on the water pipes as support. He attempted to crawl in between the pipes and boiler to read the meter. As he was attempting to enter the space behind the boiler, he knocked the cover off of the low water switch, due to the location of the cover under the victim's left chest when he was found. (If he had knocked the cover off as he was exiting the space, it is thought that the cover would be more towards the right shoulder). (See Figure 3) When he attempted to exit the space, his right chest contacted the exposed terminals, "bending" one terminal into the energized terminal. (See Figure 4) He was apparently touching either the water pipes or the boiler with his body as he provided a path to ground. After collapsing, he became wedged between the vertical pipes behind the boiler.

Figure 3. Low water switch box cover hanging from bracket

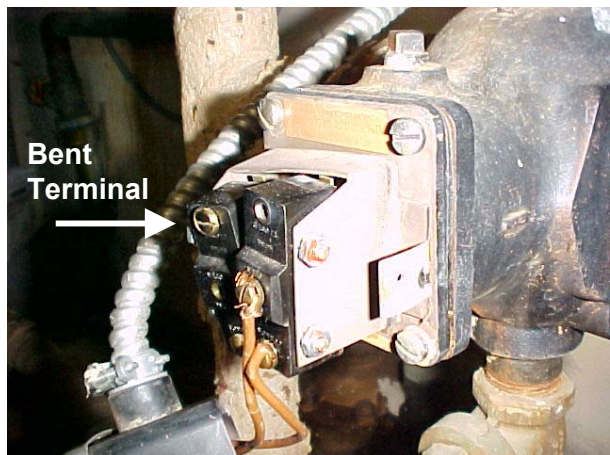
The boiler involved was a Hydrotherm model from 1975. It had received a boiler inspection, and passed, in 2002. This model heats an incoming water supply and supplies heated water to the apartment complex heating units. Eight apartments received their hot water from this boiler unit. The boiler has a 120-volt low-water level cut-off switch located behind and to the side of the boiler on a water pipe. The low water switch will turn off the boiler when water is lost through the system. The 120-volt low water cut-off switch had two terminals and was not properly

grounded. On the day of the incident, the boiler was running and distributing heat to the apartments.

A resident of the apartment complex saw the open boiler room door, and upon walking through, noticed boots near the boiler. The resident went to get the apartment complex manager and the manager went to investigate. Upon seeing the victim, the manager called 911. Emergency response arrived. Police found the victim in a kneeling position, with one leg extended. His head was resting on a hot water pipe from the boiler. His left hand was under his body, his right hand by his hip. His back was against the boiler. The low-water level cut-off switch cover was hanging under his body. There was a burn mark on his shirt and a corresponding burn mark on his chest below the right nipple, nearly the size of the terminals from the cut-off switch. No exit area for the electricity was noted.

Figure 4. Low water switch terminals after victim contact
