MIFACE INVESTIGATION: #03MI179

SUBJECT: Welder Dies from Fall off Rigging

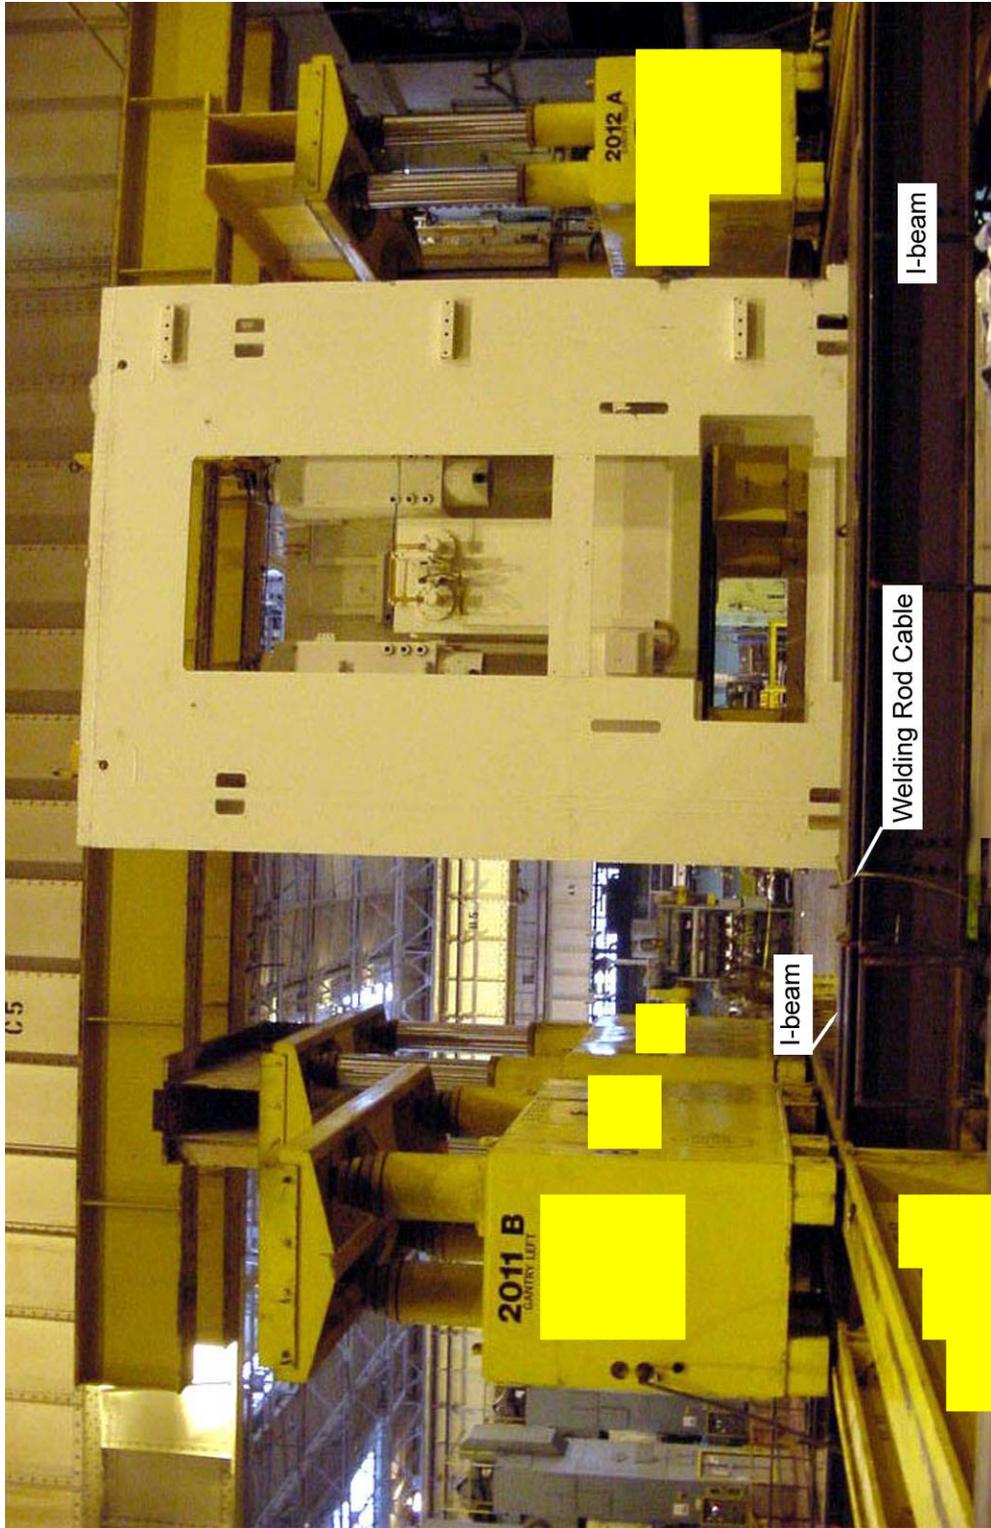
Figure 1.
Press Front, Hydraulic Lifts and Rails

of the press (Figure 1). The crown would then be raised by the lifting apparatus, rolled along the rails across the top of the press and set into place.

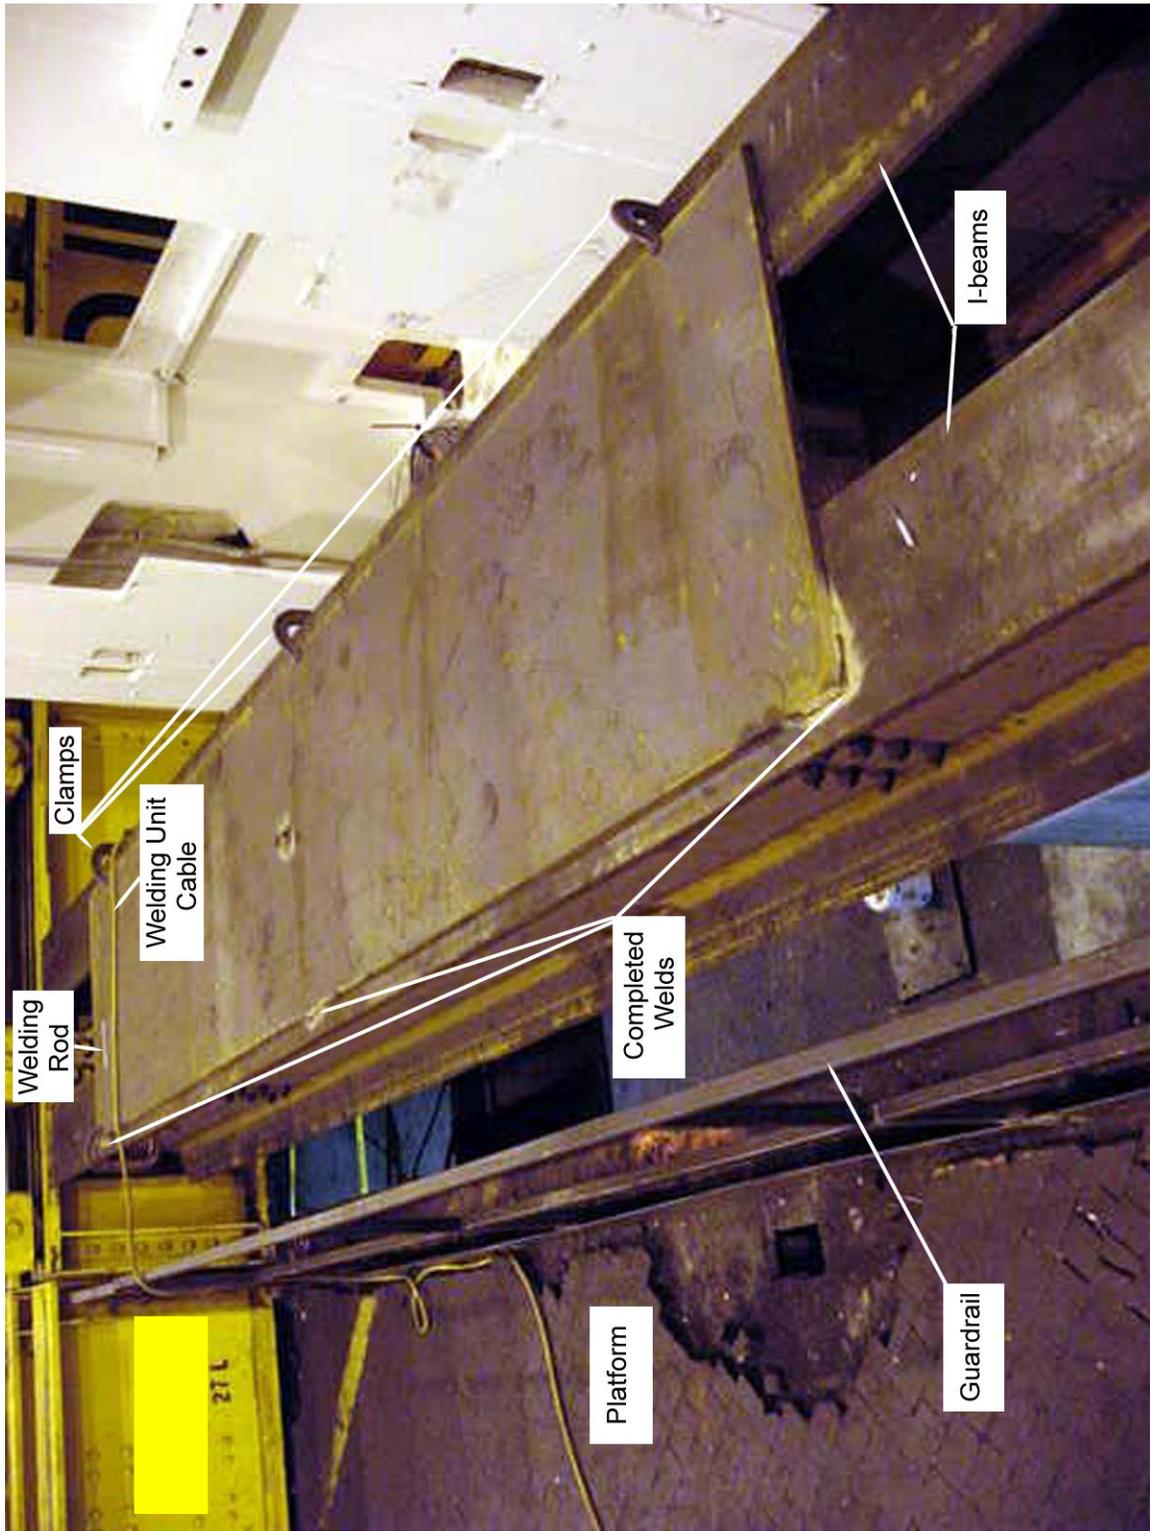
Figure 2.
Steel Plate on I-beams

Two I-beams in front of the press formed a bridge between the rails the lifting apparatus traveled along. The decedent and his co-workers were welding a steel plate, 3/4 inch thick and approximately 3 feet by 8 1/2 feet, to the top of the two I-beams to stabilize them to prevent them from twisting so they could support the weight of the crown as it was placed on the lifting apparatus. The decedent had tack-welded the steel plate onto the I-beam next to the platform he was standing on (Figure 2). He was preparing to tack-weld the far side of the plate onto the second I-beam that was closest to the press. An opening of approximately one foot existed between the I-beam and the front of the press. The apprentice welder with whom he was working saw him start to climb over a guardrail onto the top of the plate to reach the far side of the steel plate, but then turned away to put some equipment away. When he next looked back in that direction, he did not see the decedent (Diagram 1). The decedent was not wearing any type of fall protection. No one actually saw him fall from the steel plate to the press floor 24 feet below. He had fallen from the steel plate between the hydraulic lift (2011B) and the left side of the press. The electric welding unit was examined and found to be in good condition. The welding rod had not been connected to the welding lead. No burn marks were noted when he was being tended to by the emergency responders. No reason for his fall was apparent.
