## MIFACE INVESTIGATION: 04MI074

### **SUBJECT: Millwright Dies When Struck by Uncontrolled, Flailing Crane Cable**

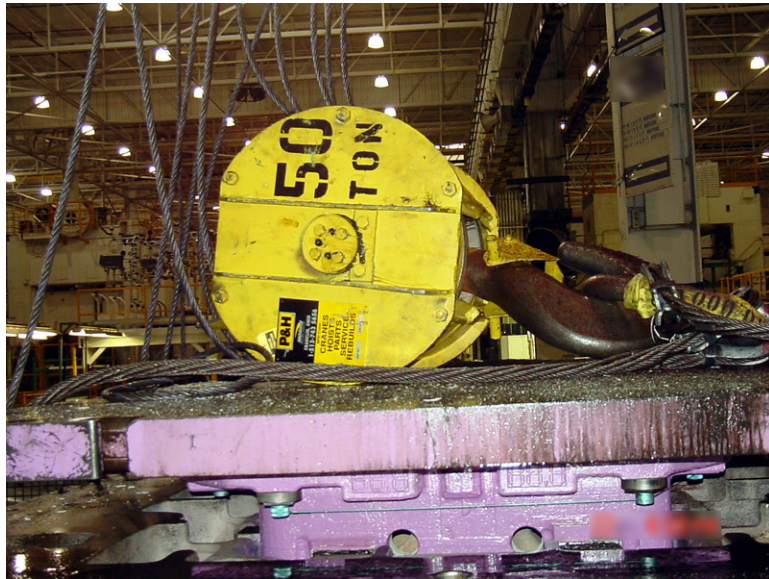
On Tuesday, June 22, 2004, at approximately 1:10 p.m., a 62-year-old millwright was fatally injured when the overhead crane he was attempting to troubleshoot malfunctioned during a lift. The crane had been used to lift a draw die weighing 42.5 tons to a height of between 15 and 25 feet above the plant floor (Figure 1). After the initial lift, the die setter found he was unable to raise or lower the load. This left the load suspended in the air. He

Figure 1. Crane hoist

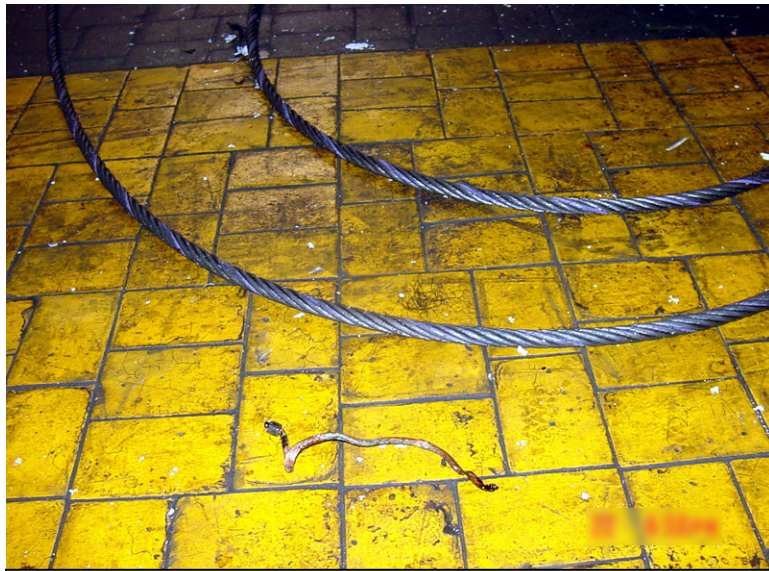
As he was attempting to dislodge the metal piece from the gear, a catastrophic failure occurred resulting in the suspended load falling to the plant floor. While the load was falling the wire rope drum cable was unreeling. The drum spun faster than the cable could unreel causing the cable to swing and jerk violently in the air near the trolley where the decedent was standing. The decedent was struck in the head and on his body by the flailing

Figure 2. Wire rope cables.

wire rope cables (Figure 2). These injuries were fatal. Fire personnel removed his body to an ambulance where it remained until the Medical Examiner arrived a short time later.

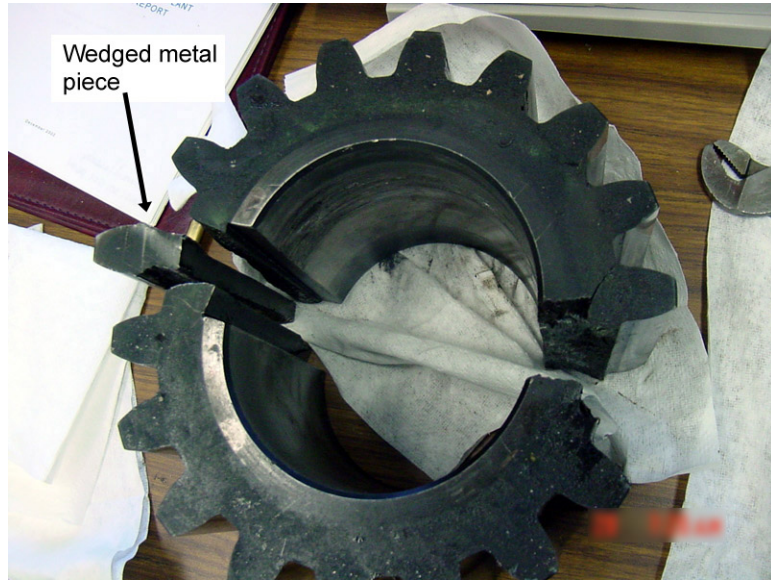
An independent third-party crane inspection expert was contracted to examine the crane components. The inspection revealed that the pinion gear had failed and broken into three pieces (Figure 3). This resulted in the drive train uncoupling allowing the load to fall to the plant floor. Subsequent investigation and metallurgical tests suggested that the failed pinion gear had cracked during one event and fractured sometime later. The tests

also revealed a high probability that the pinion gear's inside diameter was machined outside its original specifications by 0.005 inches. This added stress may have contributed to the fatiguing of the gear once it was pressed onto the shaft. This defect would not be revealed during a visual inspection.

Figure 3. Broken pinion gear.

All cranes in this plant and all similar cranes used by the company were inspected by an independent third-party crane expert. All cranes with pinion gears suspected of being cracked were taken out of service. Suspect pinion gears were sent to a laboratory for metallurgical analysis. Several pinion gears were found to have incorrect internal diameters. The information regarding the pinion gears on similar cranes was immediately sent to all other stamping plants in the company. It was also sent to the management of stamping plants in the same industry as this company. In this company all Whiting cranes built during that time period eventually had the pinion gear replaced.
