## MIFACE INVESTIGATION: #04MI107

### SUBJECT: Engineering Technician Dies When Backed Over by Cement Mixer

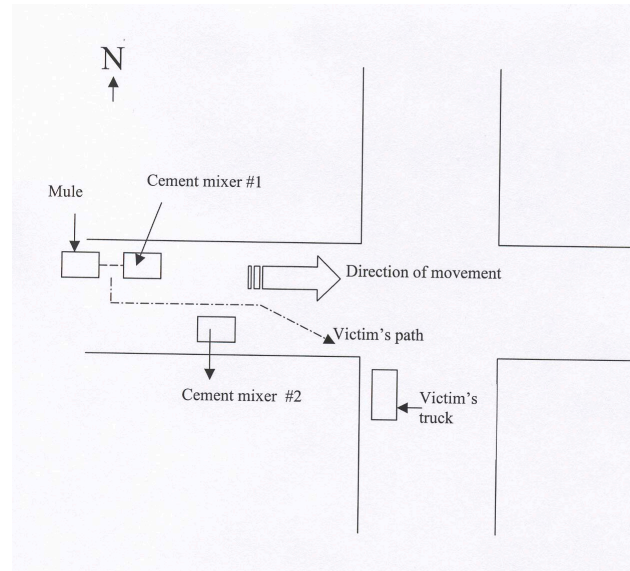
Figure 1. Drawing of incident scene

On July 29, 2004, a 40-year-old male engineering technician was struck and killed on a road-building project by a cement mixer that was traveling in reverse. The road surface was compacted aggregate and crushed limestone and had a slight incline. There were two cement mixers in the immediate vicinity. Cement mixer #1 was unloading cement into a curb-paving machine ("mule"). Cement mixer #2 had already completed unloading its cement into the mule and was being washed out by the driver. To determine if the mixer #1's concrete was within specifications, the victim took a sample that weighed approximately 600 pounds from chute and loaded the concrete into a wheelbarrow. The victim pushed the wheelbarrow past the driver side of mixer #1, and as he came to the rear of mixer #2, he turned sharply south, to his right to get to his truck. The victim's back was facing mixer #2. At approximately the same time, the driver of mixer #2 finished washing out his mixer, entered the cab, activated his backup alarms and began to move in reverse to leave the job site. See Figure 1. It appears that the victim heard the backup alarm from mixer #2 because a witness stated that he increased his pace to attempt to get out of the way of the mixer. It appears that the victim either tripped or lost control of the wheelbarrow and was struck and backed over by mixer #2. The victim was transported to a local hospital where he was declared dead.

- Employers should ensure that workers on foot remain clear of moving equipment by developing and utilizing an "Internal Traffic Control Plan" for each highway and road work zone project.
- Ensure appropriate communication methods for workers on foot and equipment operators; equipment operators should use trained spotters.
- Review options for equipment-warning devices for both construction equipment and employees.

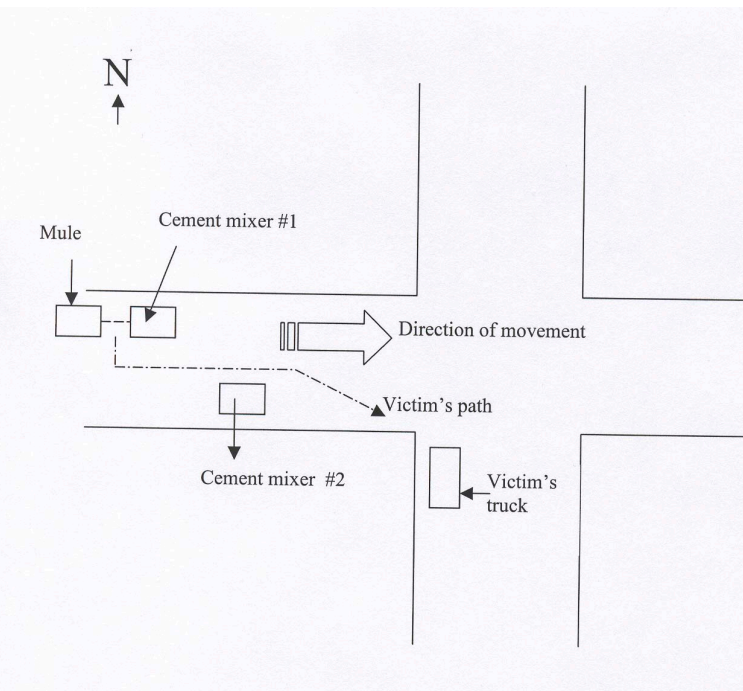
Figure 1. Drawing of incident scene

Curbs were being laid by a slip form paving machine or "mule." This machine is an extrusion-type of machine, and does not use a permanent form for the concrete. Concrete is discharged from the mixer via the chute directly into the mule. The mule lays the curb at approximately 2000 feet/day and must stay moving. Therefore, when a cement mixer is empty, it moves out of the way and another mixer takes its place. The mule and mixer #1 were laying curb on the north side of the road. They were moving east – this required mixer #1 unloading the cement into the mule to be traveling in reverse. The backup alarm was operational. A cement mixer that had previously unloaded its cement, cement mixer #2, had moved to the south side of the road and was being washed out by the driver.

The incident occurred around 11:00 a.m. The victim parked his truck on the southwest corner of the existing crossroad, at the base of the incline of the road under construction. This allowed him to push the empty wheelbarrow up the incline and take the full wheelbarrow down the incline. He took the wheelbarrow to cement mixer #1 and asked for the load ticket. After he gathered the information, he unloaded approximately 600 pounds of concrete from the chute. The victim proceeded back to his truck so he could conduct the quality checks. See Figure 1. The victim pushed the wheelbarrow past the driver side of the mixer #1, and as he came to the rear of mixer #2, he turned sharply south, to his right, to get to his truck. At approximately the same time, the driver of mixer #2 finished washing out his mixer, entered the cab, activated his backup alarms and began to move in reverse to leave the job site.

The driver of cement mixer #2 stated he looked in both mirrors and backed up very slowly with his foot on the brake. All safety features of mixer #2 were in good operating order. According to the police report, a witness thought that the victim heard the backup alarm because he quickened his pace in what looked like an attempt to get out of the way of the mixer. The victim either lost his balance or tripped and fell toward the wheelbarrow. The passenger side rear tire of mixer #2 struck the victim on his right side, and ran over him and the wheelbarrow.

An alternate route, although construction vehicles would have to be moved, was available for mixer #2 to leave the jobsite. The unpaved road under construction continued to the west. After the vehicles were moved, mixer #2 could have driven forward to the west, and followed the road to exit the jobsite instead of exiting the jobsite in reverse.
